THE TOWNSHIP OF BONFIELD

BRIDGE MANAGEMENT STUDY REPORT (DRAFT)

6 BRIDGES / 10 CULVERTS

DECEMBER 2022

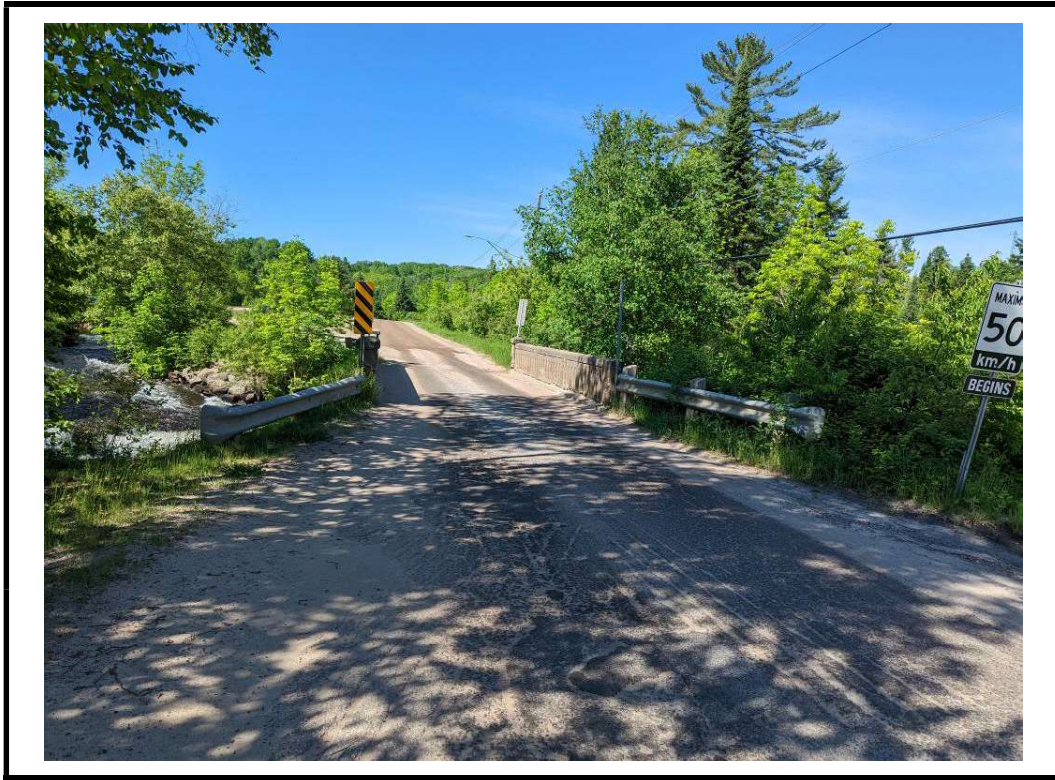
Photo 1 Structure from east approach

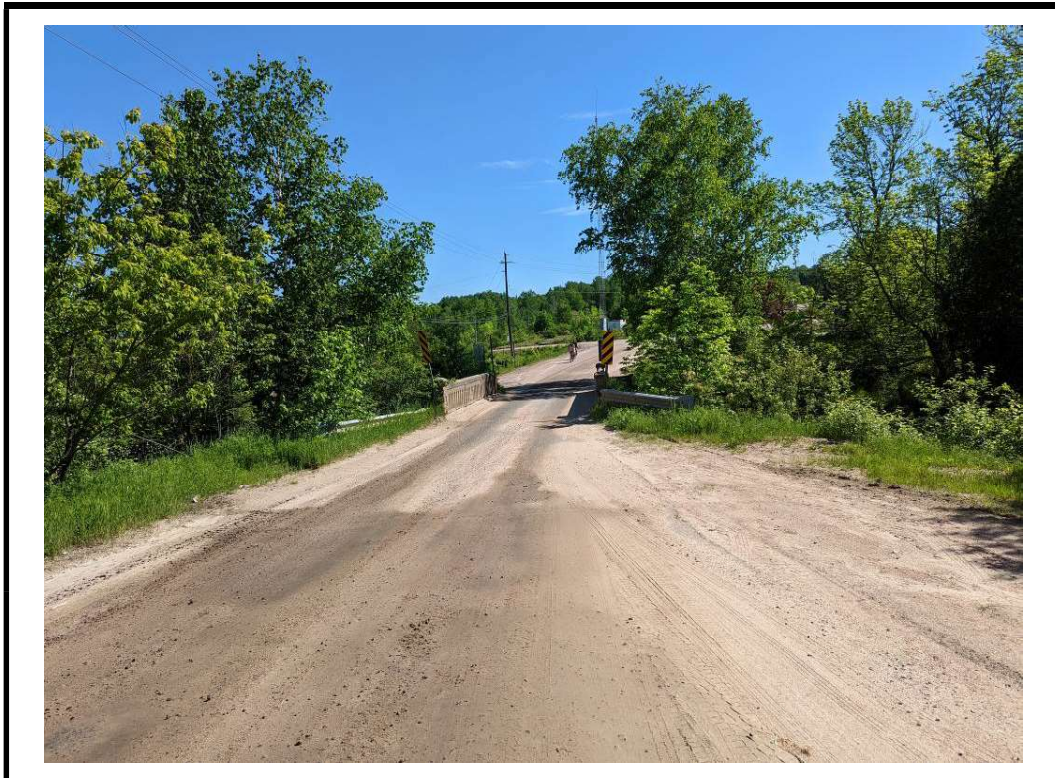
Photo 2 Structure from west approach

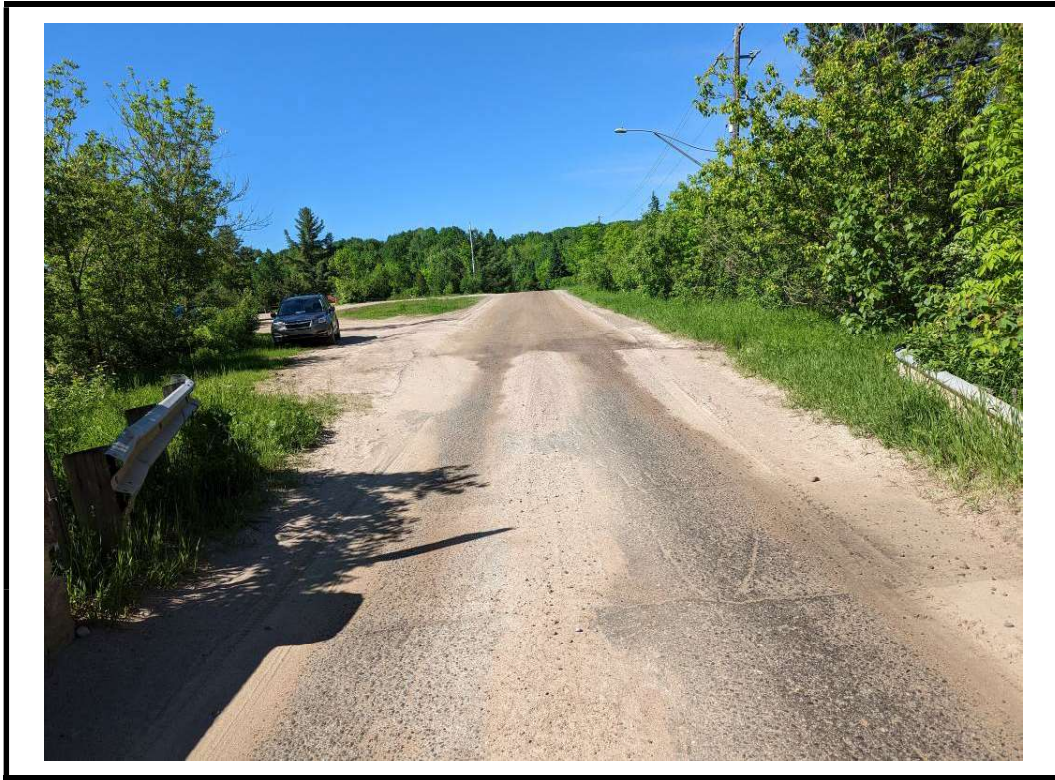
Photo 3 East approach from centre of structure

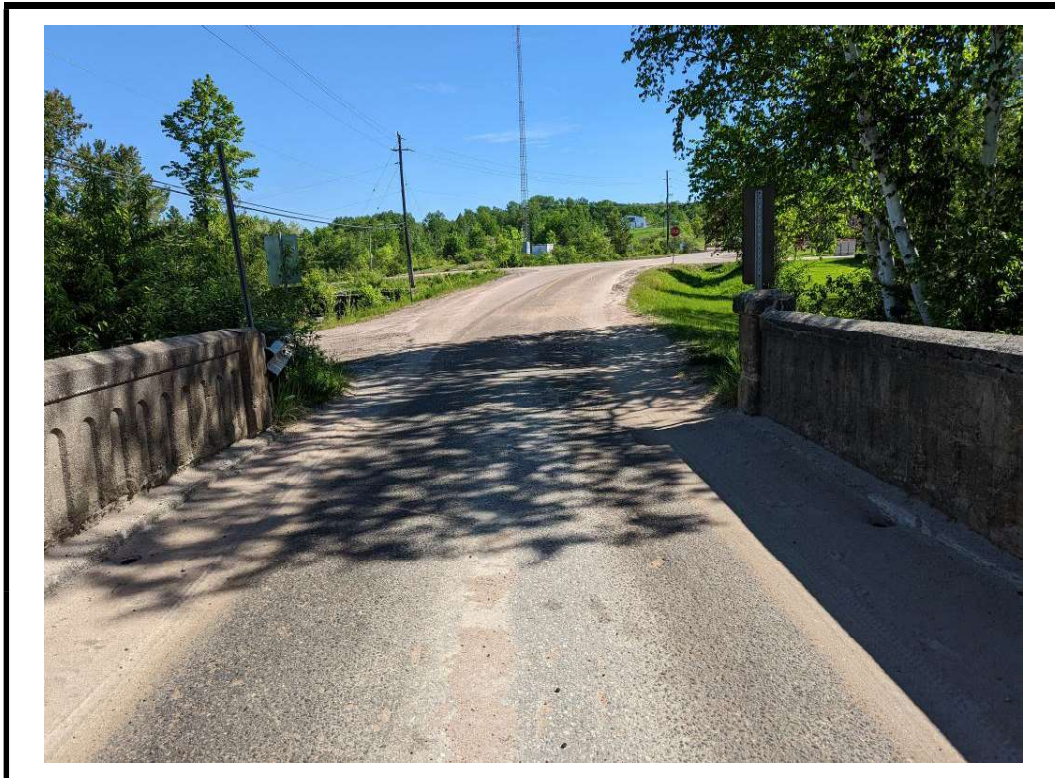
Photo 4 West approach from centre of structure

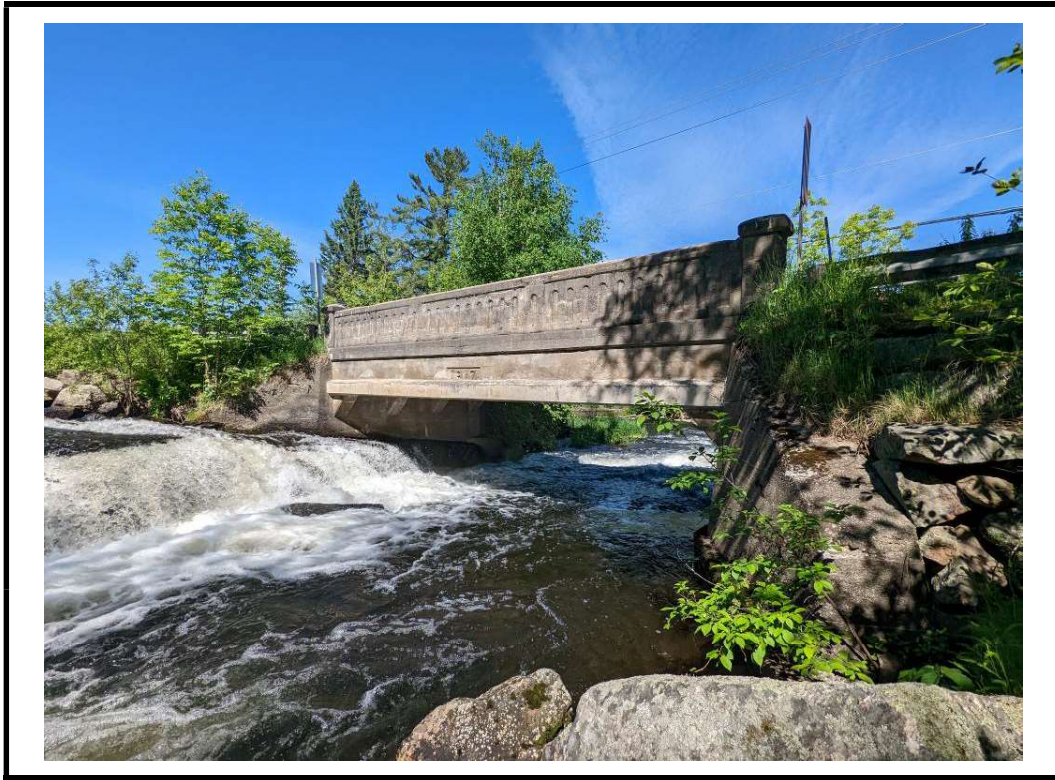
Photo 5 North elevation

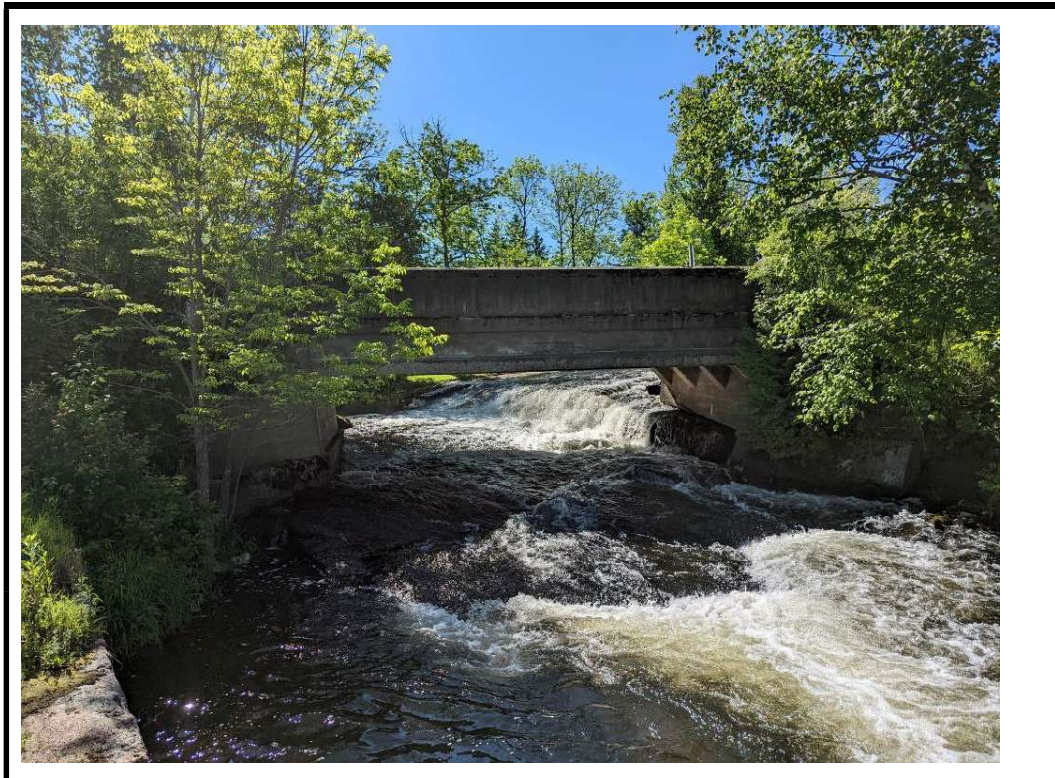
Photo 6 South elevation

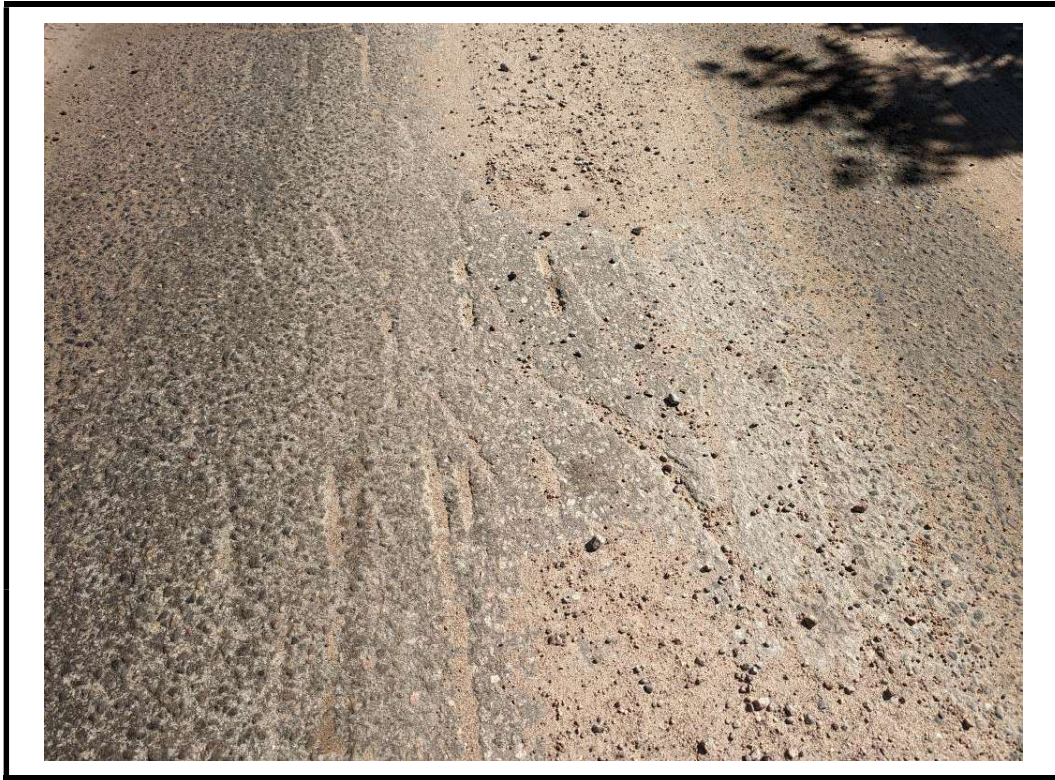
Photo 7 Moderate scaling, tire rutting and gravel accumulation in approach wearing surface (Typical)

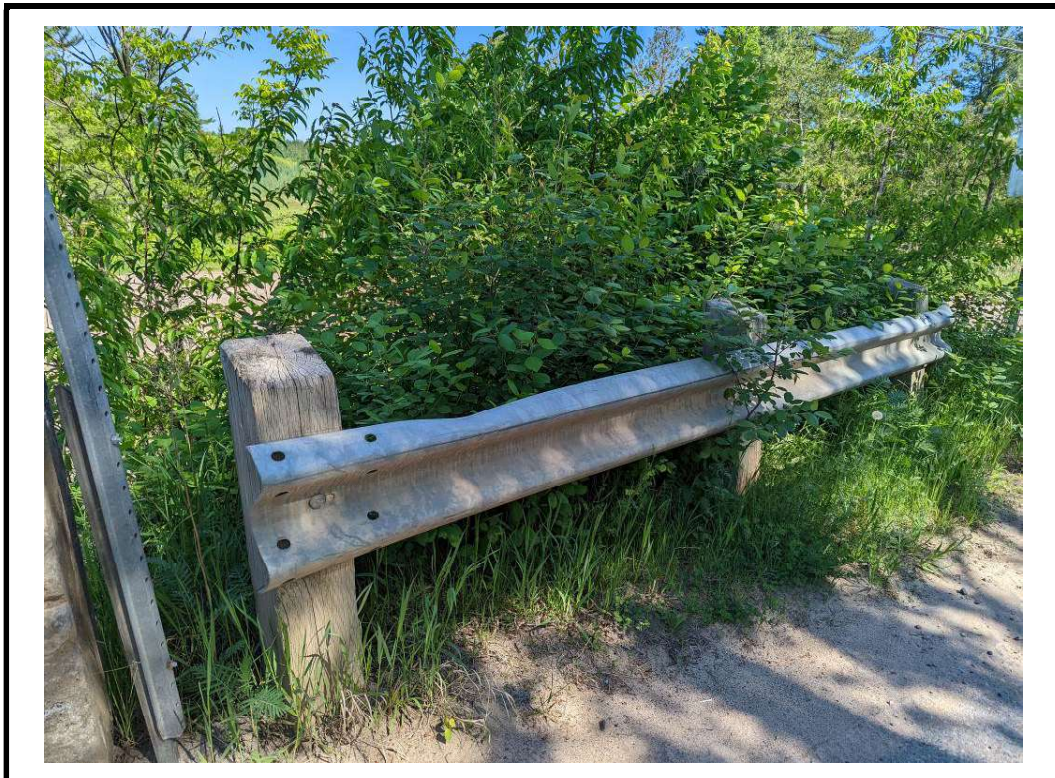
Photo 8 Typical approach barrier at northeast corner with collision damage

Approach Barrier length appears to be substandard and should be further reviewed. Approach barrier end treatments and connections to structure are substandard and should be replaced with code compliant components. Narrow diagonal cracks observed on concrete girders adjacent to abutments. Light undermining noted at both abutments. Small spall with exposed corroded reinforcement at intermediate girder west end.

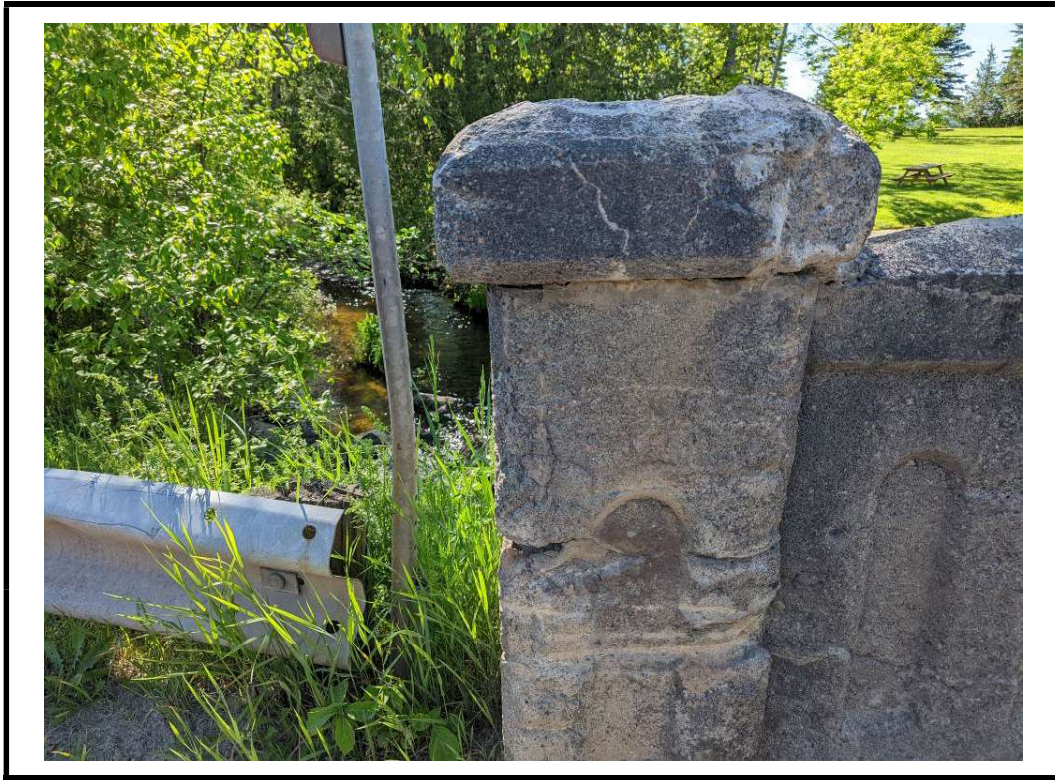
Photo 9 Substandard connection at northwest approach barrier (Typical)

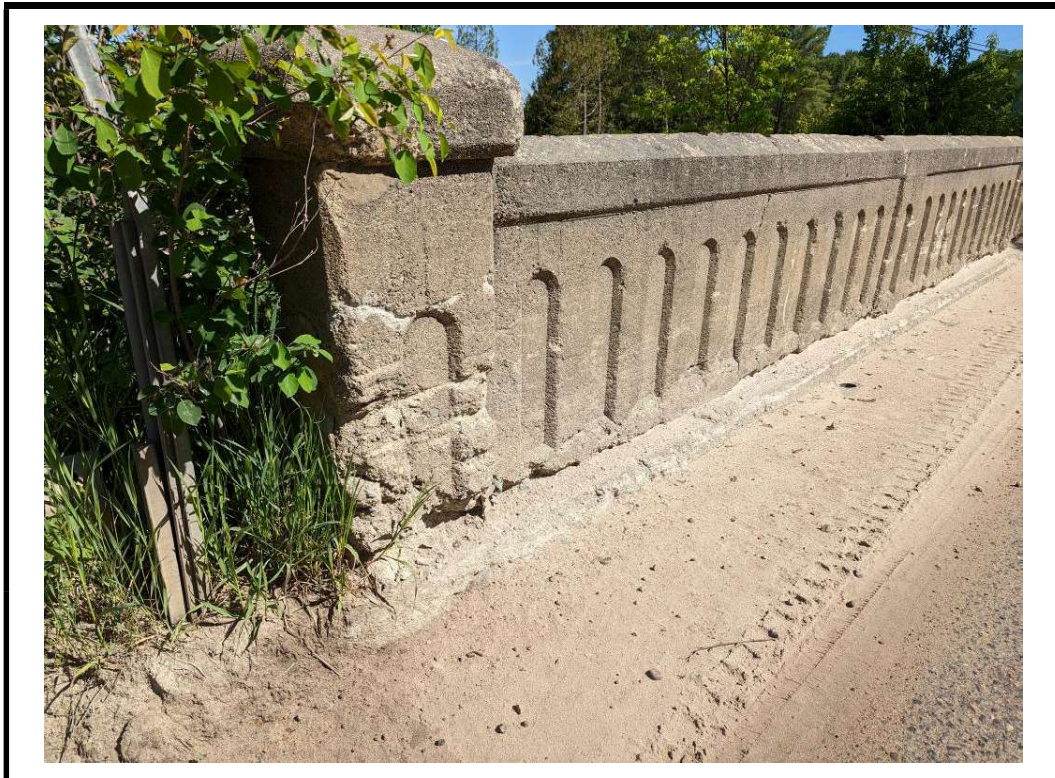
Photo 10 Moderate to severe scaling along base of north parapet wall

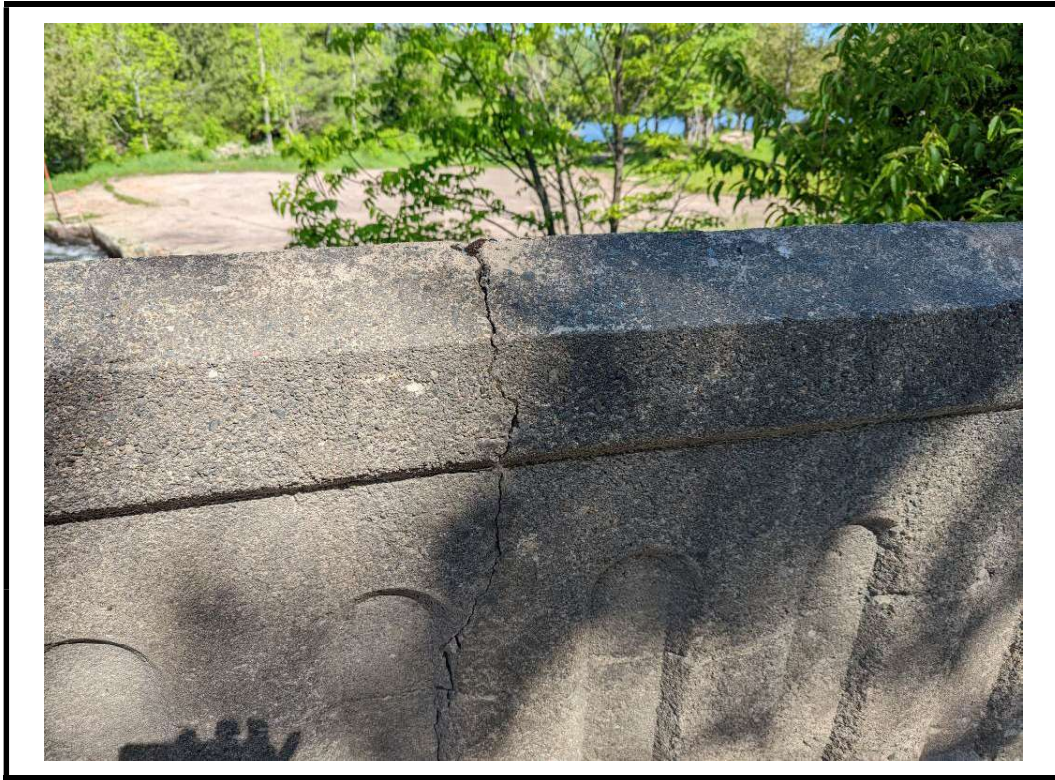
Photo 11 Medium to wide transverse crack noted on parapet wall (Typical)

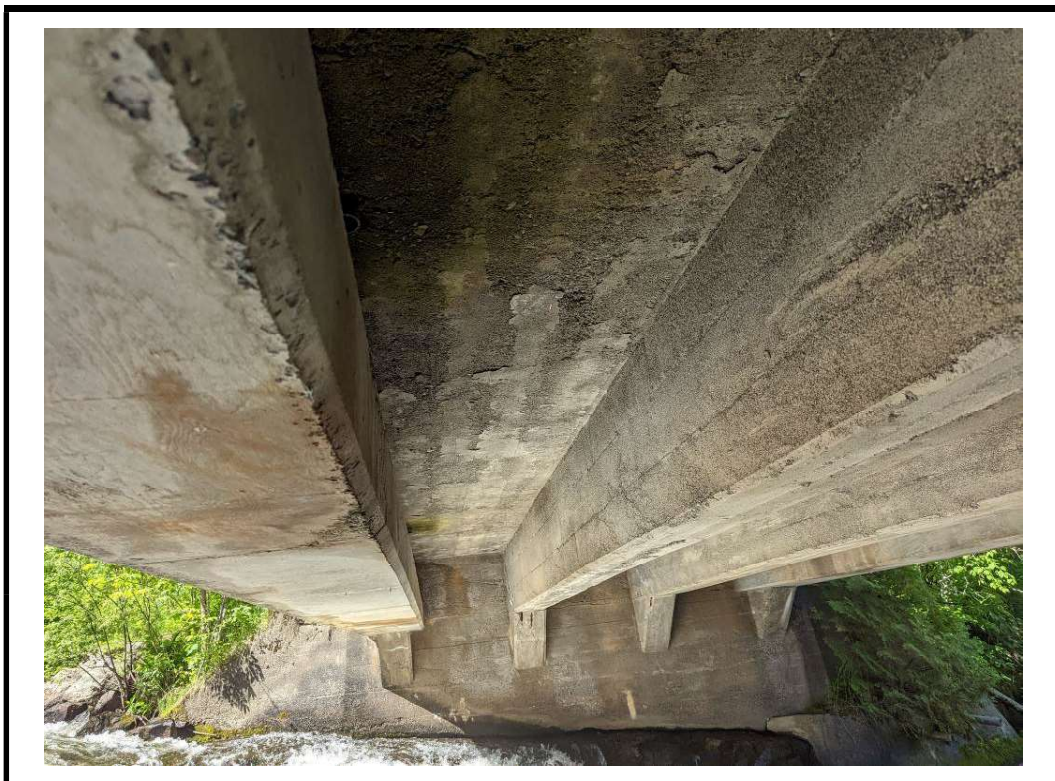
Photo 12 Light scaling on interior deck soffit

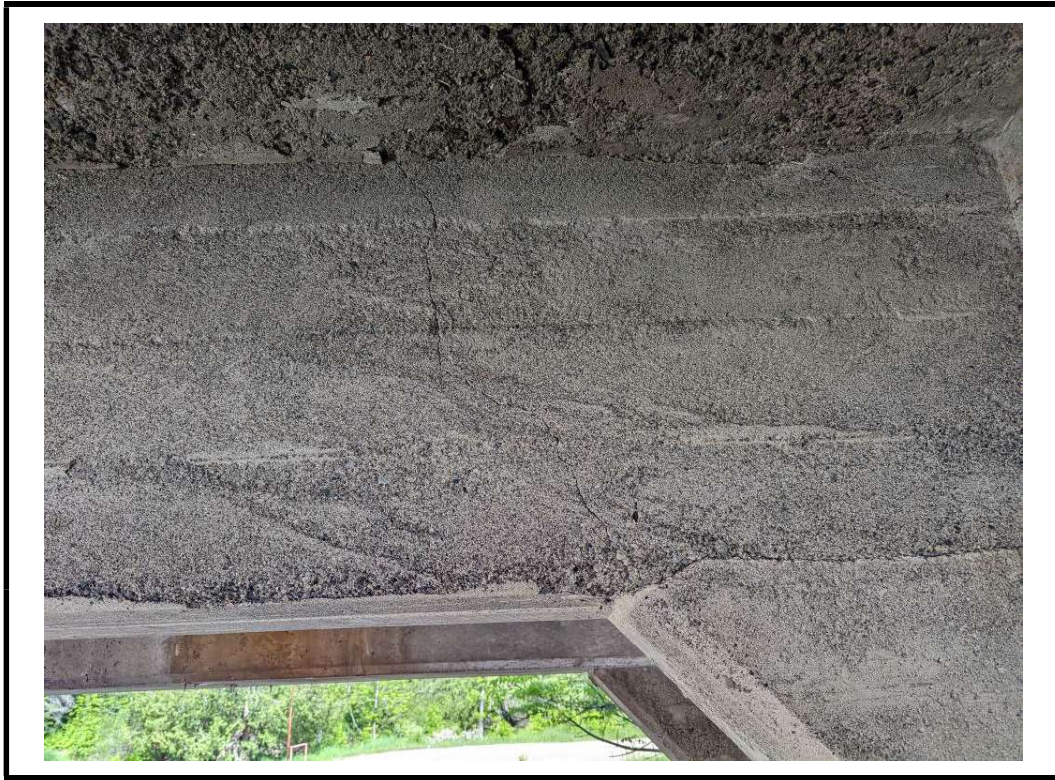
Photo 13 Narrow crack on girder

A rehabilitation / replacement study is recommended due to the age of the structure and the condition of the soffit and girders; it is recommended that the structure be replaced in 6-10 years.

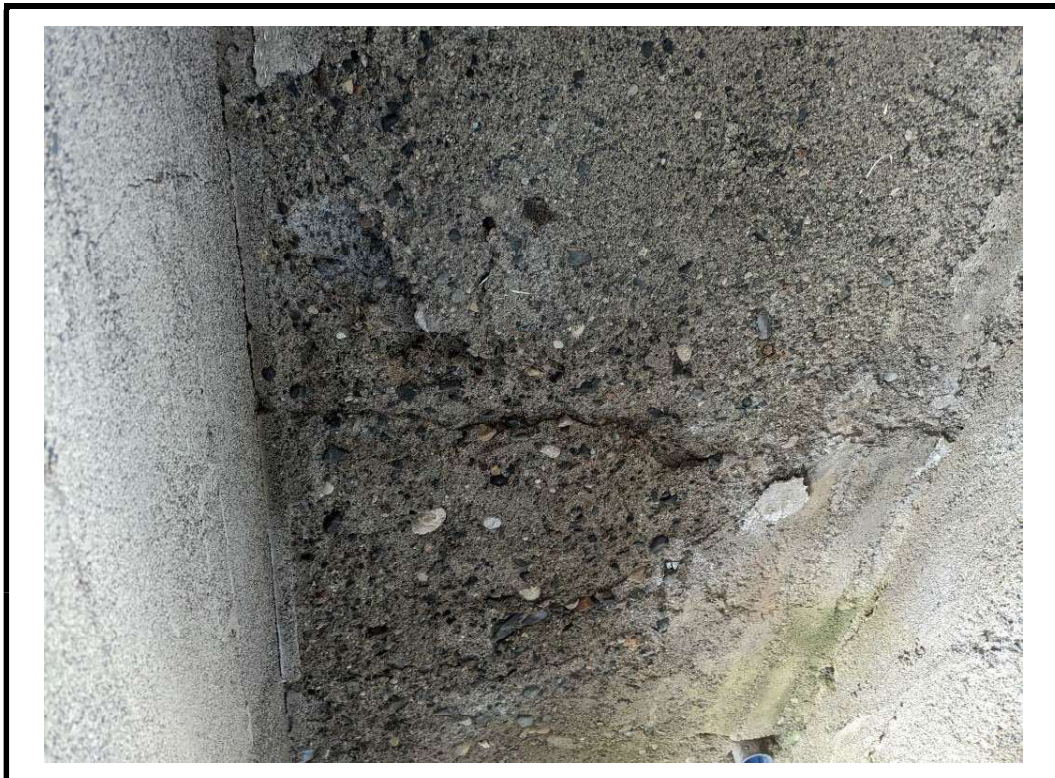
Photo 14 Moderate to severe scaling, narrow cracks and delamination noted on deck soffit

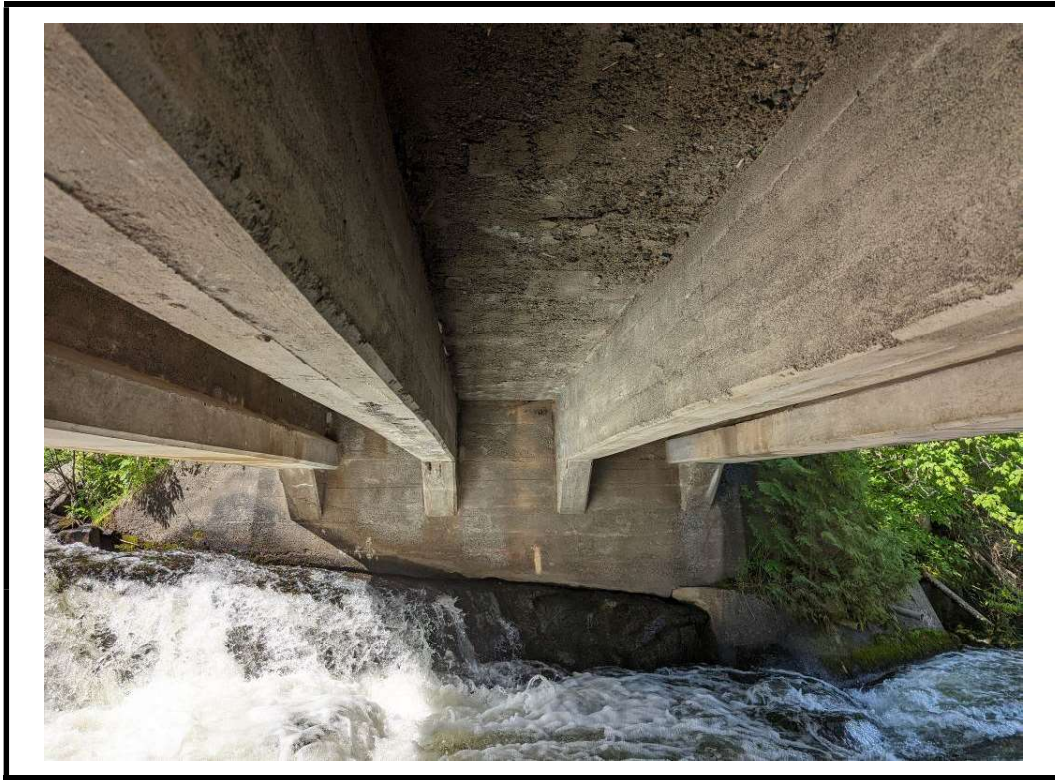
Photo 15 West underside of Structure

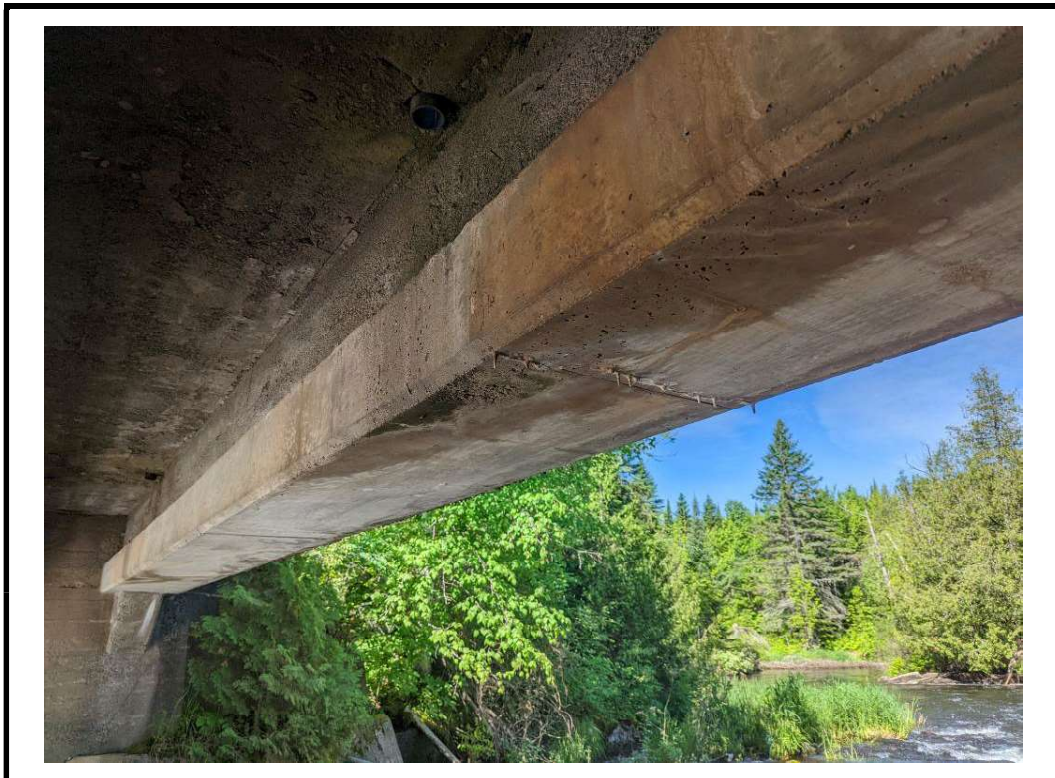
Photo 16 Stalactites observed on previous concrete repairs at girders

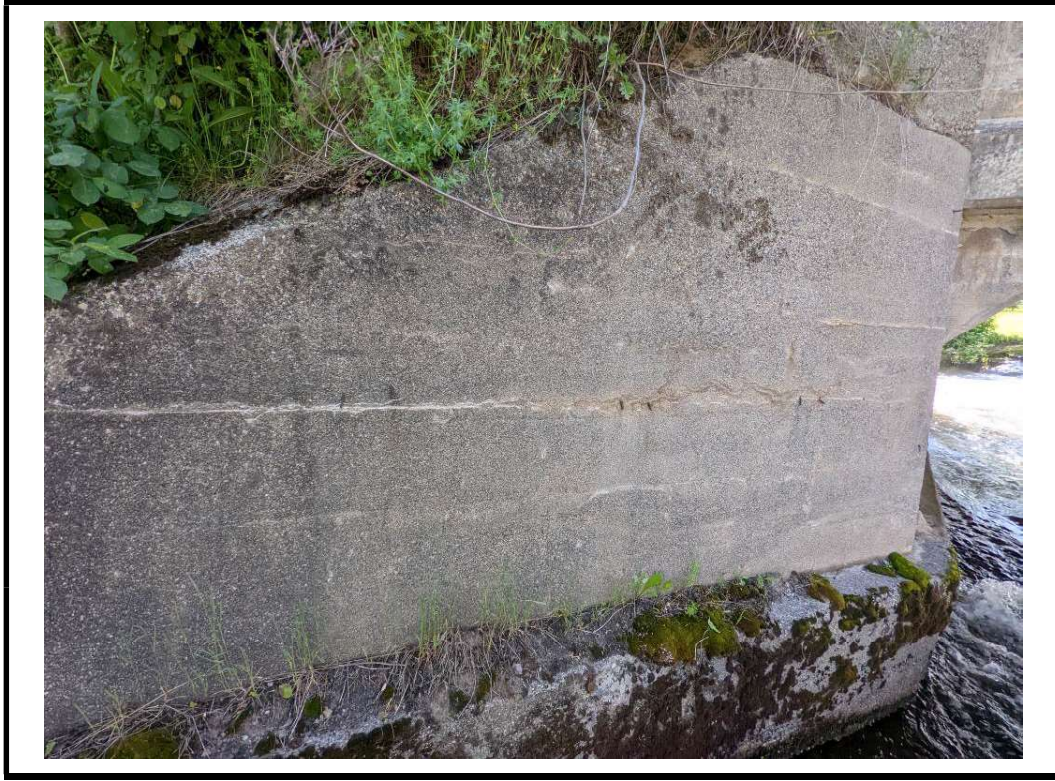
Photo 17 Narrow longitudinal and transverse cracks, damp stains and moos grown at wingwalls (Typical)

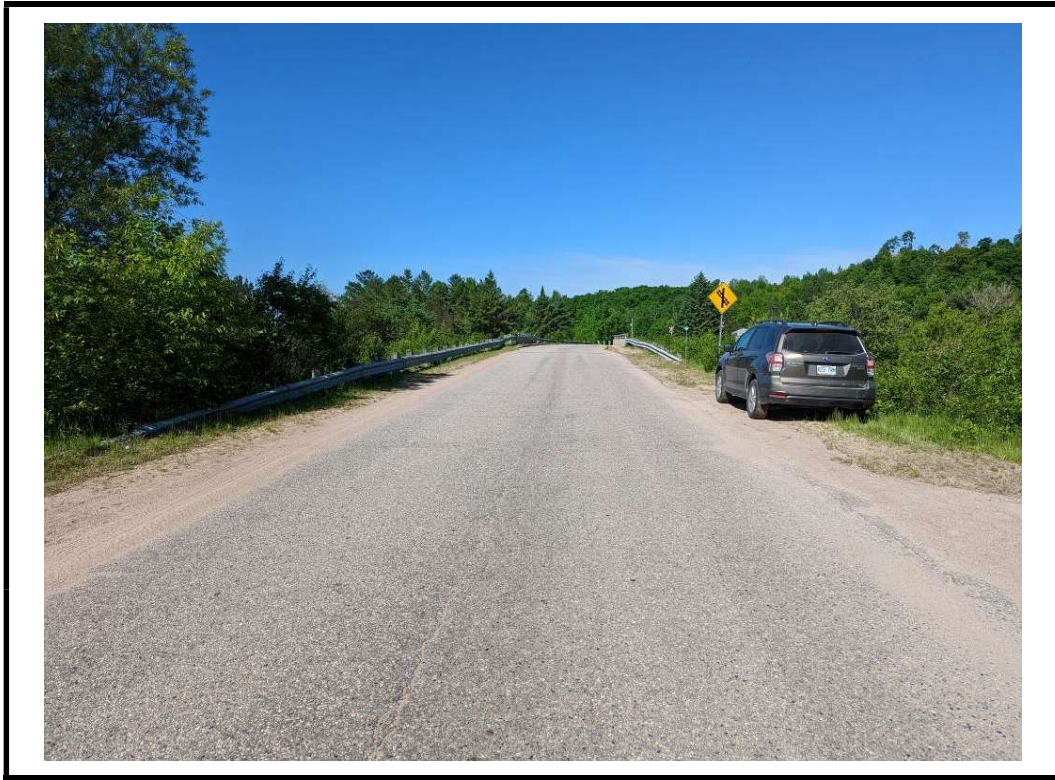
Photo 1 Structure from east approach

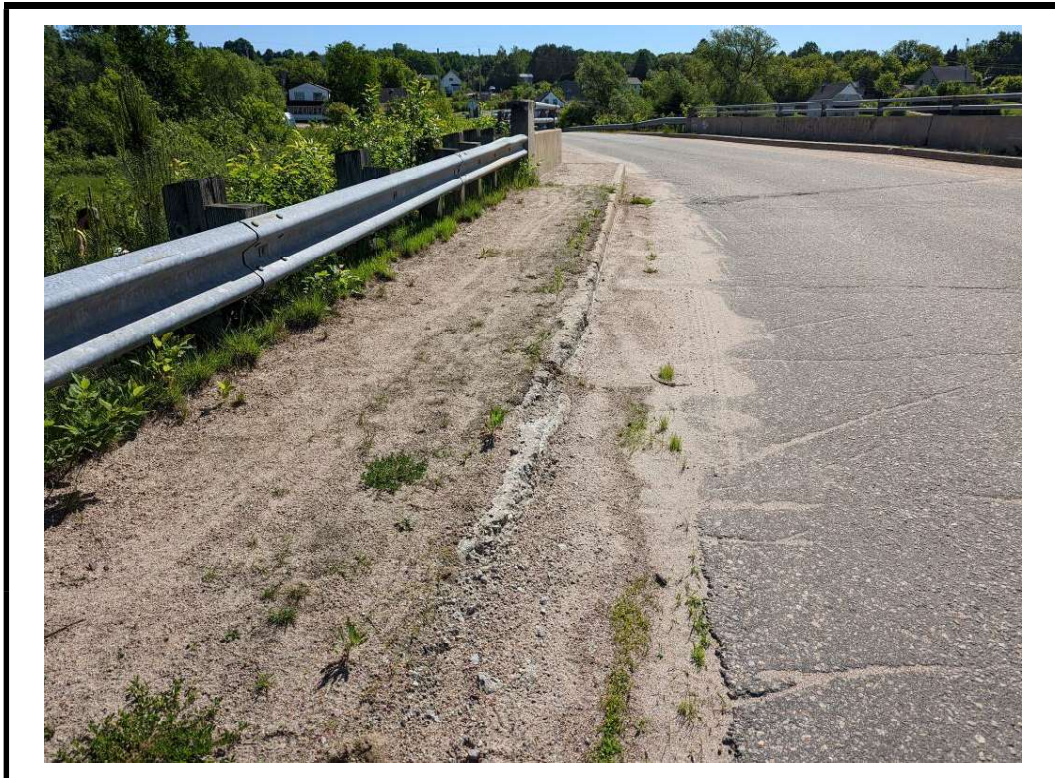
Photo 2 Structure from west approach

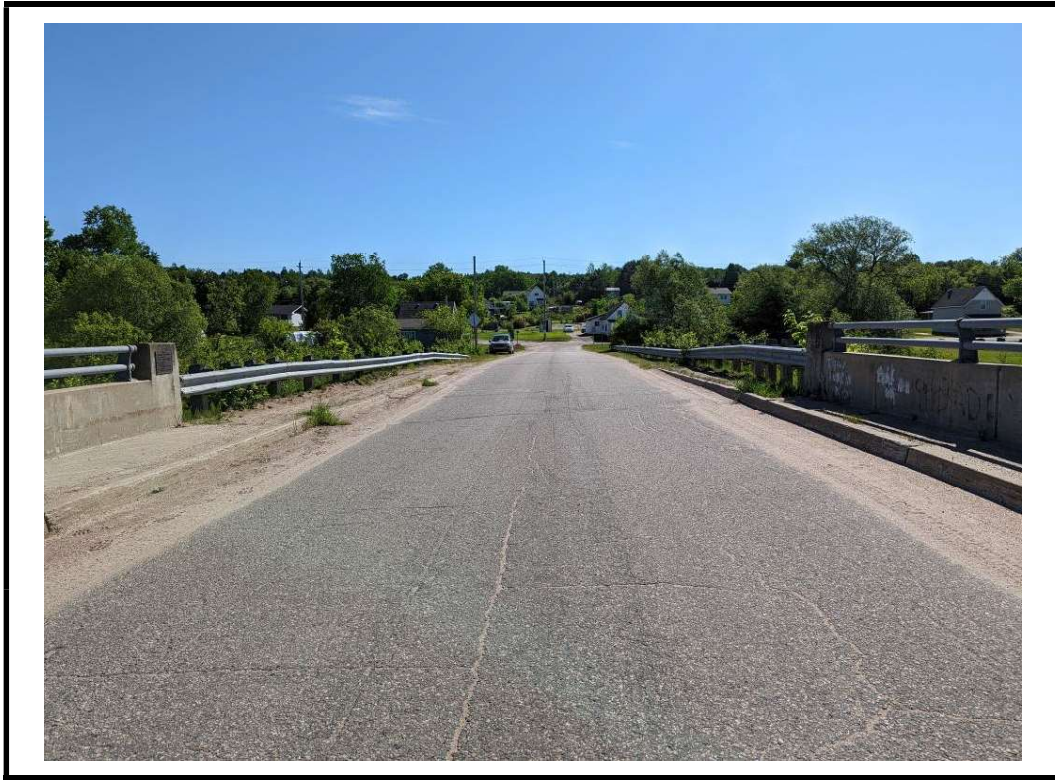
Photo 3 East approach from centre of structure

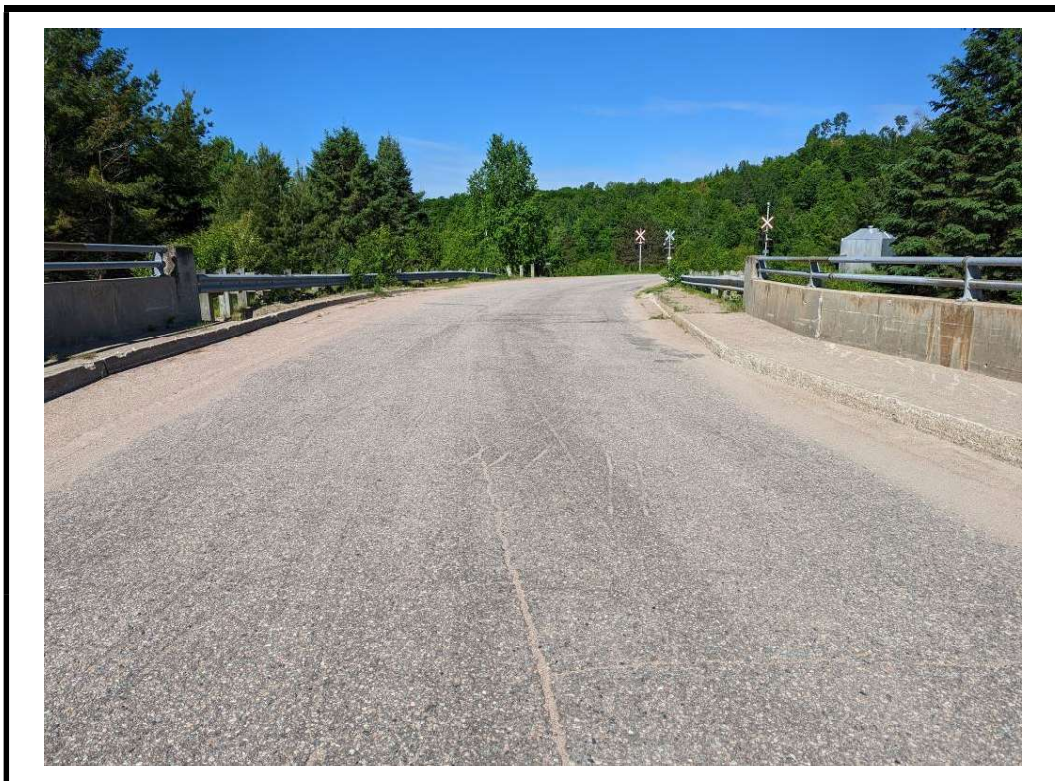
Photo 4 West approach from centre of structure

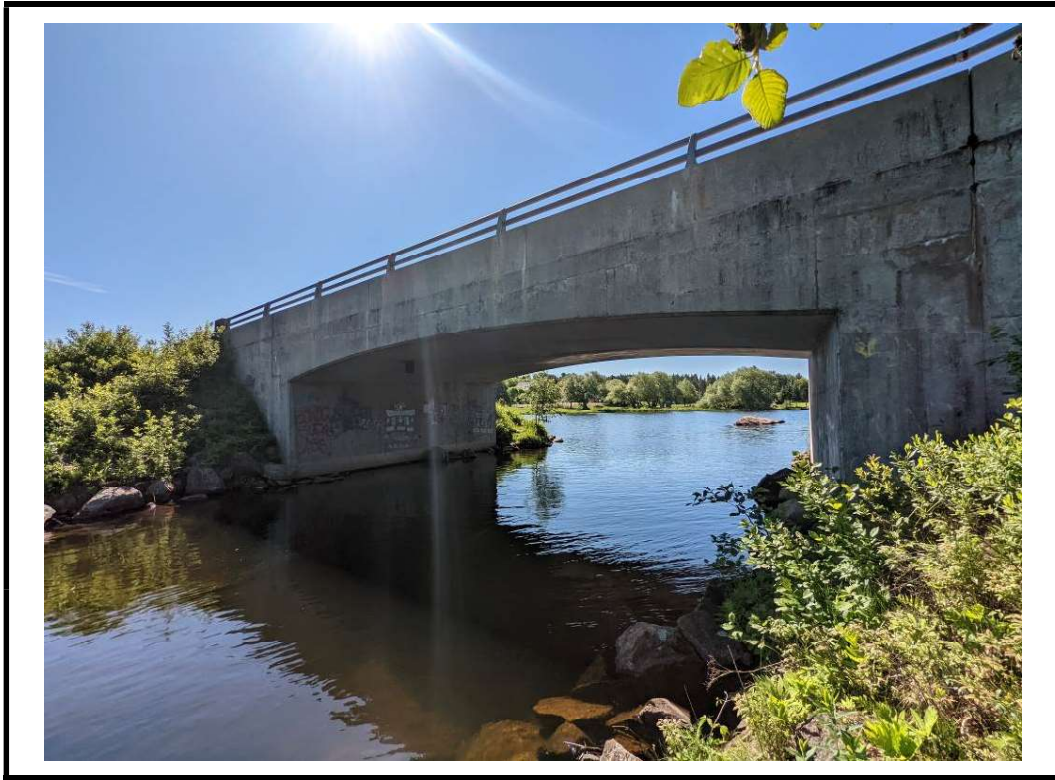
Photo 5 North elevation

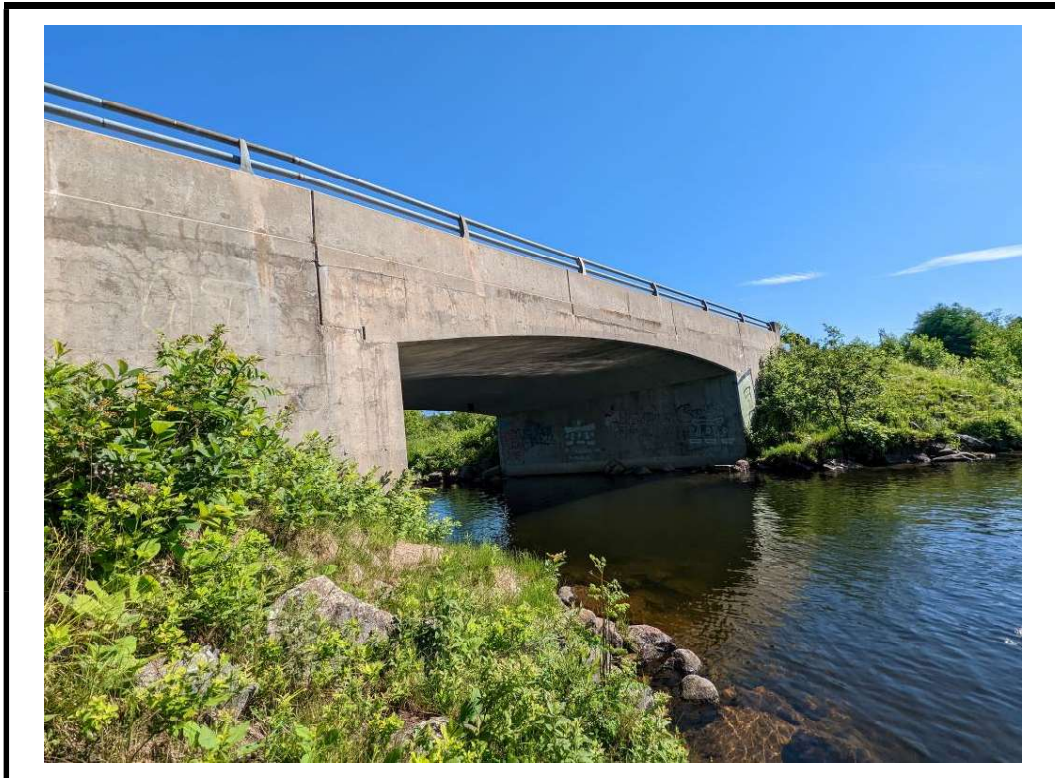
Photo 6 South elevation
