MUNICIPAL STRUCTURE INSPECTION FORM

CULVERT

Structure Name Boundry Road Culvert
Structure Number 05
Date of Inspection June 03, 2022
Project No. 22035
Consultant HP Engineering Inc.

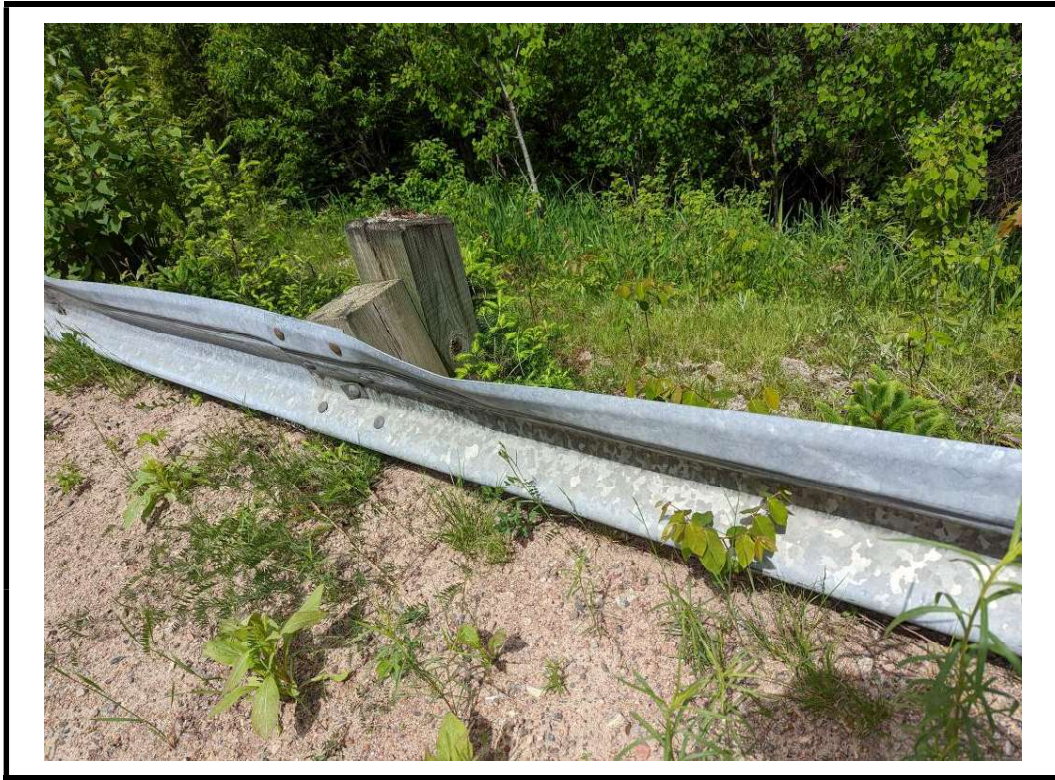
Photo 7 Collision damage noted on steel beam at north barrier

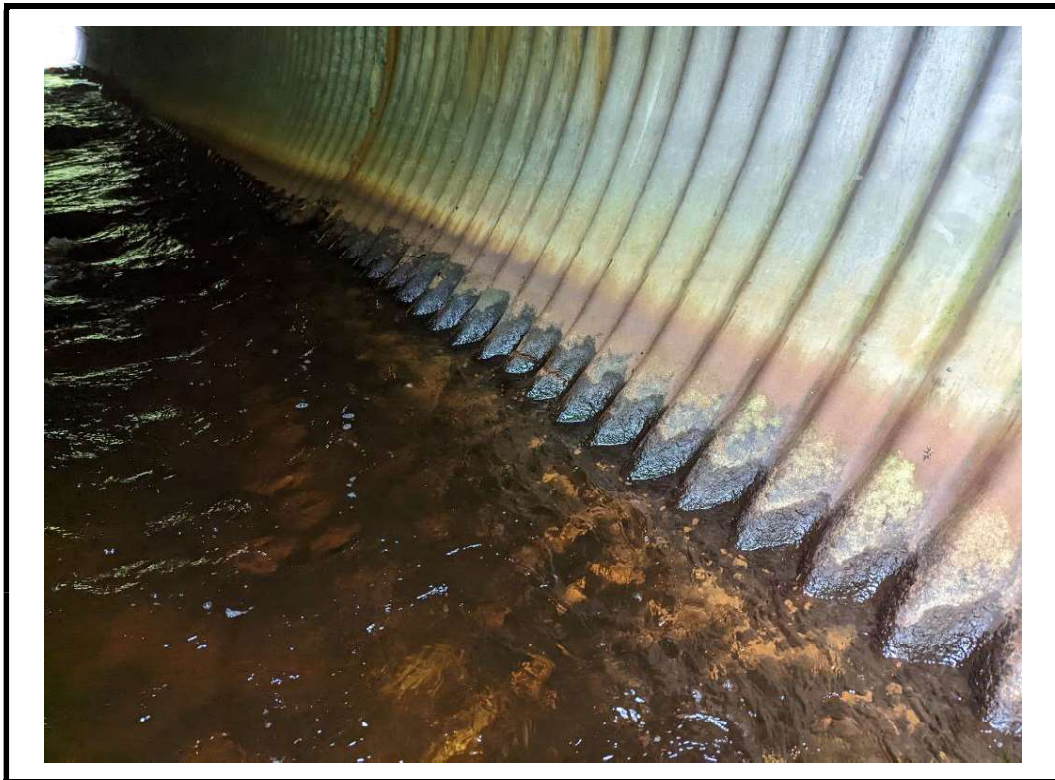
Photo 8 Moderate corrosion noted along bottom of barrel

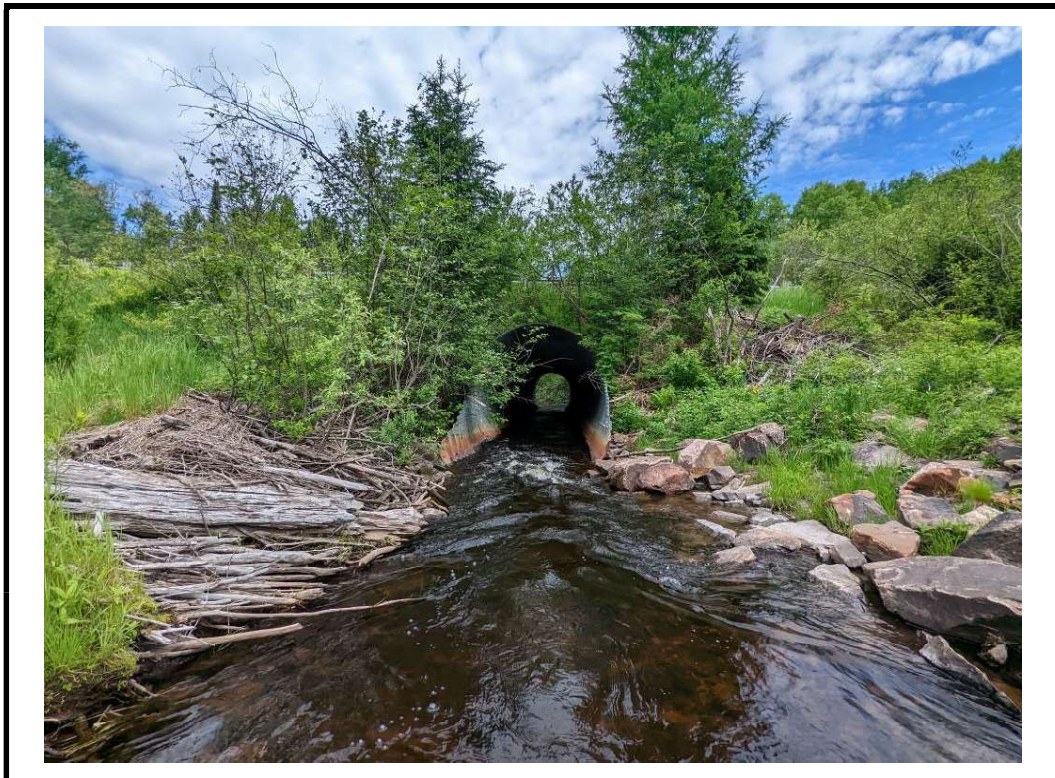
Photo 10 Accumulation of branches noted at south end of culvert.

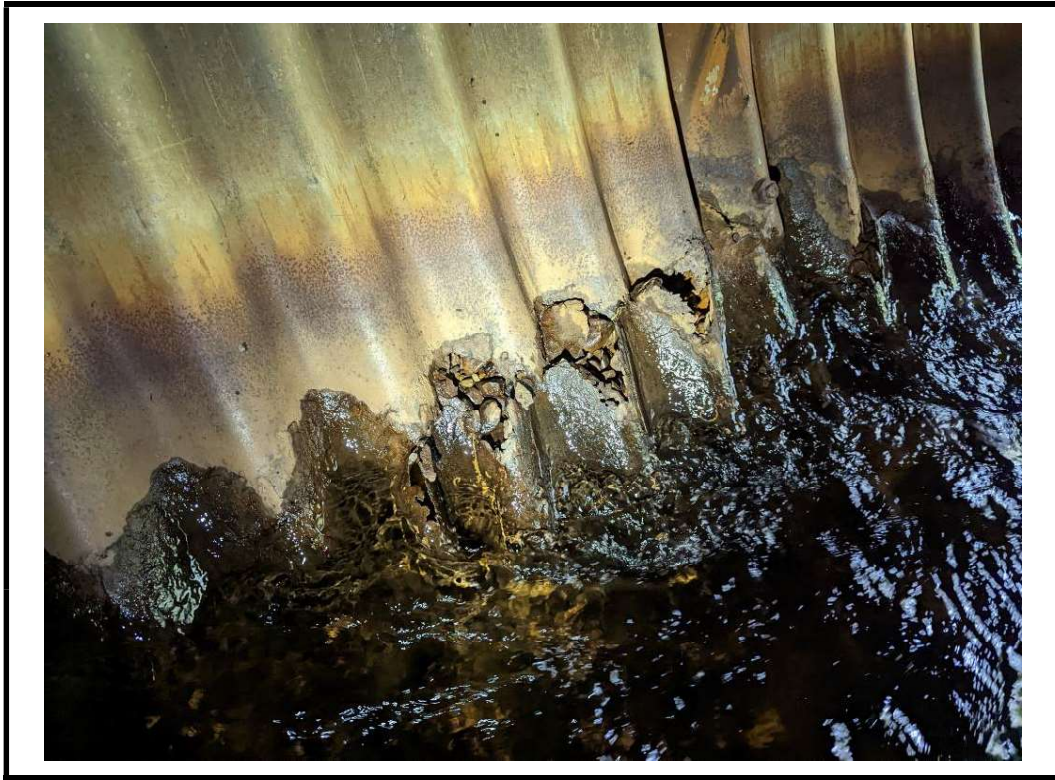
Photo 11 Localized perforation at bottom of barrel, near north end of barrel

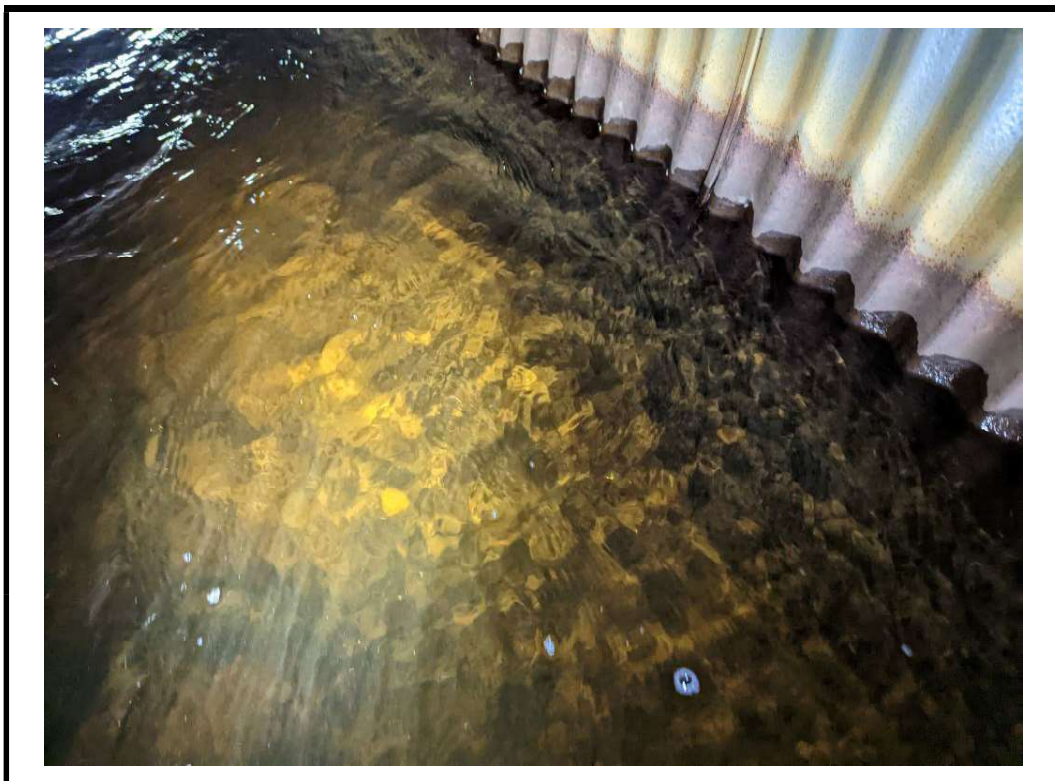
Photo 8 Light to moderate corrosion noted below waterline

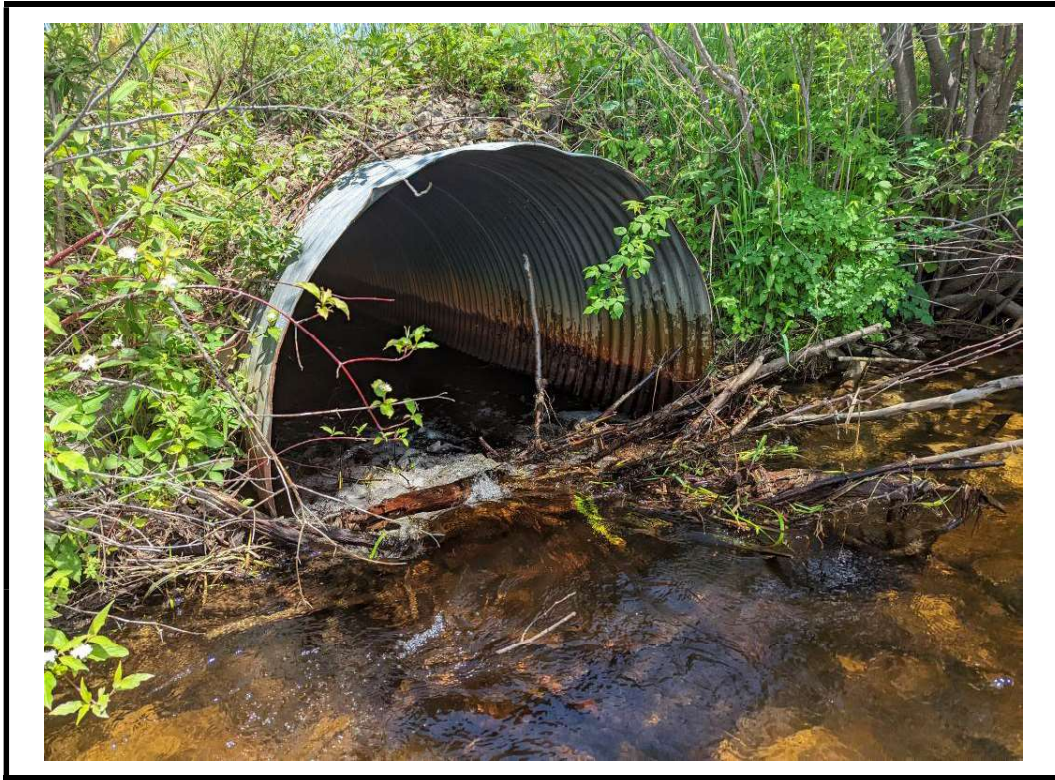
Rehabilitation/replacement study is for traffic barrier only.
 No barrier was present at the time of inspection; a code compliant barrier with end treatments should be installed.
 Beaver dam observed at inlets of east barrel and local moderate corrosion noted below waterline. Vegetation at upstream and some rocks at outlet causing minor flow obstruction.

Photo 9 Beaver dam observed at south end of east barrel

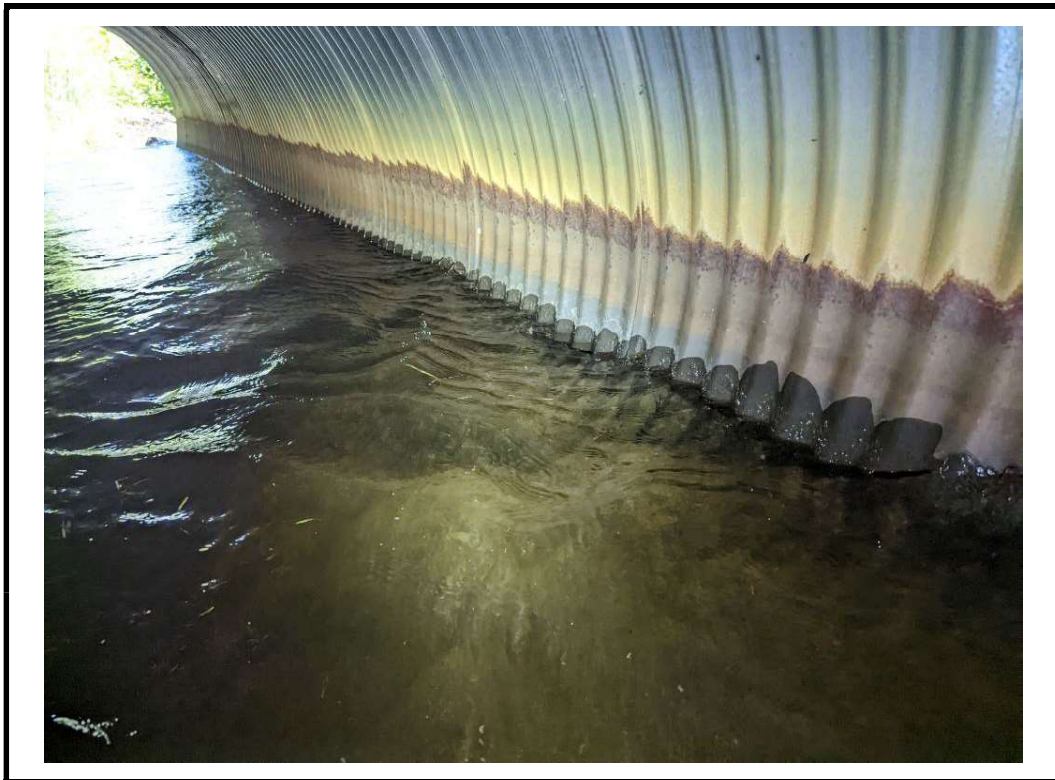
Photo 10 Localized moderate corrosion noted above waterline.

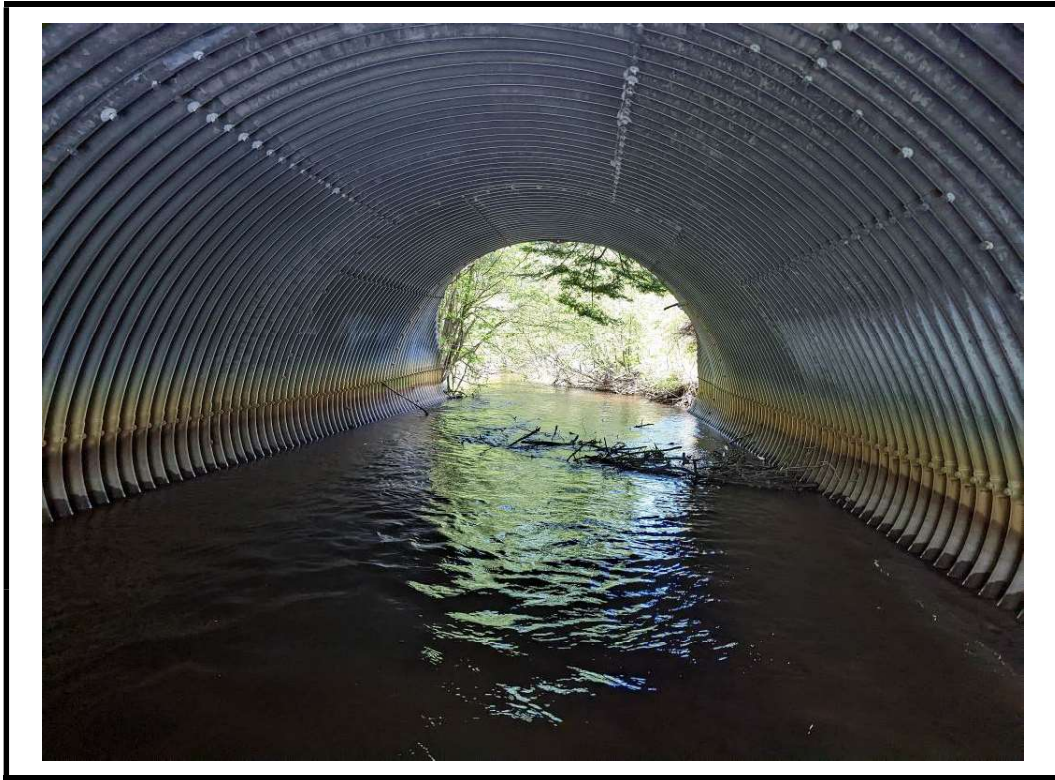
Photo 7 Debris noted in middle of barrel obstructing stream flow

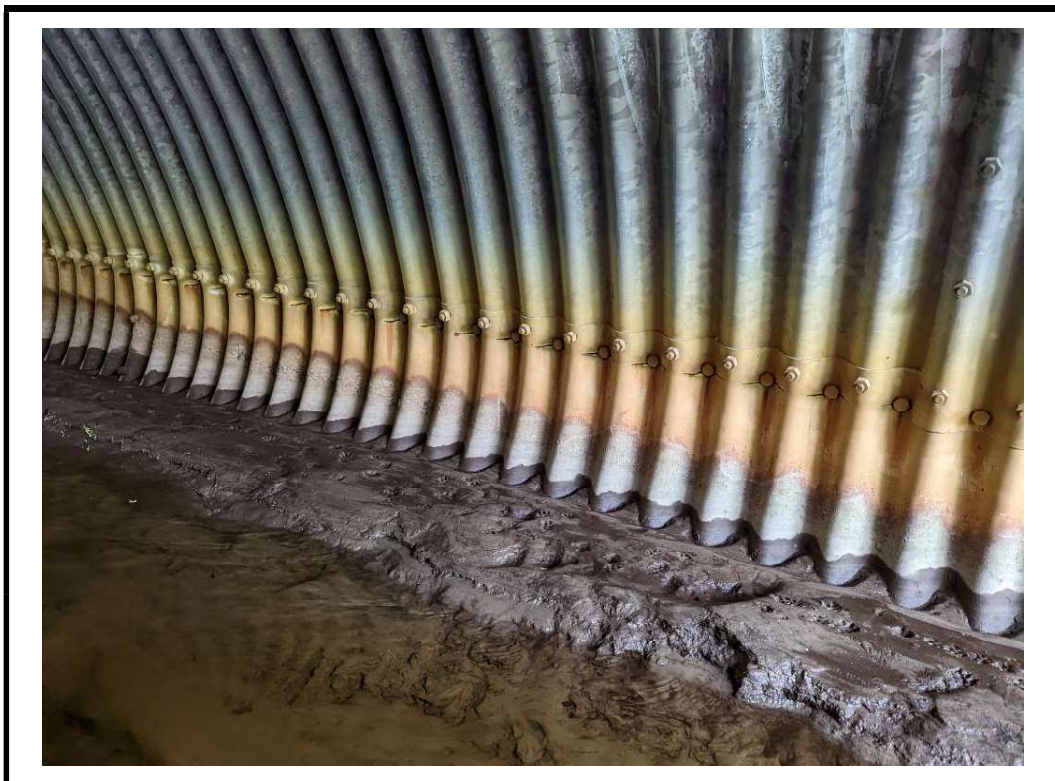
Photo 8 Light to localized moderate corrosion noted at and below waterline

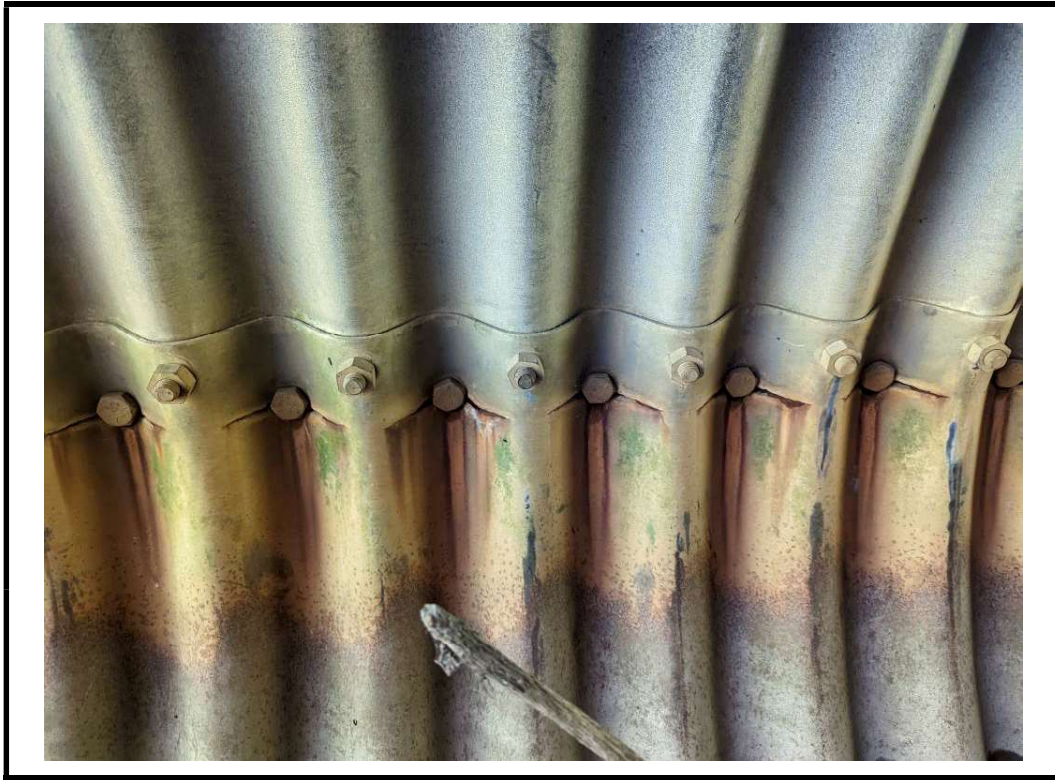
Rehabilitation/replacement study is for culvert barrel and barrier.
 No approach barrier presents at structure. A code compliant approach barrier and end treatment should be installed.
 Culvert Barrel has splitting at bolt locations and localized deformations; it is recommended that the barrel be replaced in 1 – 5 years. Light to localized moderate corrosion form middle of barrel to below waterline. It is recommended to monitor the barrel movement.

Photo 9 Medium cracking noted along bolt line

REPAIR AND REHABILITATION REQUIRED		Priority			Estimated Cost
Element	Repair and Rehabilitation Required	6 - 10 Years	1 - 5 Years	< 1 year	
Approaches	Install a code compliant barrier			X	\$ -
Barrel	Replace Culvert Barrel		X		\$ 358,000.00
					\$ -
					\$ -
					\$ -
					\$ -
					\$ -
					\$ -
					\$ -
Total Cost					\$ 358,000.00

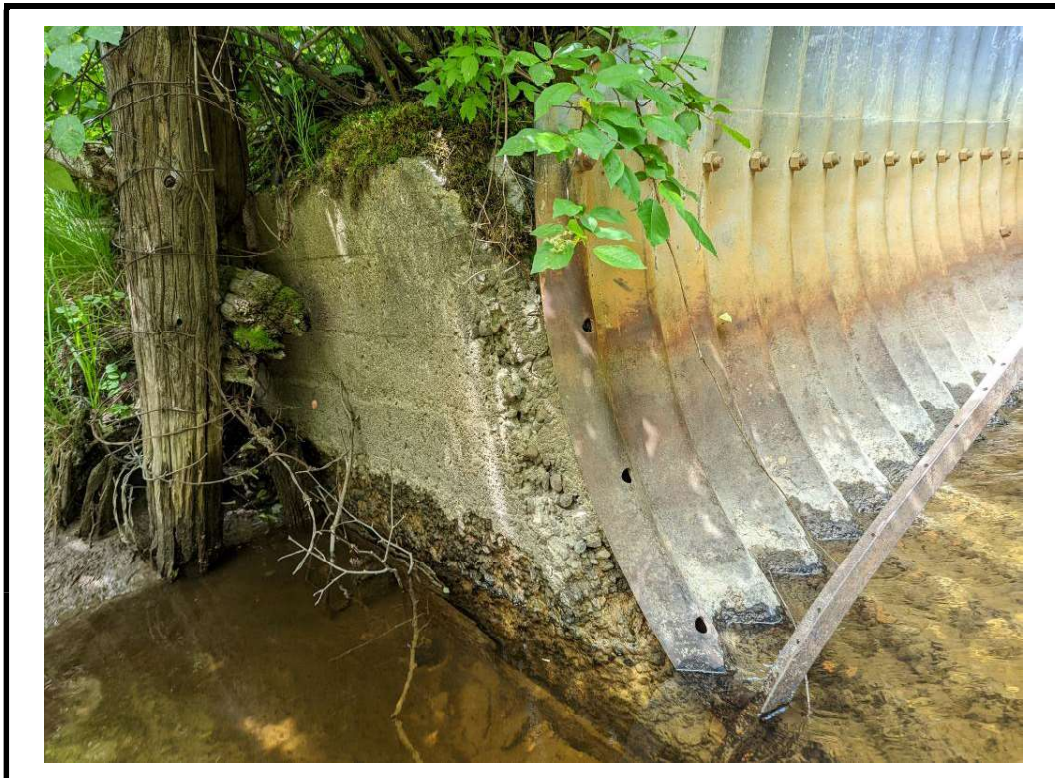
Photo 10 Light to moderate scaling noted on concrete inlet at south end

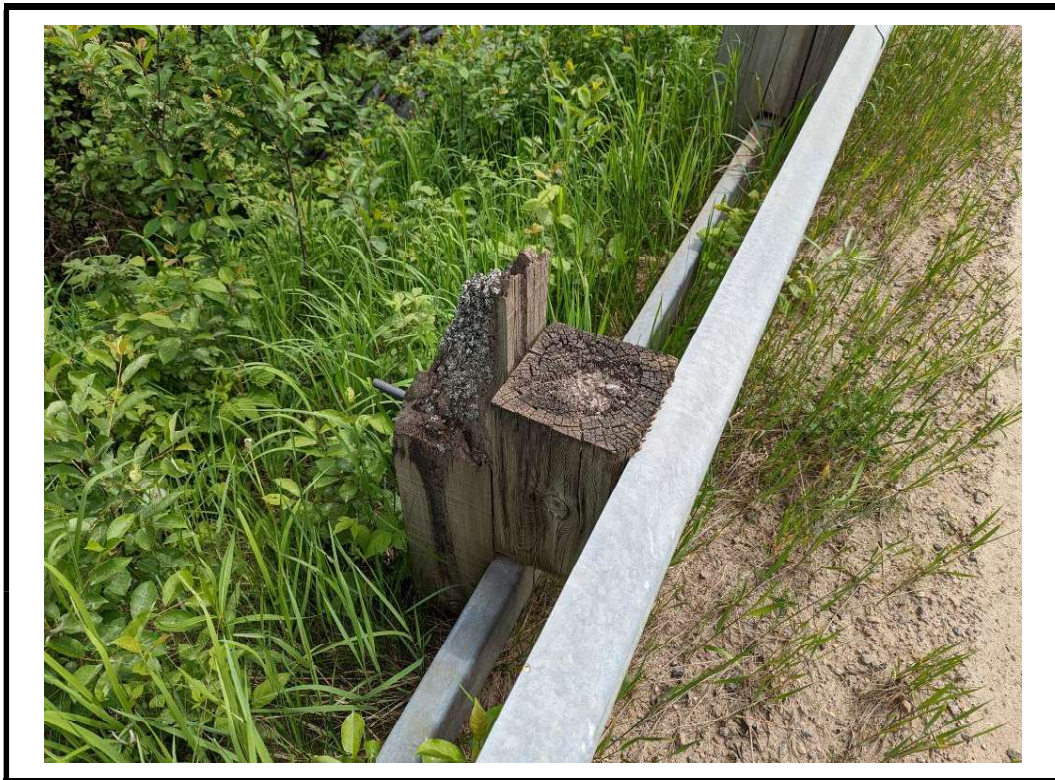
Photo 7 Rot, splits and checks on timber barrier posts

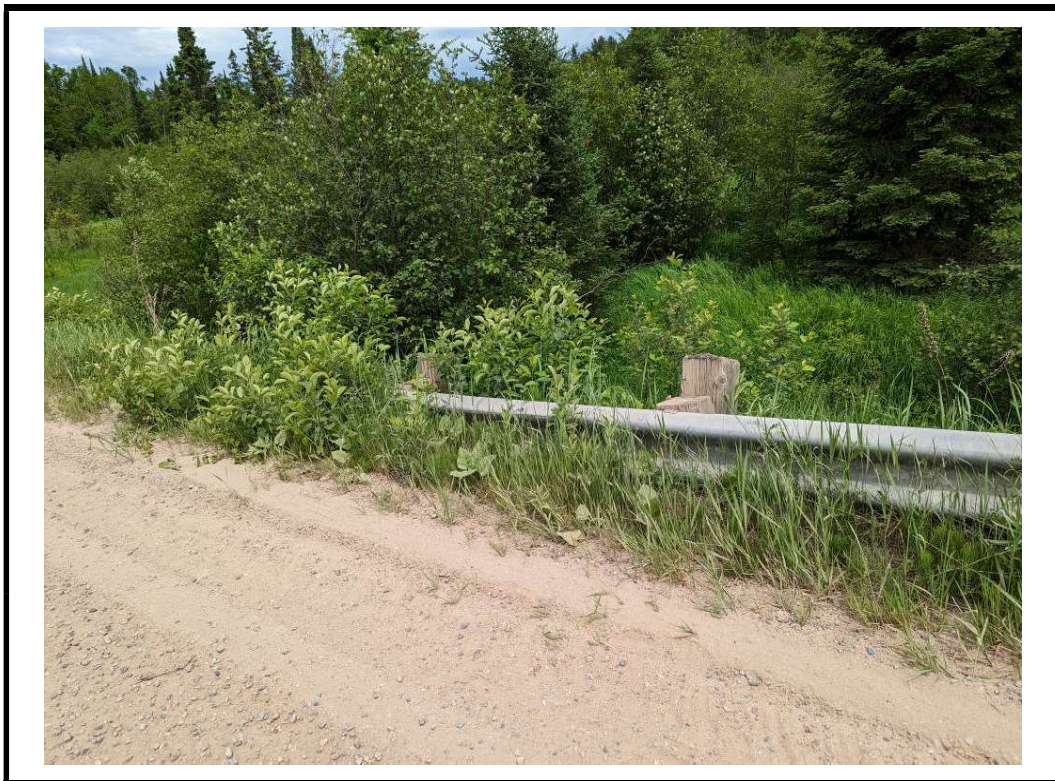
Rehabilitation/replacement study is for traffic barrier only.
 Barrier buried end treatments are substandard and should be replaced with code compliant end treatments.
 Limited inspection due to dams and fences installed at inlet. Light corrosion noted at and below water line at both barrels and some missing bolts. Beaver dam and fallen tree obstructing the waterway should be removed.

Photo 8 Substandard buried end treatment at approach barrier

REPAIR AND REHABILITATION REQUIRED		Priority			Estimated Cost
Element	Repair and Rehabilitation Required	6 - 10 Years	1 - 5 Years	< 1 year	
Approach Barrier	Install code compliant end treatments			X	\$ 24,000.00
Total Cost					\$ 24,000.00

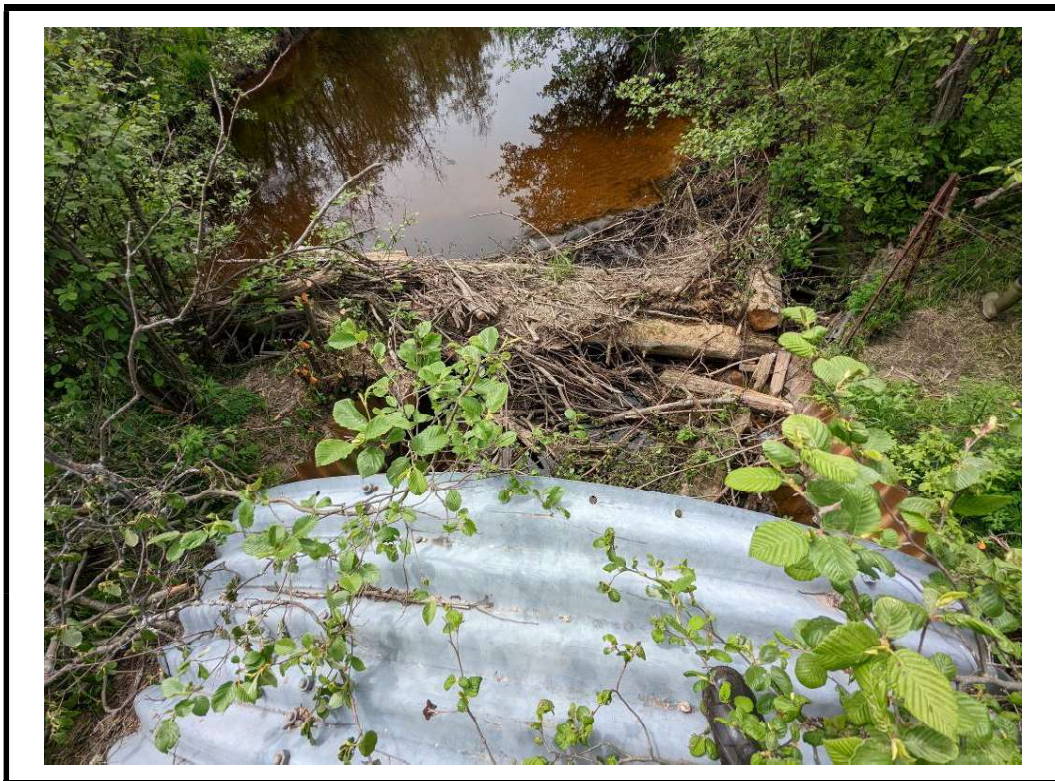
Photo 10 Obstruction at west end of north culvert.

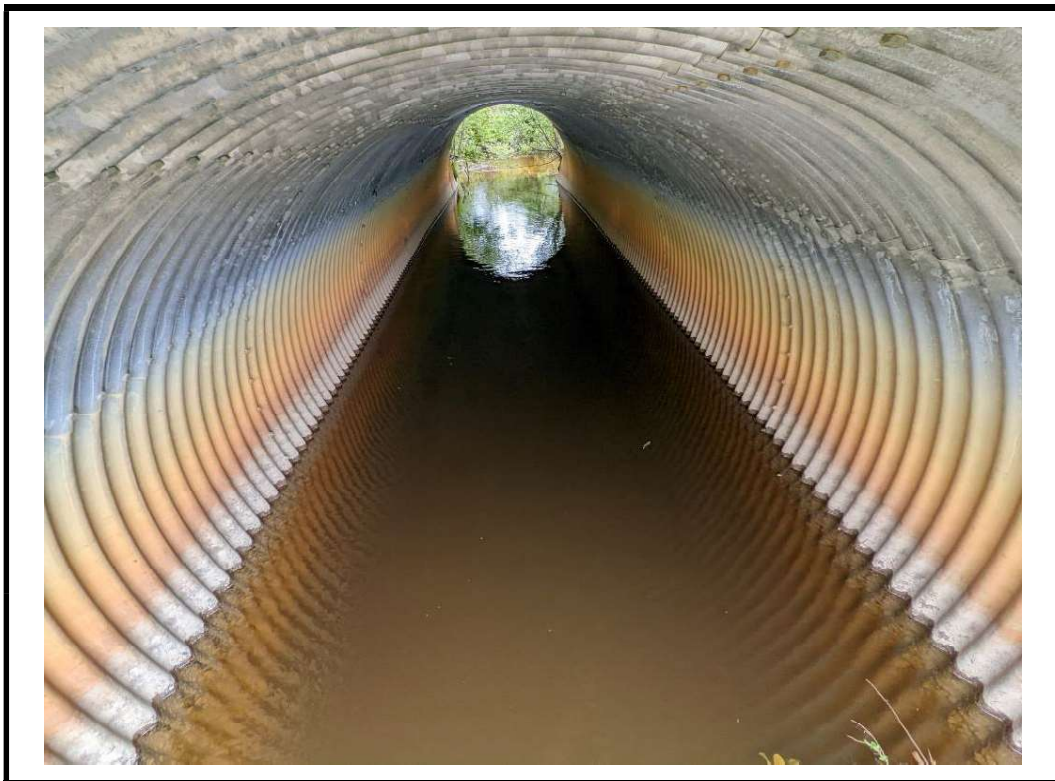
Photo 12 Light corrosion noted at waterline in north culvert barrel (Typical)

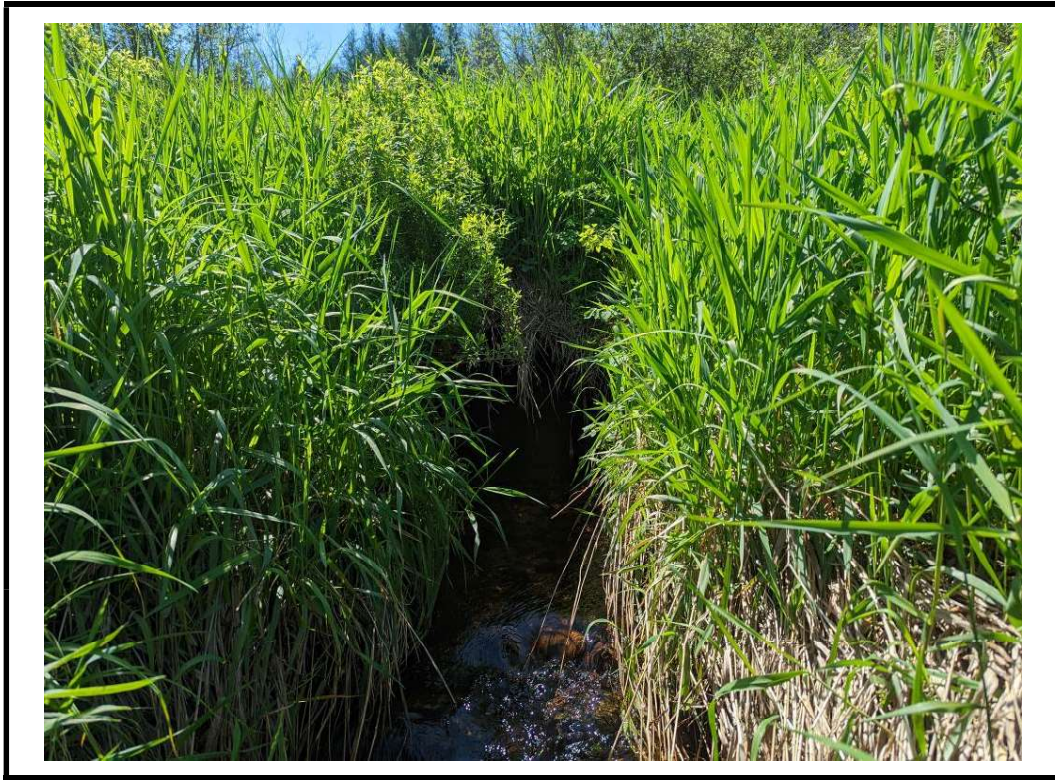
Photo 5 Heavy vegetation grown at north side of barrel

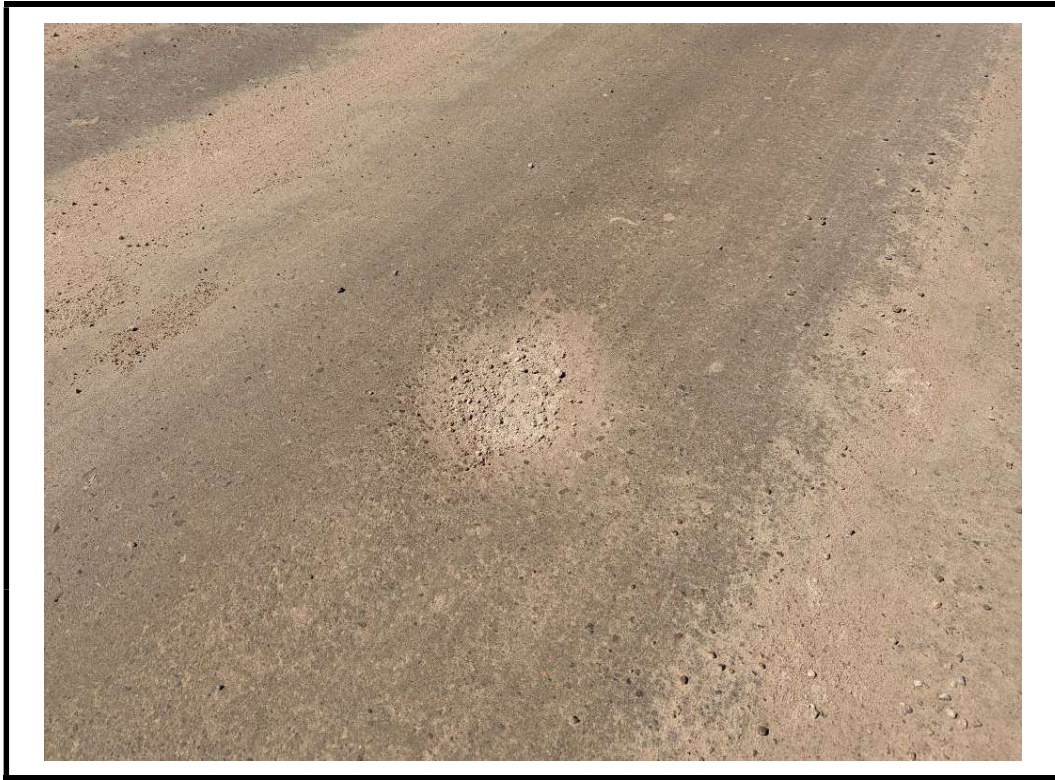
Photo 7 Several small potholes on west approach

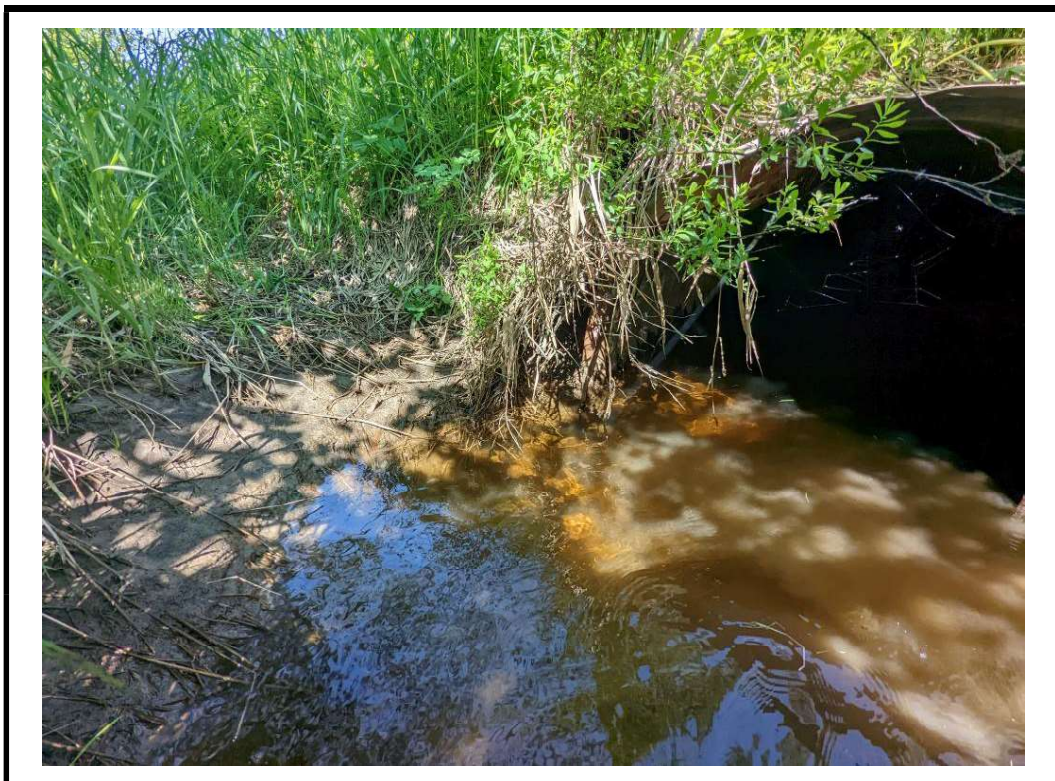
Photo 8 Minor erosion of embankment noted at south end of structure

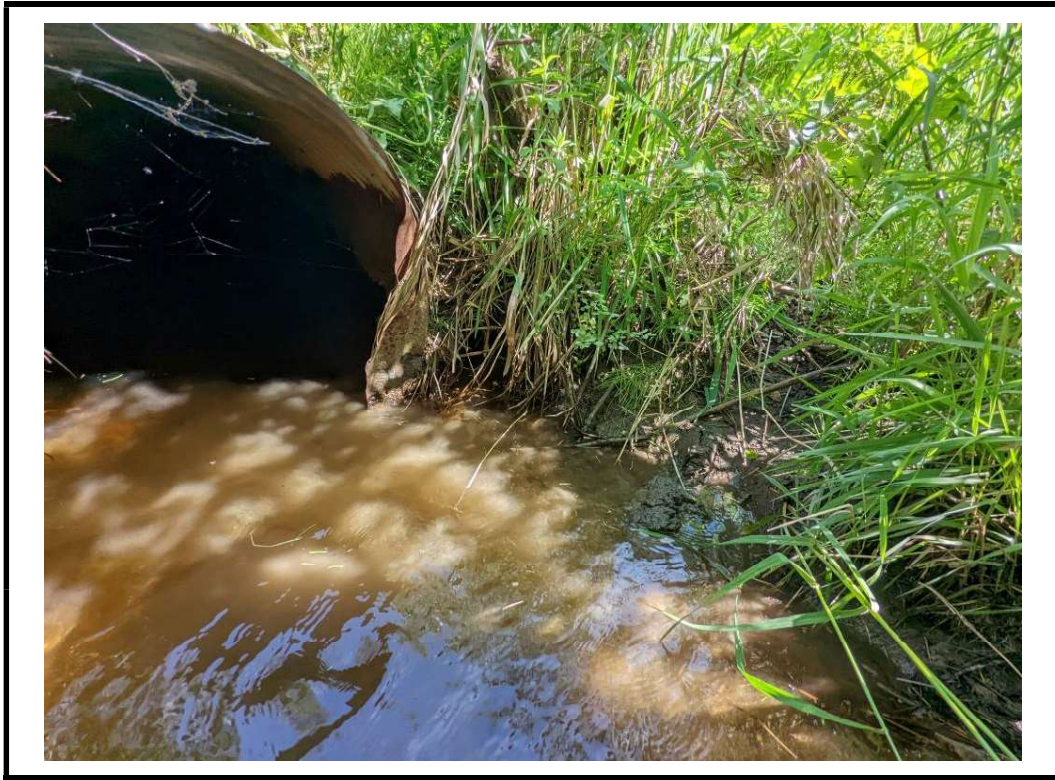
Photo 9 Dents noted at south end of barrel

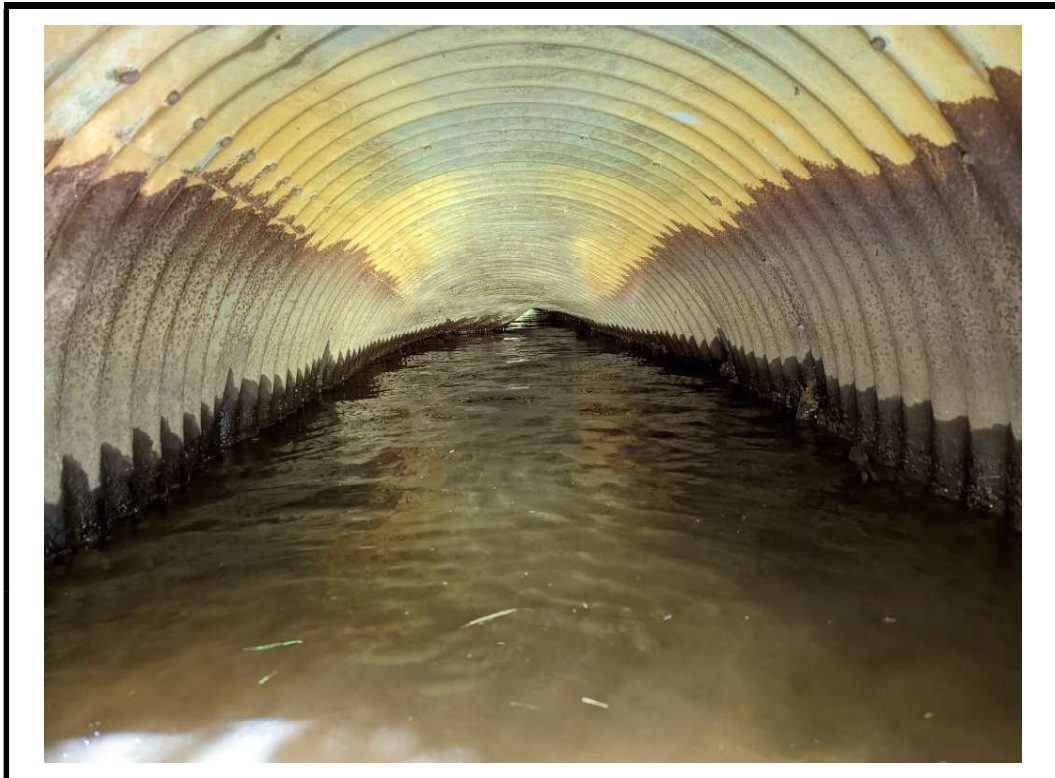
Photo 10 Apparent deformation noted inside barrel
