Structure Name Trunk Road Culvert
Structure Number 13
Date of Inspection June 3, 2022
Project No. 22035
Consultant HP Engineering Inc.

MUNICIPAL STRUCTURE INSPECTION FORM

CULVERT

Site No.: 13

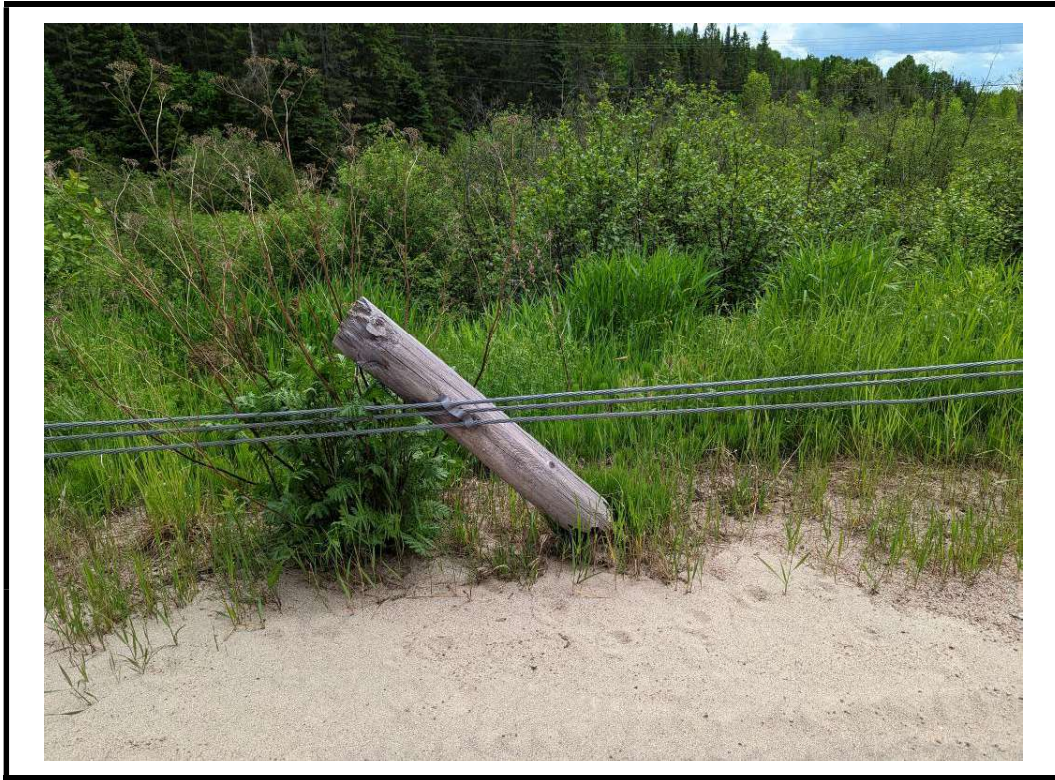
Rehabilitation/replacement study is for culvert barrier.
 Install code complaint traffic barrier including code compliant end treatments. Patched potholes and moderate to severe ravelling noted on approach wearing surface. Broken post noted on north barrier and loose cable observed on both barriers.
 Beaver dam observed at south end of east barrel.
 Barrel is generally in good condition.

Photo 7 Broken post observed in north barrier

REPAIR AND REHABILITATION REQUIRED		Priority			Estimated Cost
Element	Repair and Rehabilitation Required	6 - 10 Years	1 - 5 Years	< 1 year	
Approaches	Install approach guiderail			X	\$ 57,000.00
					\$ -
					\$ -
					\$ -
					\$ -
					\$ -
					\$ -
					\$ -
					\$ -
Total Cost					\$ 57,000.00

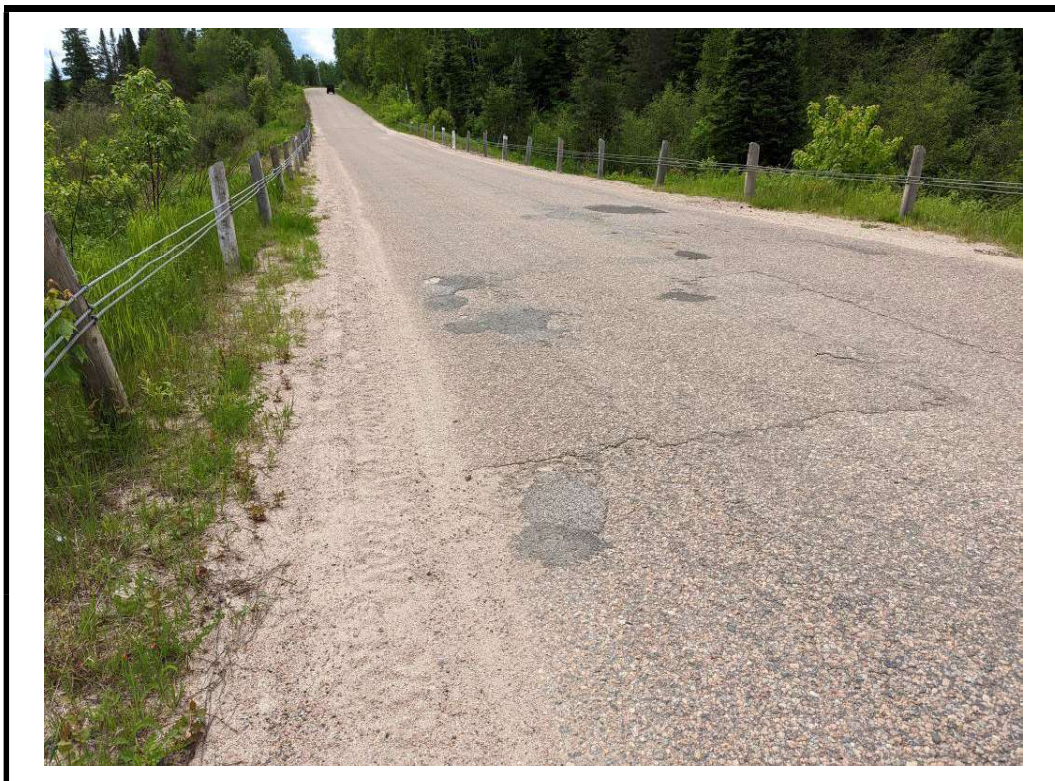
Photo 8 Moderate raveling, patched potholes noted in east approach wearing surface

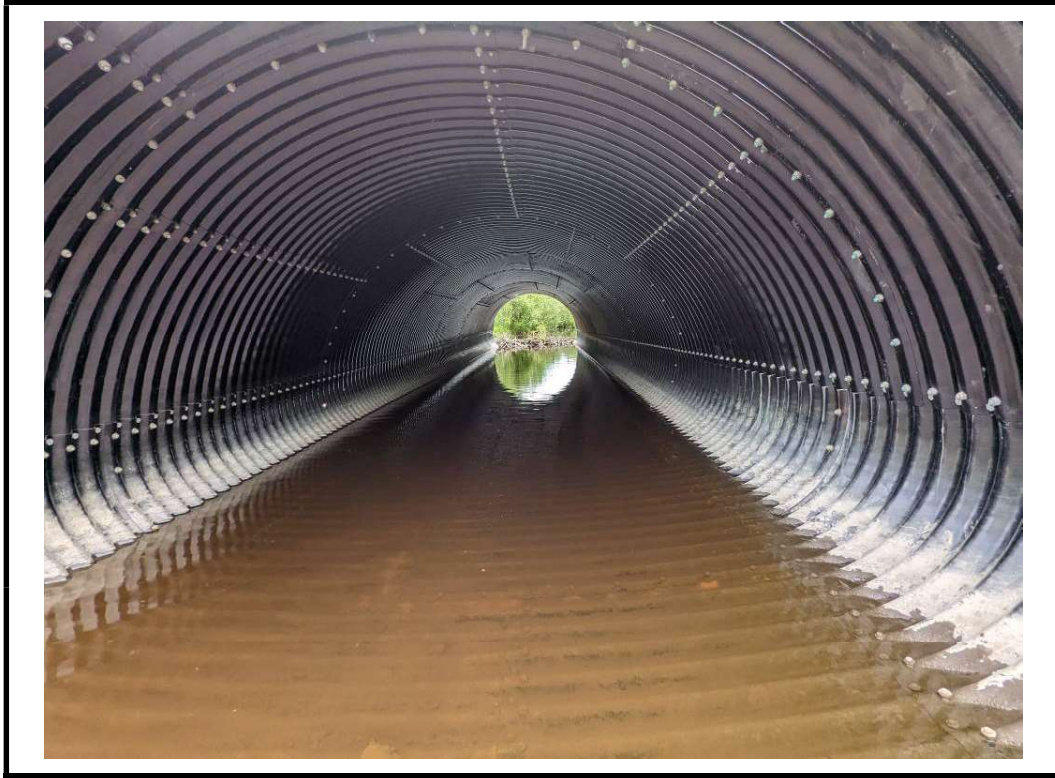
Photo 9 Interior of east culvert barrel looking south

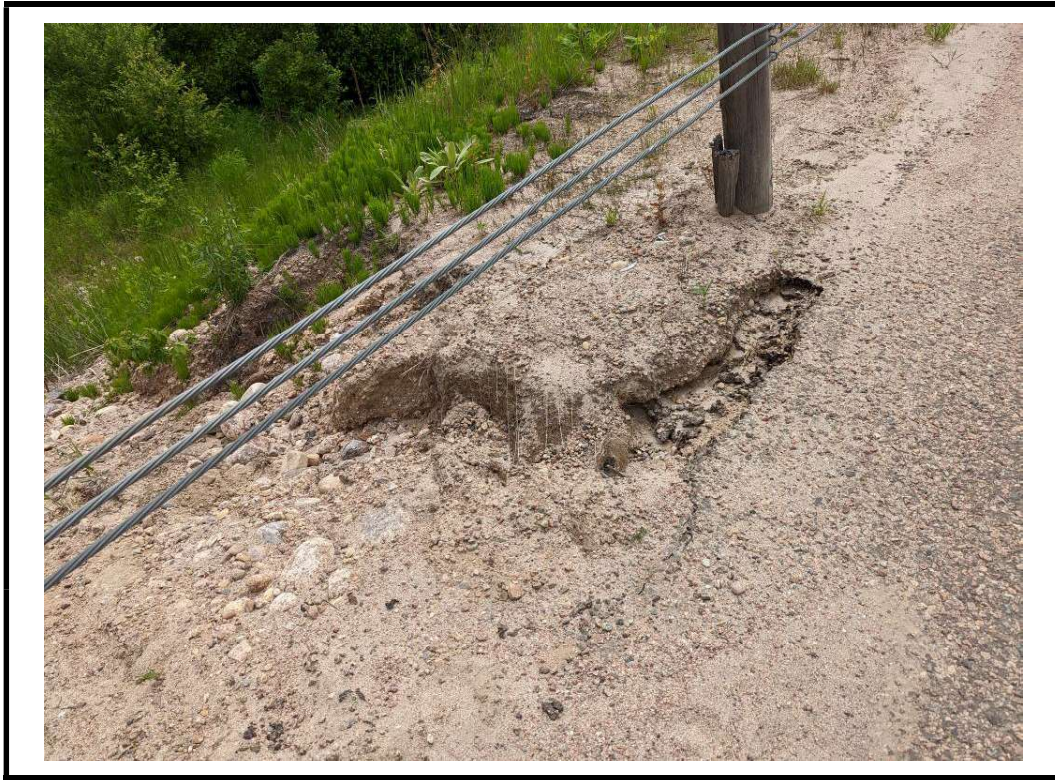
Photo 11 Heavy washout noted at southwest corner over structure

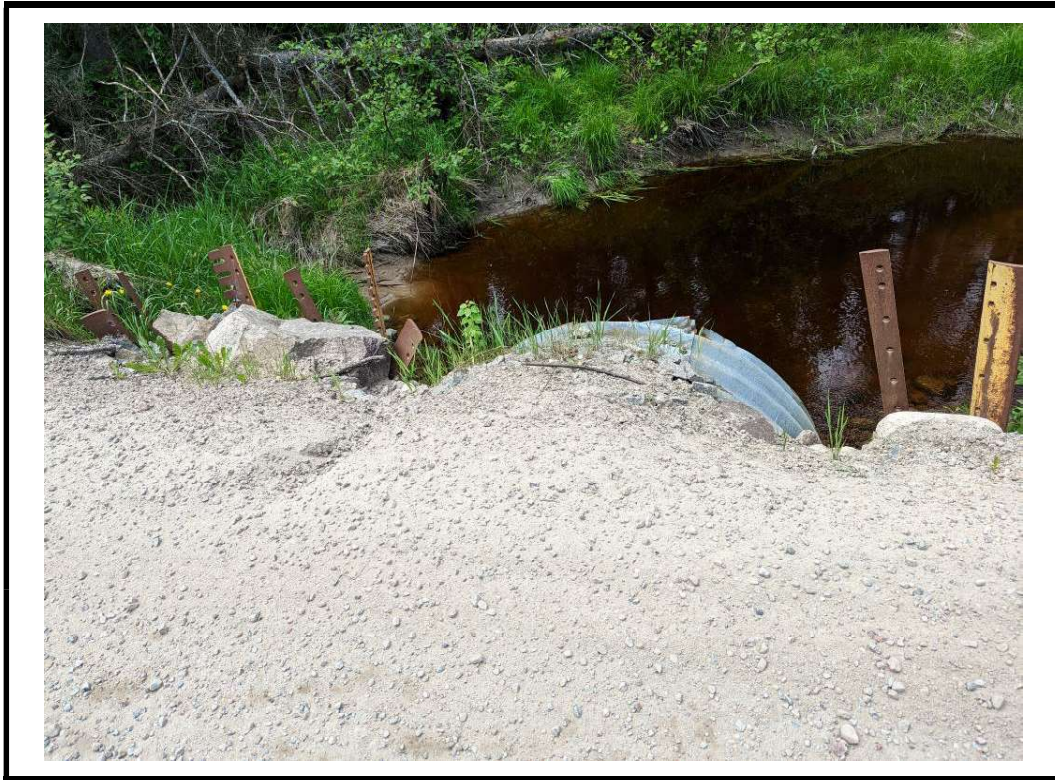
Photo 7 Erosion of edge of shoulder at west end of structure

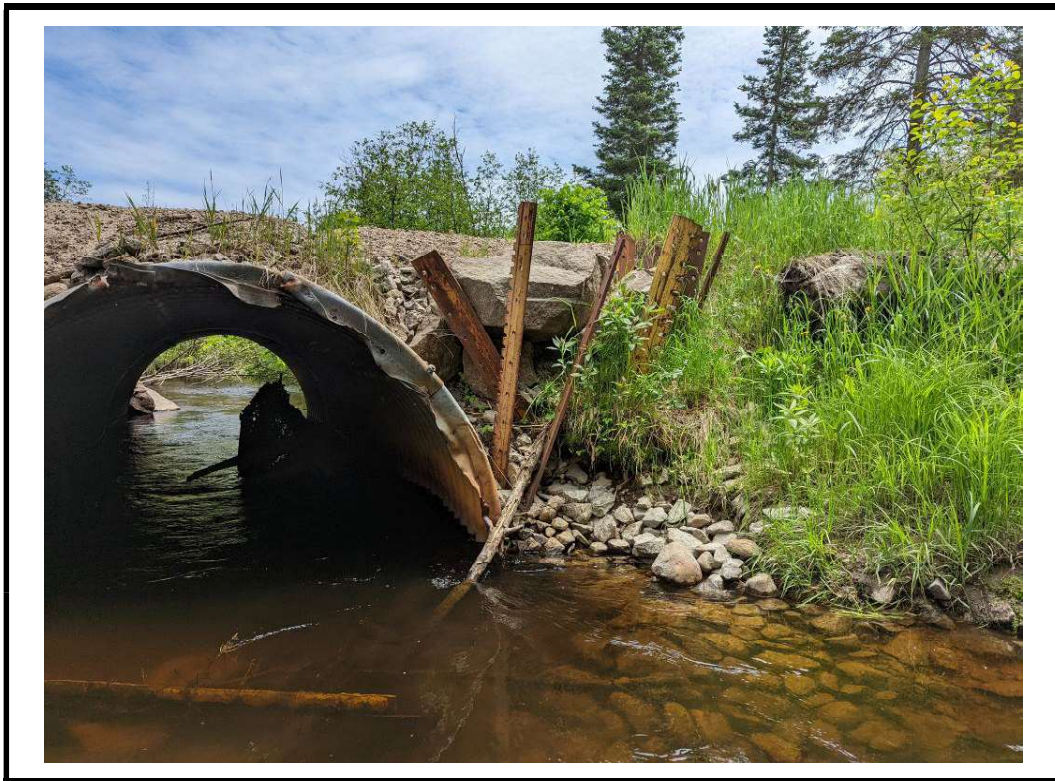
Element Group:	Culvert			Length:	8.7 m	
Element Name:	Barrel			Width:	2.4 m	
Location:	Below Roadway			Height:	1.8 m	
Material:	Corrugated Steel			Count:	1	
Element Type:	Structural Plate CSP			Total Quantity:	57.69 m ²	
Environment:	Benign			Not Inspected:	<input type="checkbox"/>	
Protection System	Hot-Dip Galvanized				Performance Deficiencies	Maintenance Needs
Units	Excellent	Good	Fair	Poor		
m ²	-	2.69	30	25	01	-
Comments: Severe corrosion and perforations at and below water line with the bottom of the barrel having partially separated from the structure. Efflorescence at seams and a dent was noted at inlet (west). Debris build up observed in structure. Barrel is deformed. It is recommended that the structure be replaced from 1 – 5 years. A piece of CSP from a different structure was found in the barrel, obstructing flow. Dents noted at west end of barrel. Monitoring of barrel deformation is recommended.

Photo 8 Dents noted at west end of barrel

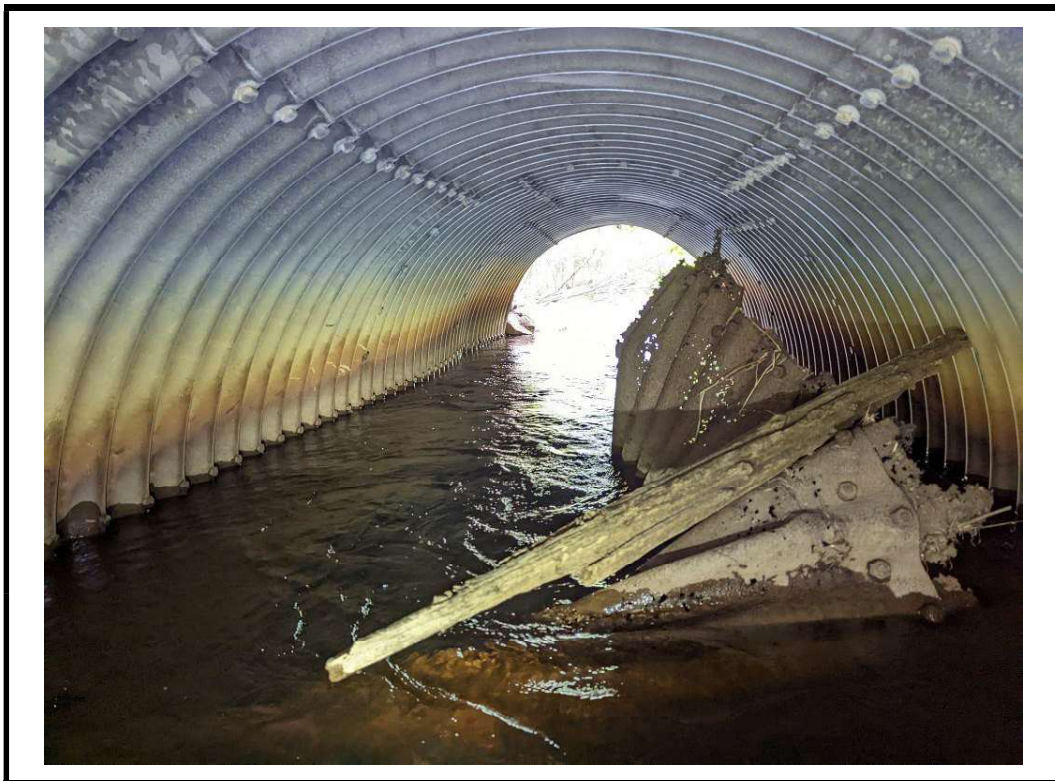
Photo 10 Efflorescence noted at seams and along boltline

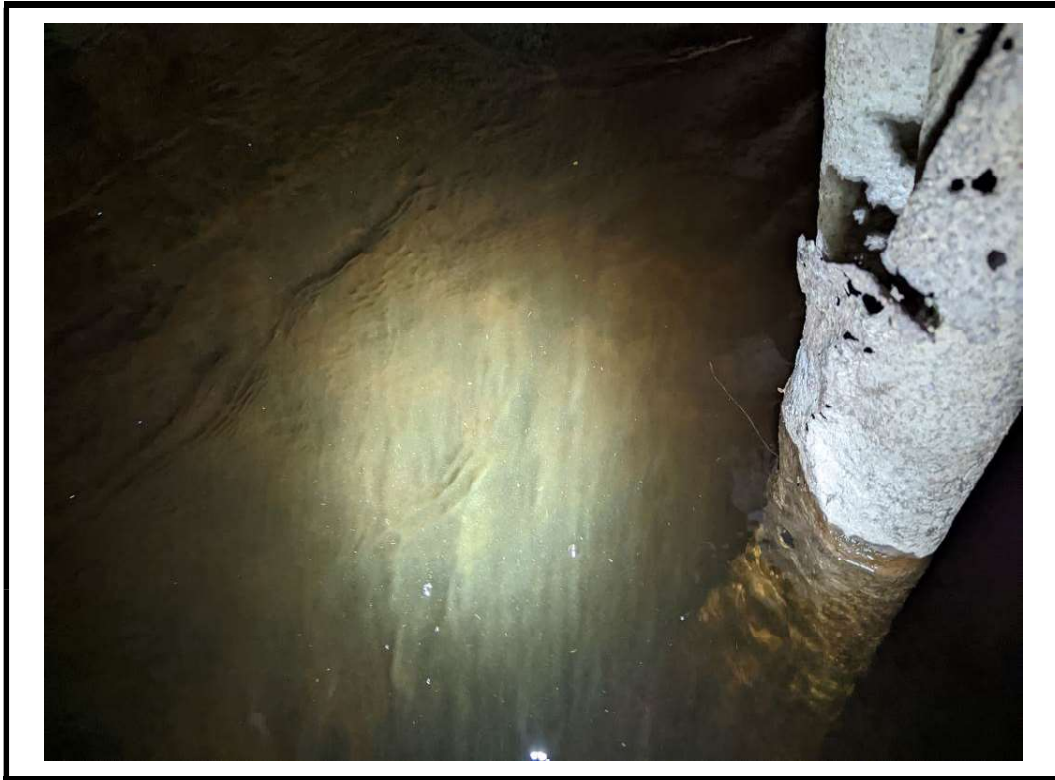
Rehabilitation/replacement study is for traffic barrier and structure. Monitoring of barrel deformation is recommended.
 No traffic barrier observed at structure. Code complaint approach barrier should be installed.
 Severe corrosion and perforations observed in barrel and efflorescence noted at bolts and seams.
 Posts installed around structure at west in an effort to restrict erosion.
 It is recommended that the culvert barrel be replaced in 1-5 years.

Photo 11 Severe perforation noted at and below waterline

REPAIR AND REHABILITATION REQUIRED		Priority			Estimated Cost
Element	Repair and Rehabilitation Required	6 - 10 Years	1 - 5 Years	< 1 year	
Approaches	Install Code Compliant Approach Barrier			X	\$ -
Barrel	Replace barrel		X		\$ 207,000.00
					\$ -
					\$ -
					\$ -
					\$ -
					\$ -
					\$ -
					\$ -
Total Cost					\$ 207,000.00

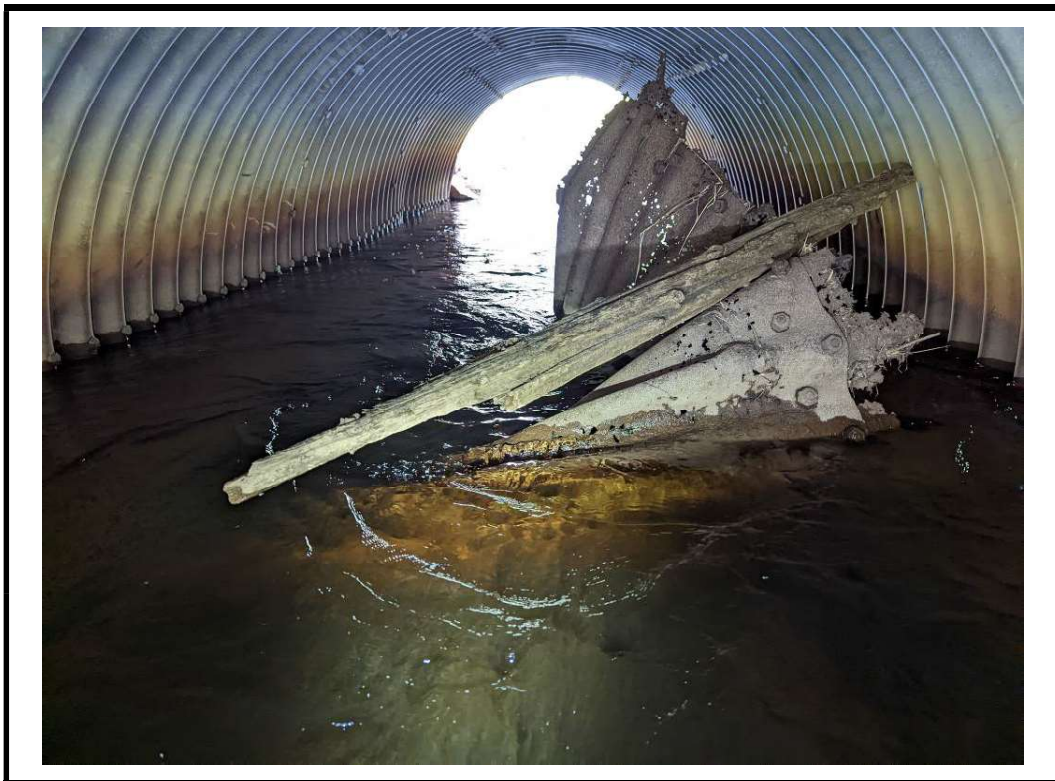
Photo 12 Damaged section of CSP in barrel, does not appear to be from this structure

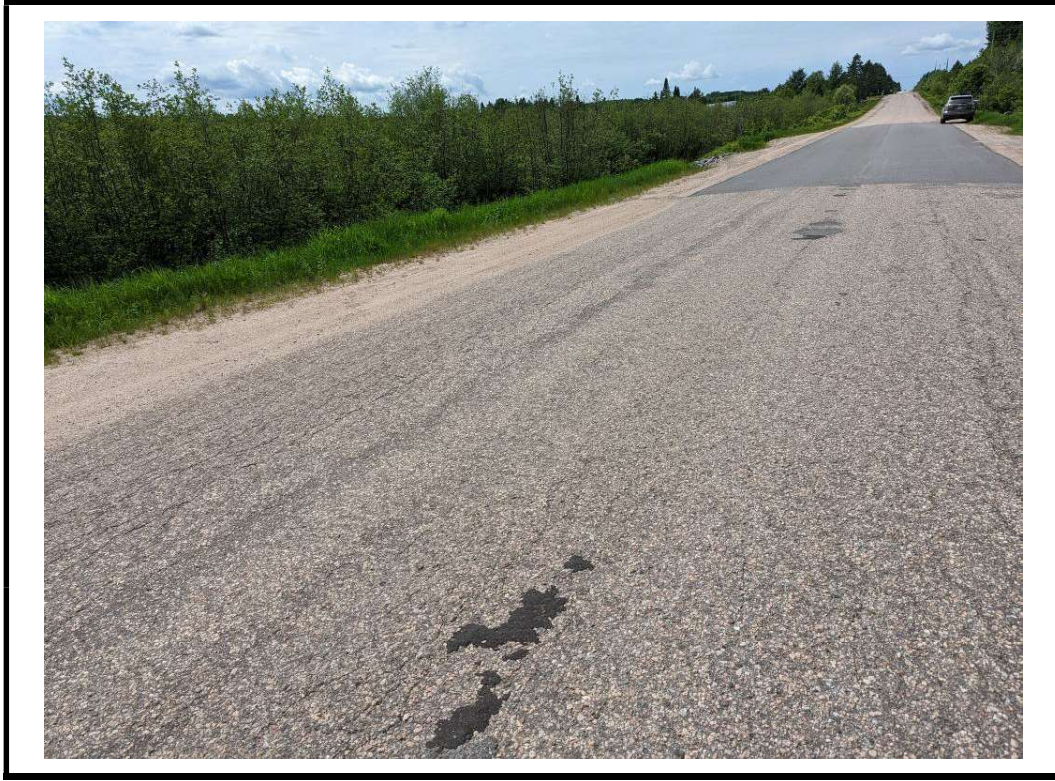
Photo 7 Medium to wide longitudinal cracks and patches noted at east approach

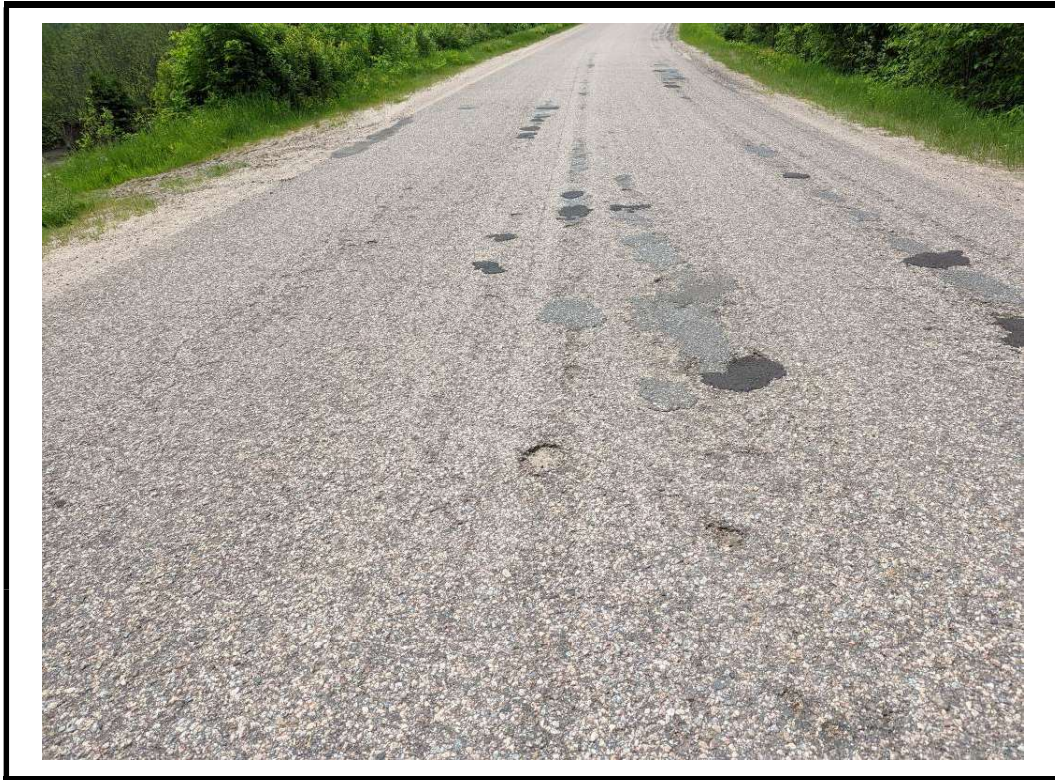
Photo 7 Previous patches, moderate raveling and potholes forming at west approach

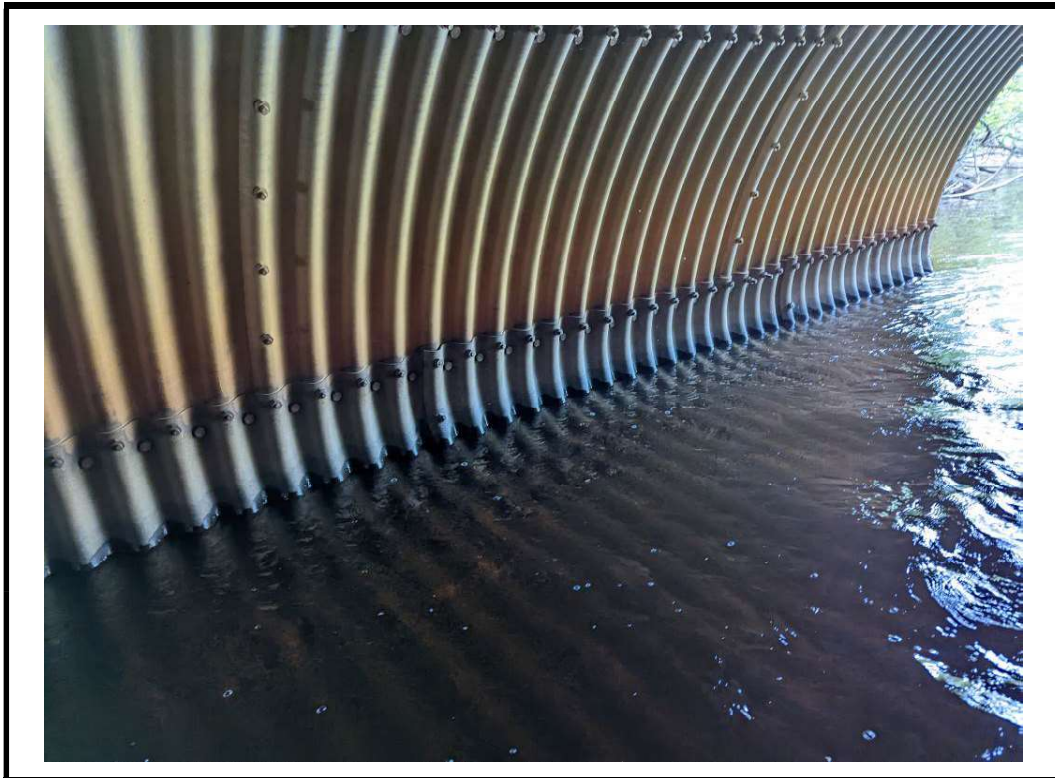
Photo 8 Light to moderate corrosion noted at waterline

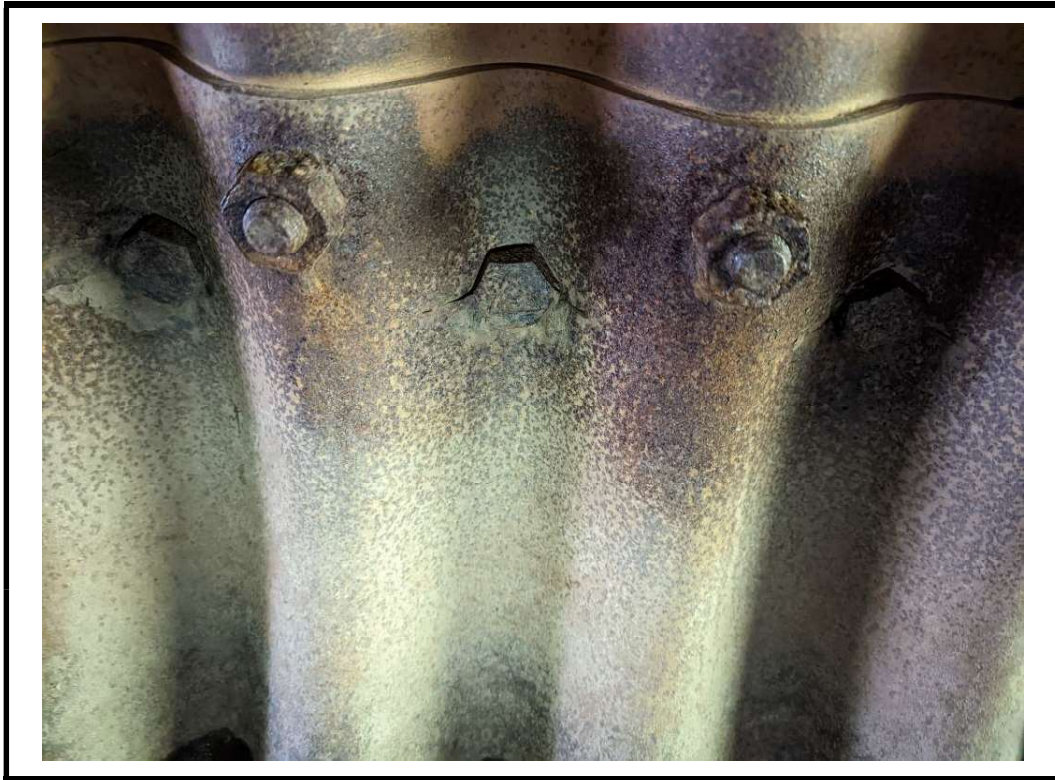
Photo 9 Cracks at bolt line at the west side of structure
