MUNICIPAL STRUCTURE INSPECTION FORM

SITE PHOTOGRAPHS

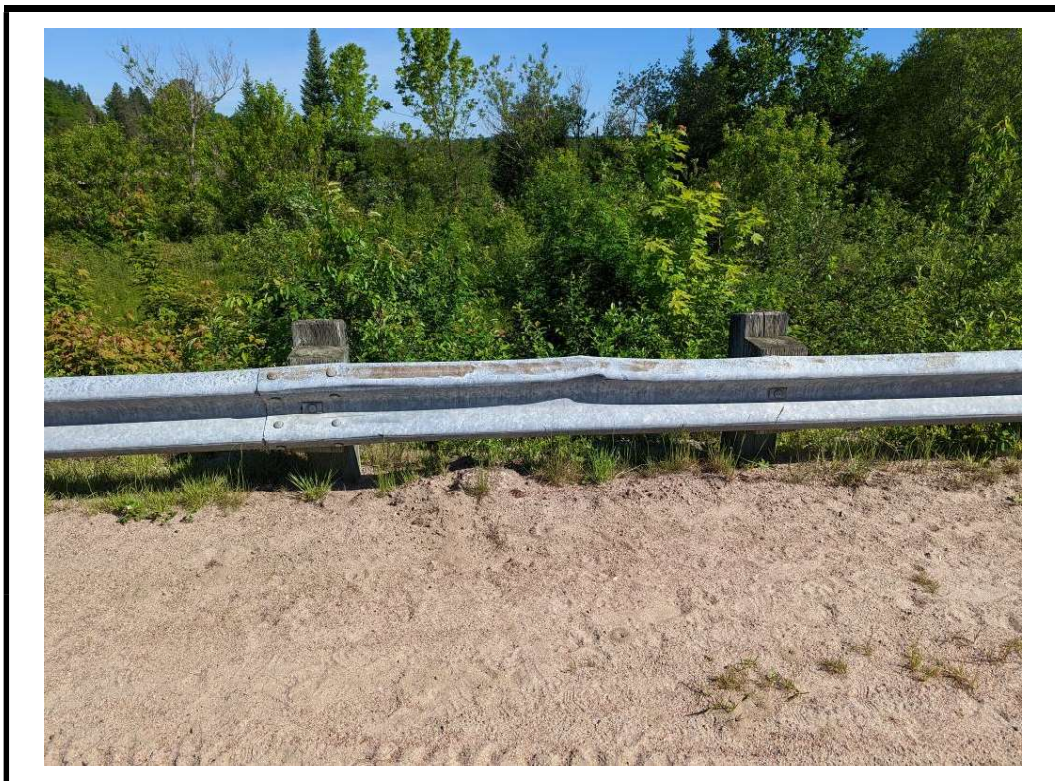
Photo 8 Collision damage noted on approach barrier at southwest corner

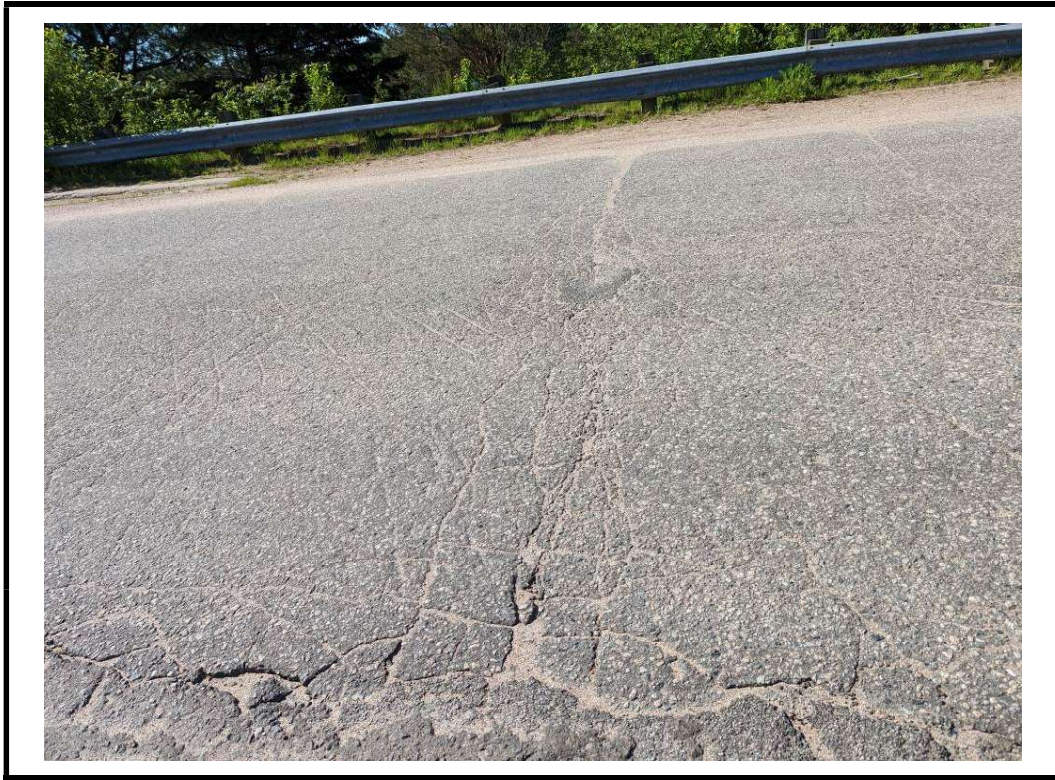
Photo 9 Medium transverse cracks with potholes in west approach

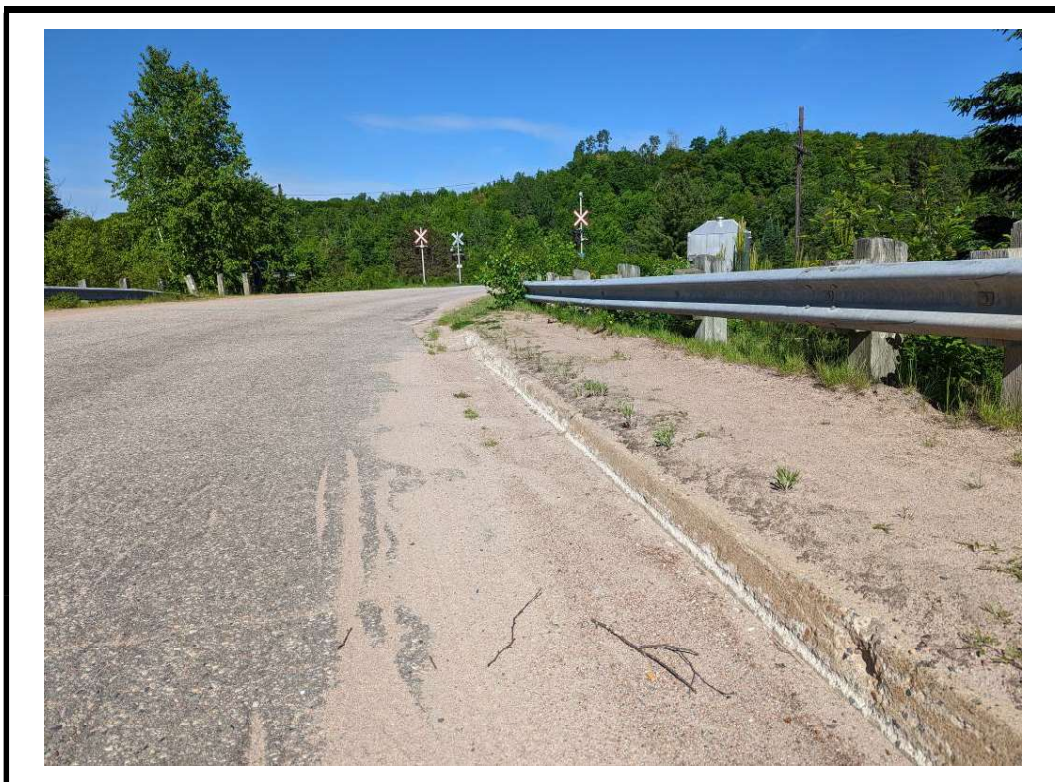
Photo 10 Significant abrasion noted on approach curb at northwest corner

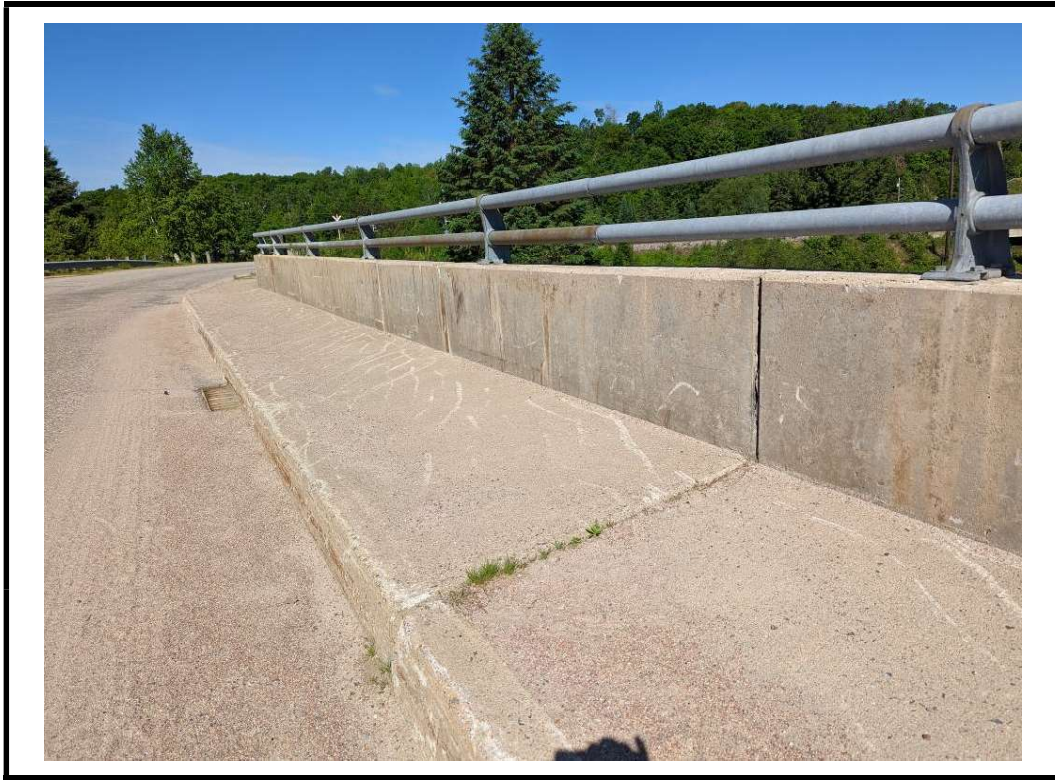
Photo 11 Narrow map cracks with efflorescence and stains with spall on parapet wall

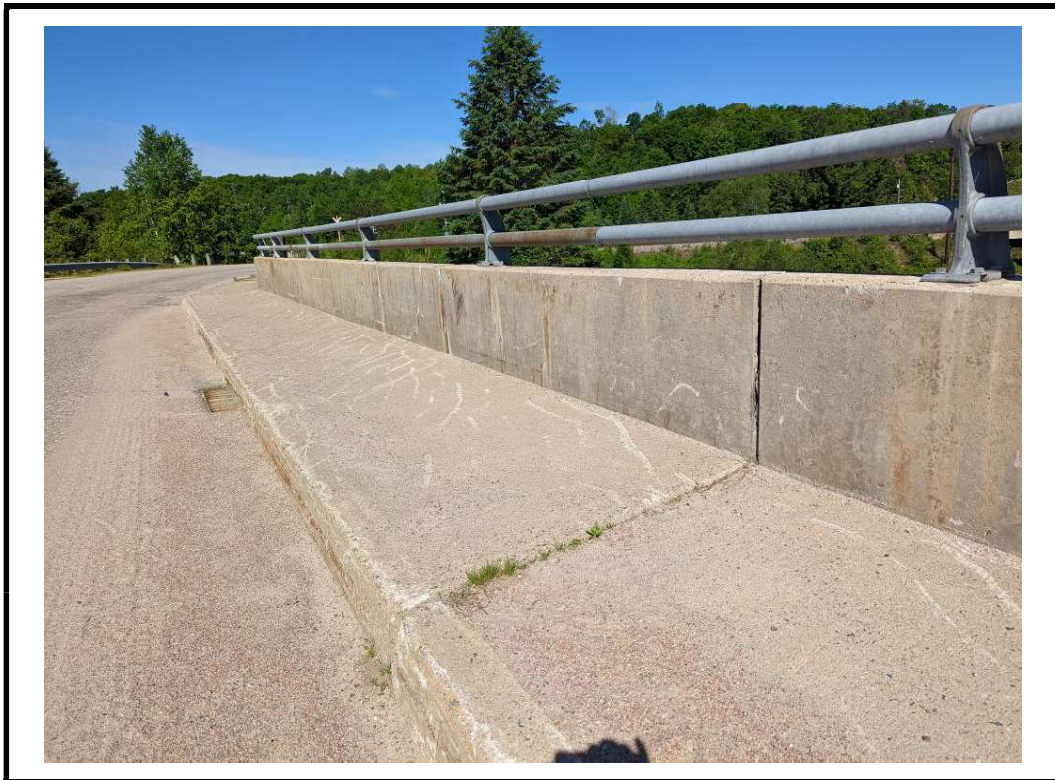
Photo 12 Narrow map cracks with efflorescence and stains with spall on parapet wall

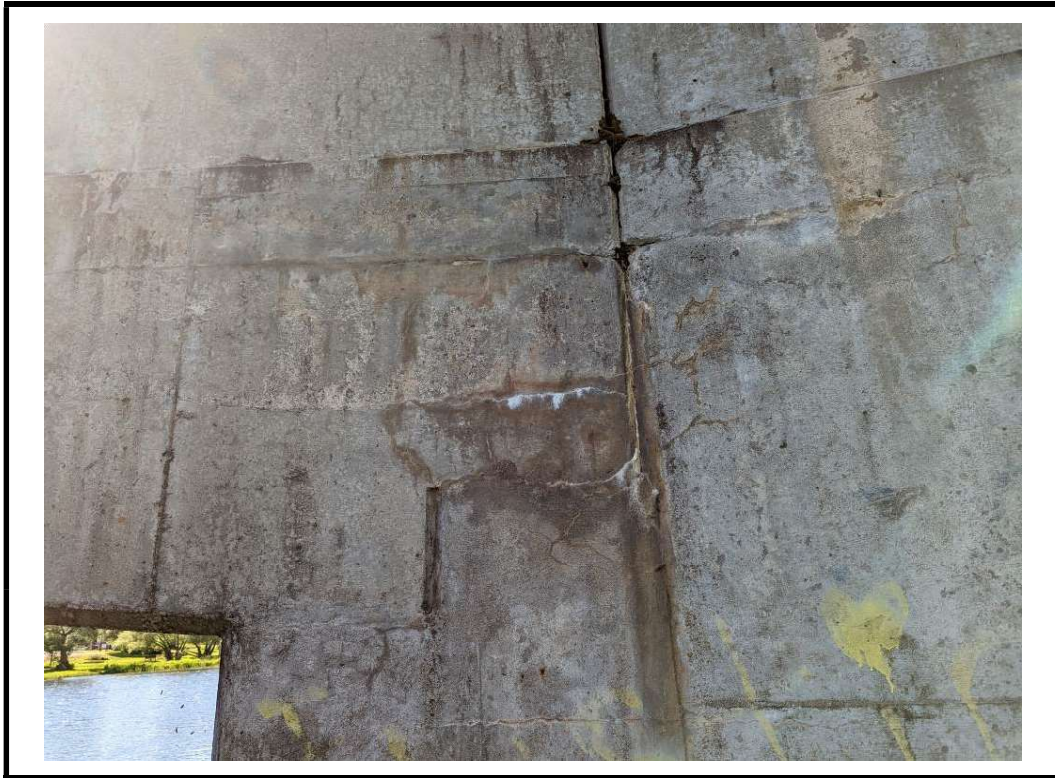
Photo 13 Narrow longitudinal and transverse cracks and damp stains on fascia.

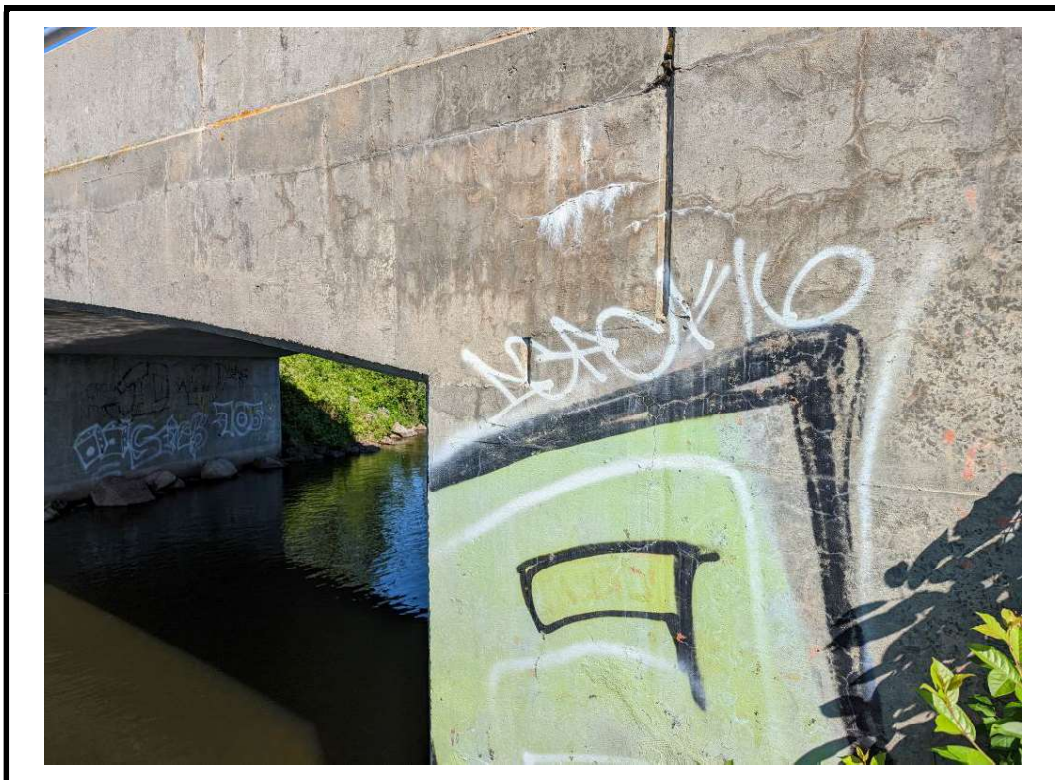
Photo 14 Narrow cracks, damp stains with efflorescence, & graffiti on southeast wingwall.

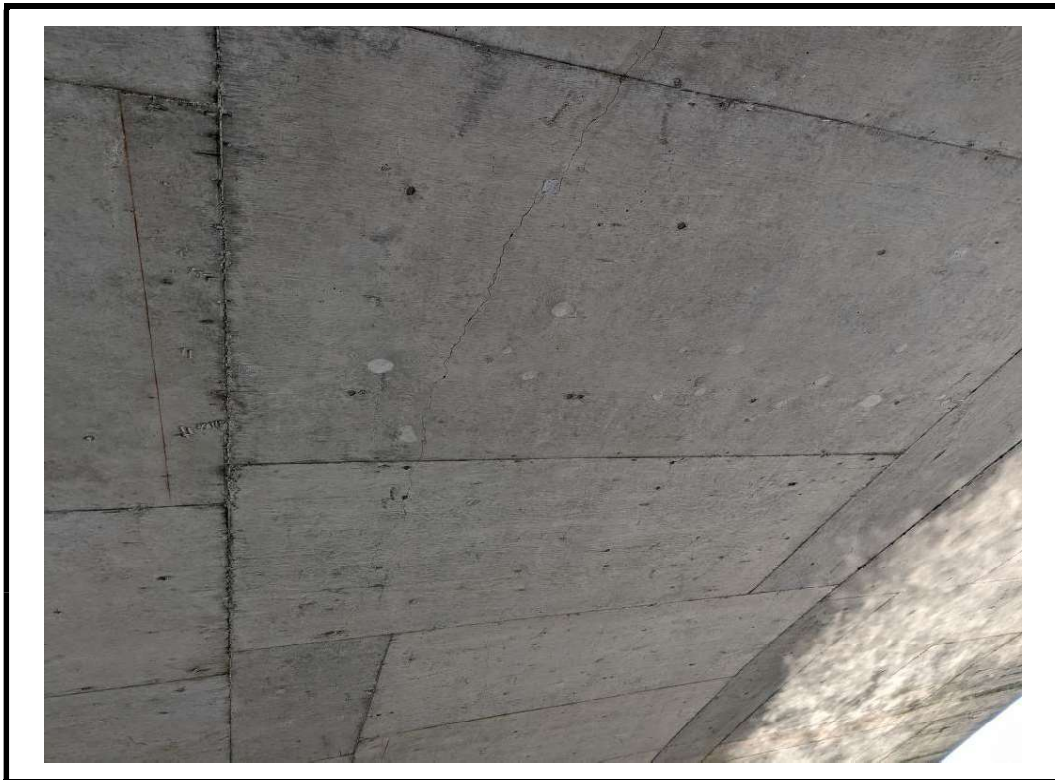
Photo 16 Narrow longitudinal cracks noted with origins at abutment wall

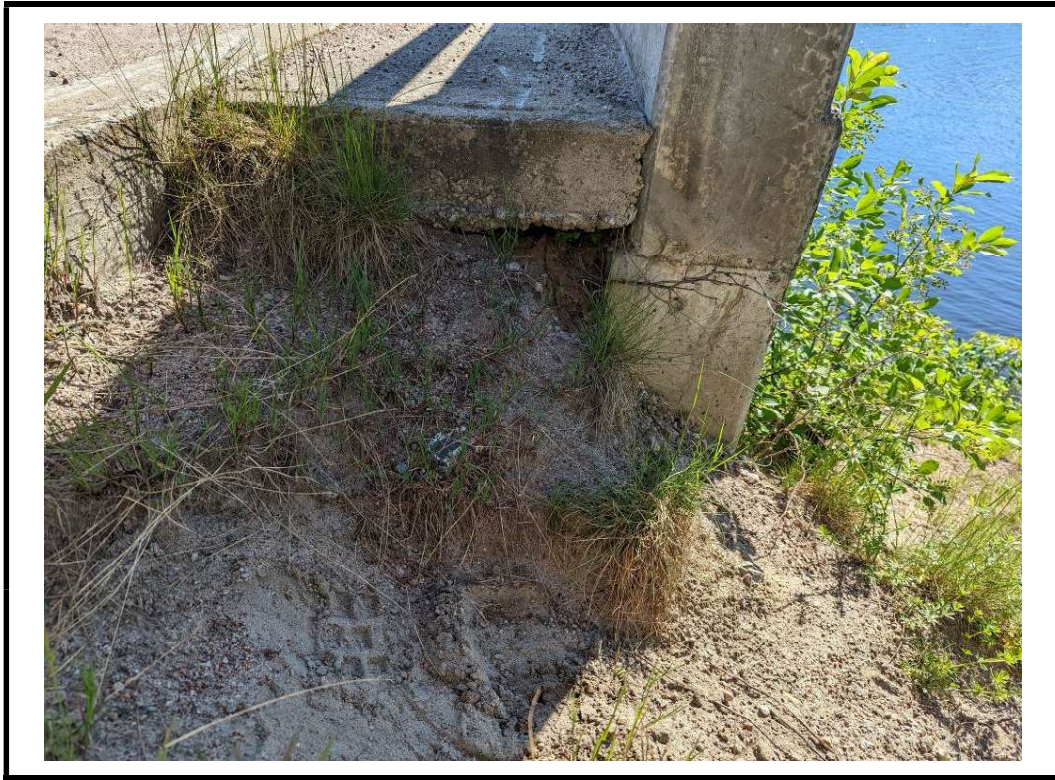
Photo 17 Minor washout noted at southwest corner near deck end

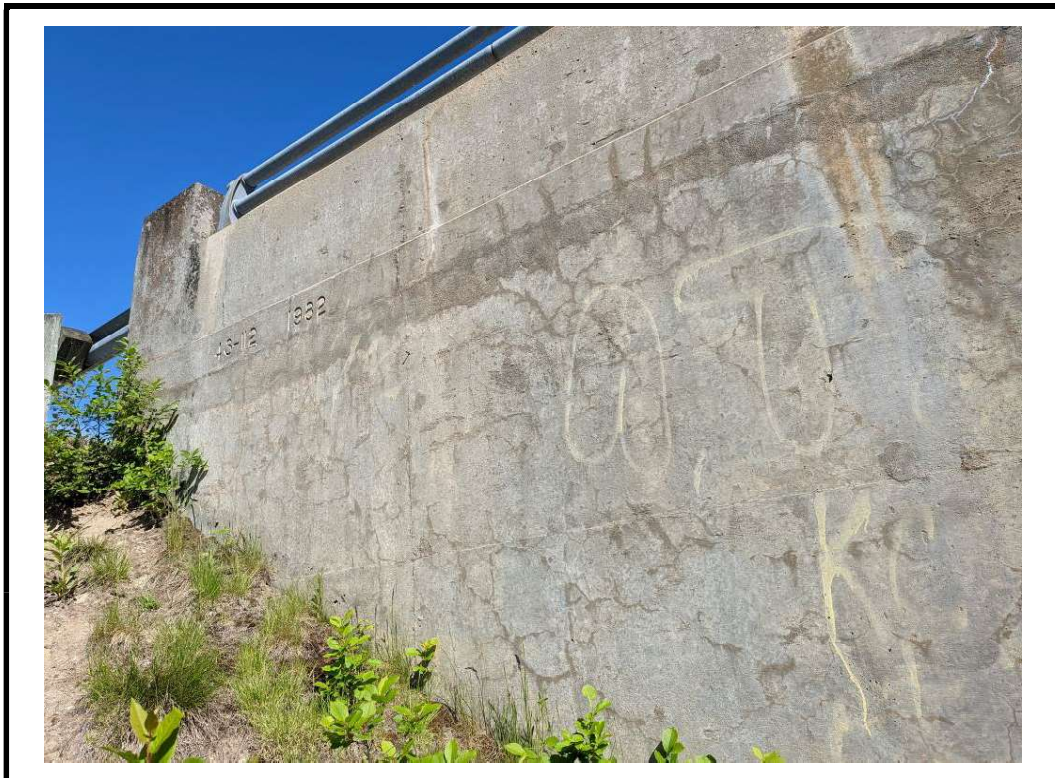
Photo 18 Typical southwest wingwall with graffiti and damp map cracks throughout

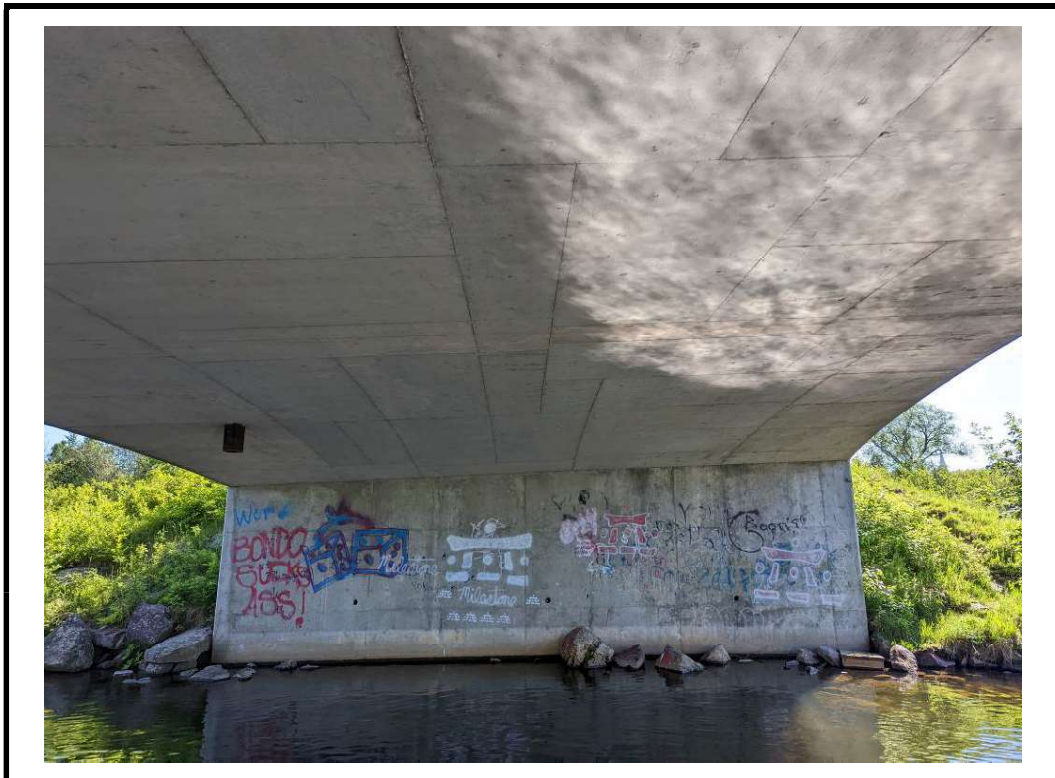
Photo 20 Narrow full length vertical cracks and graffiti noted on abutment walls (Typical)

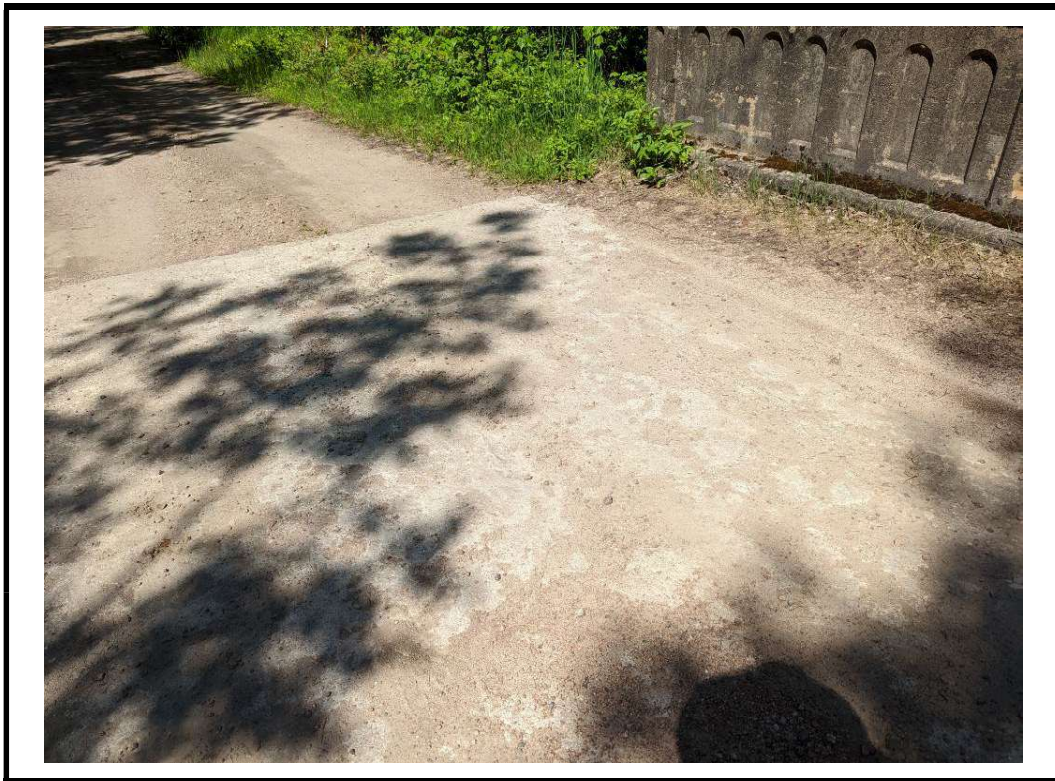
Photo 8 Moderate scaling, small spalls and dirt accumulation on exposed deck top.

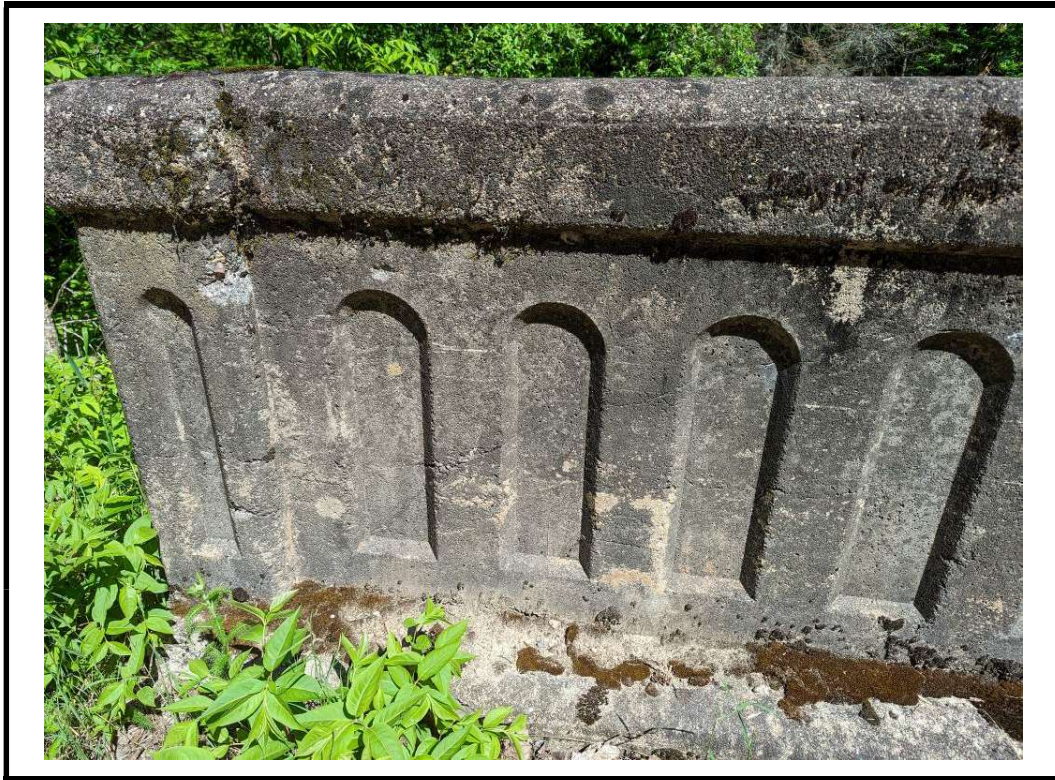
Photo 9 Light to moderate scaling and discoloration noted on parapet wall

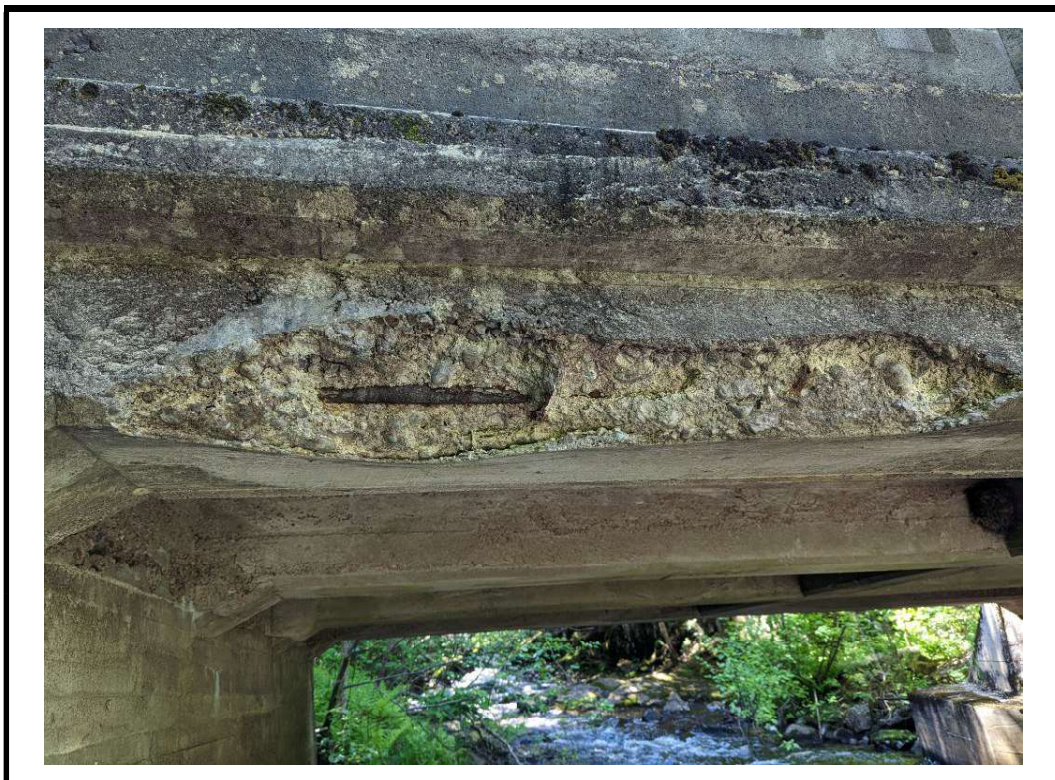
Photo 10 Large spall with exposed corroded reinforcing on north fascia.

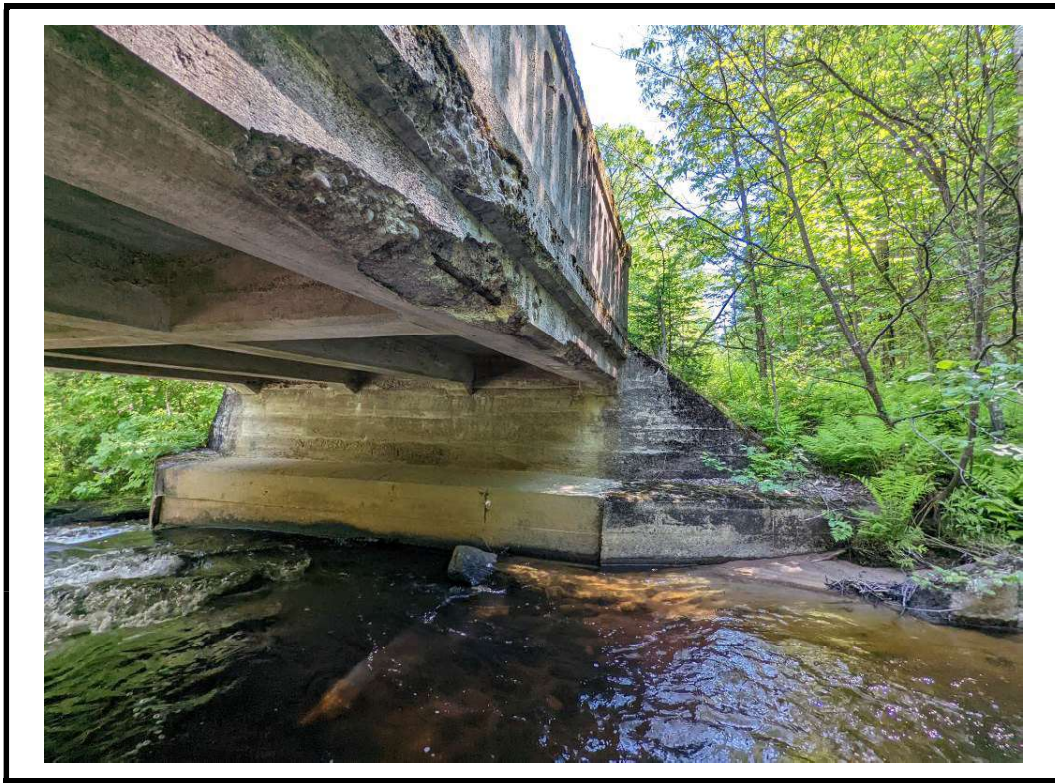
Photo 11 Spalls with exposed corroded reinforcement on face of exterior girder

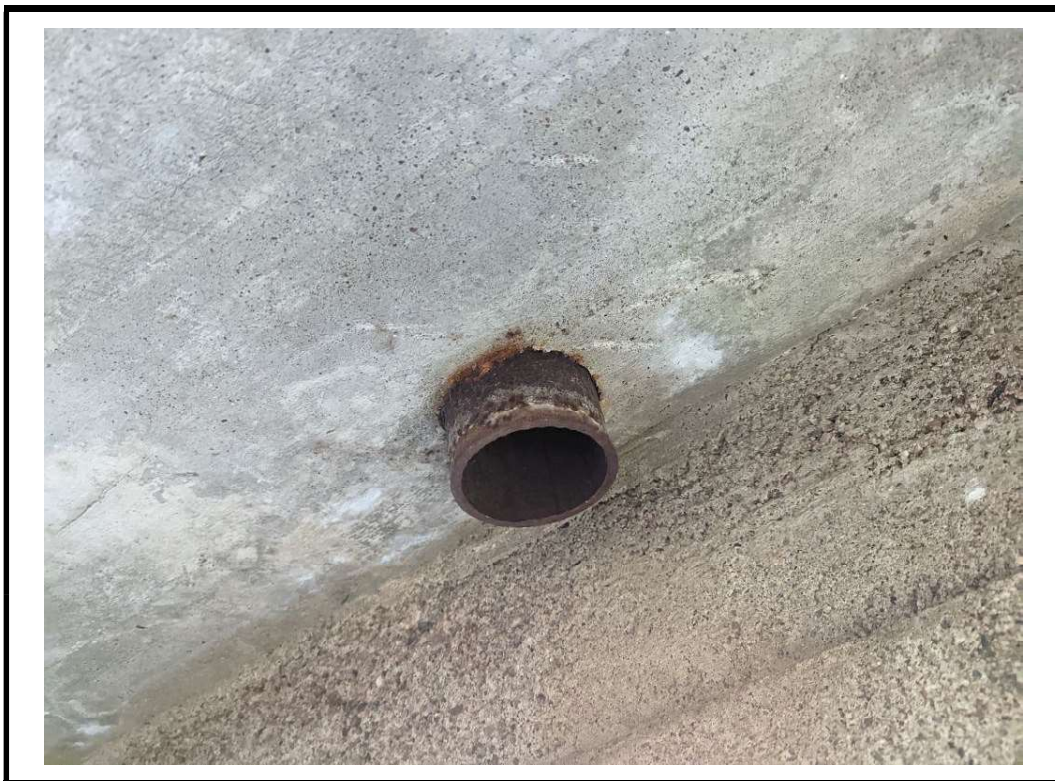
Photo 12 Corrosion and perforation noted at deck drain (Typical)

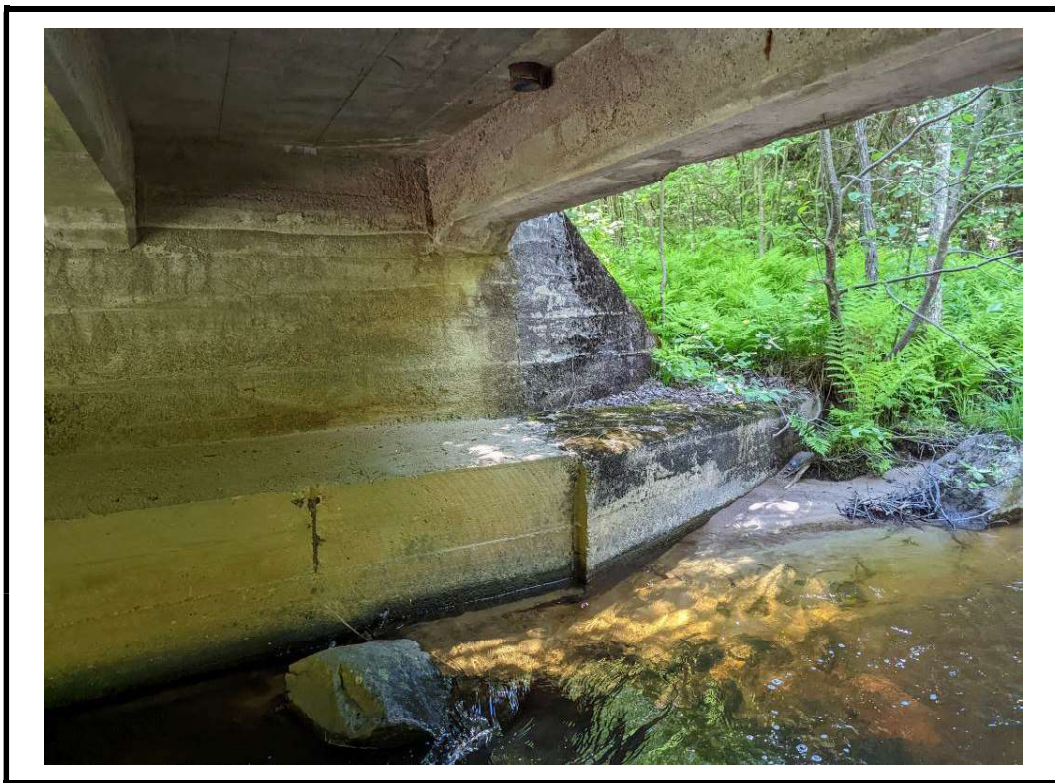
Photo 14 Spall with exposed corroded reinforcing steel on abutment wall

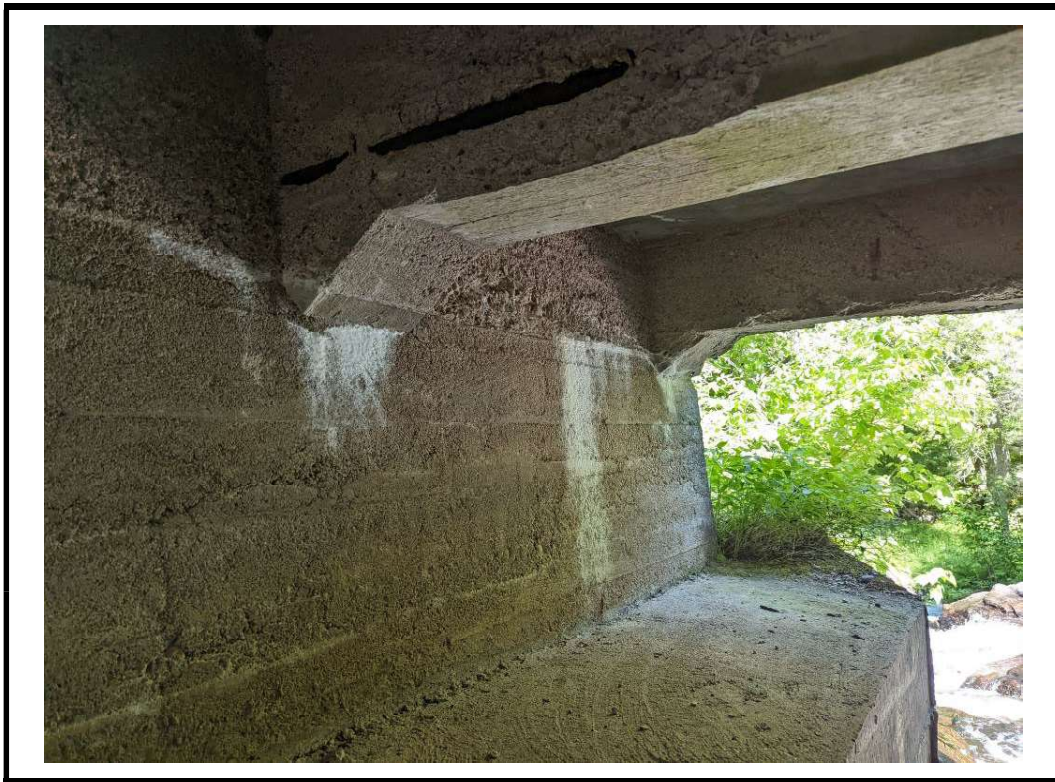
Photo 15 Moderate scaling and efflorescence stains noted on abutment wall

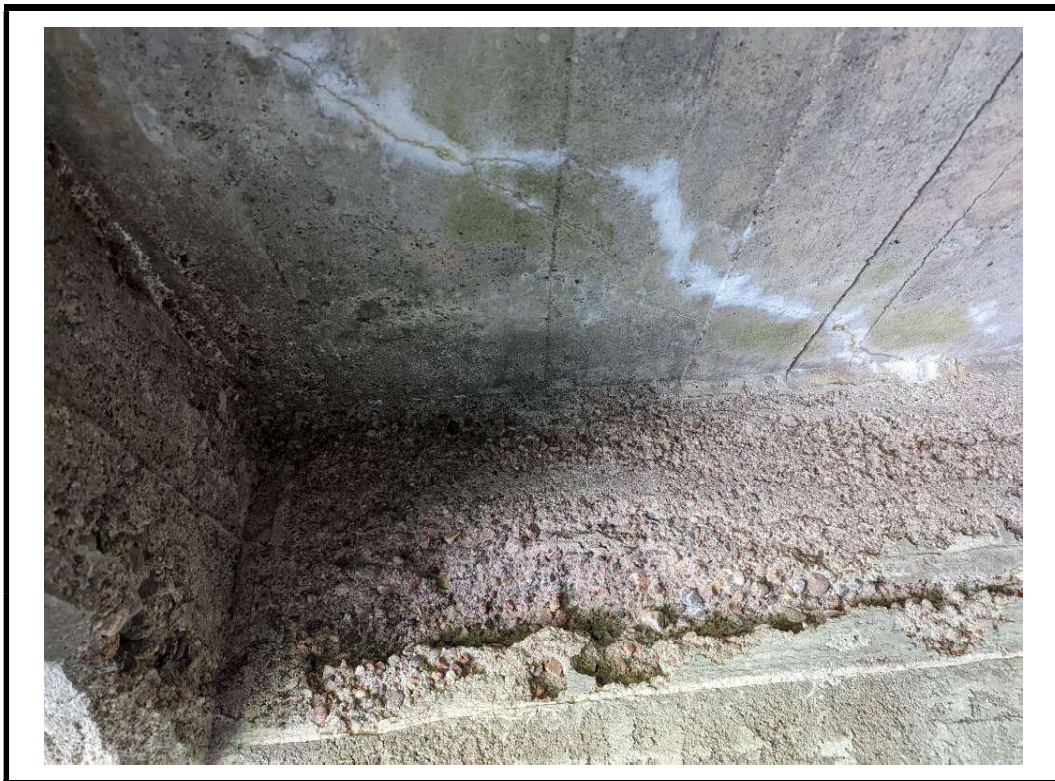
Photo 16 Severe scaling on ballast wall and cracks with efflorescence noted on deck soffit

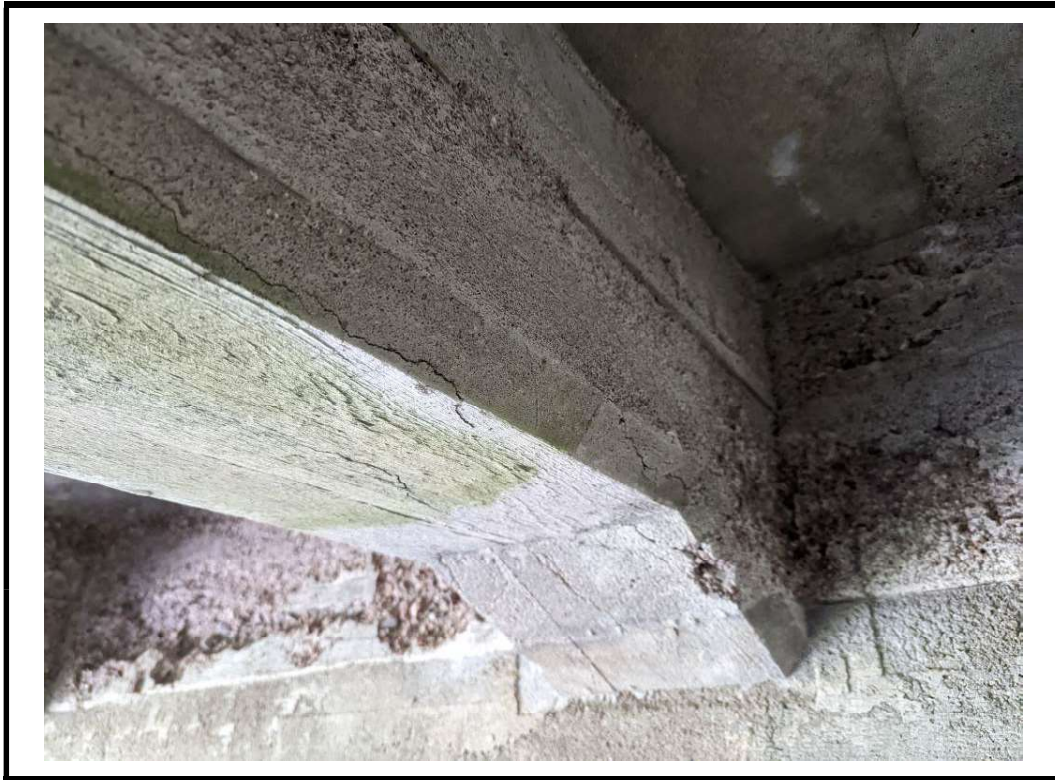
Photo 17 Spall and longitudinal cracks noted on girders

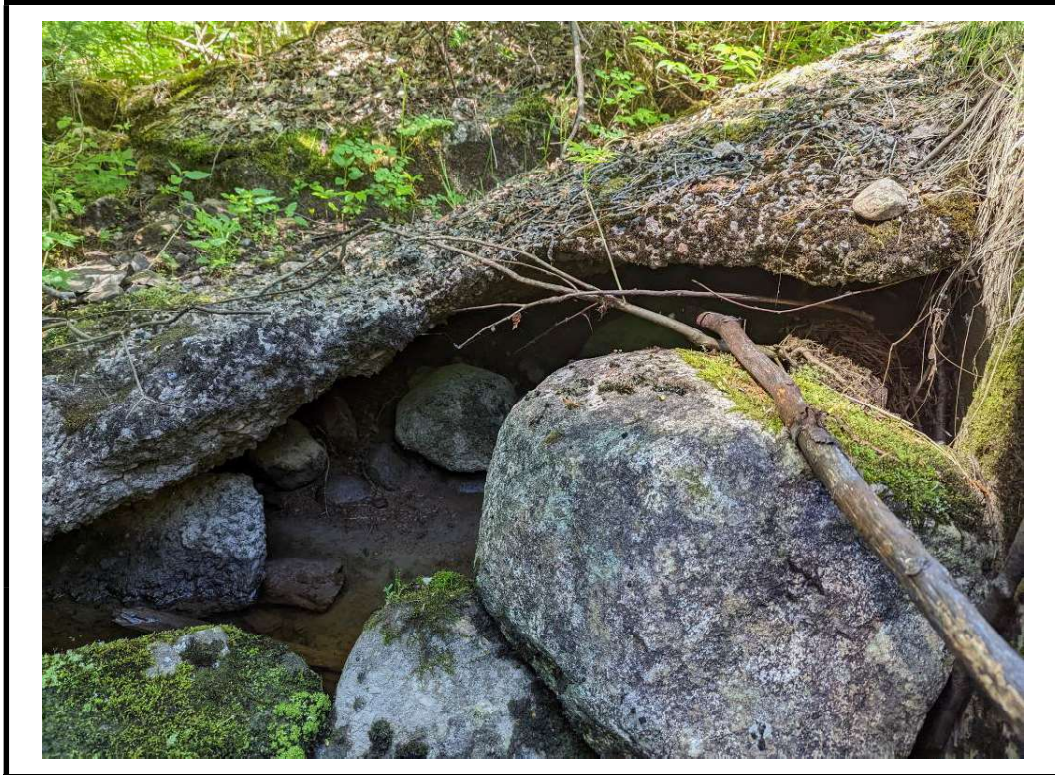
Photo 18 Concrete slope protection at southwest corner failed

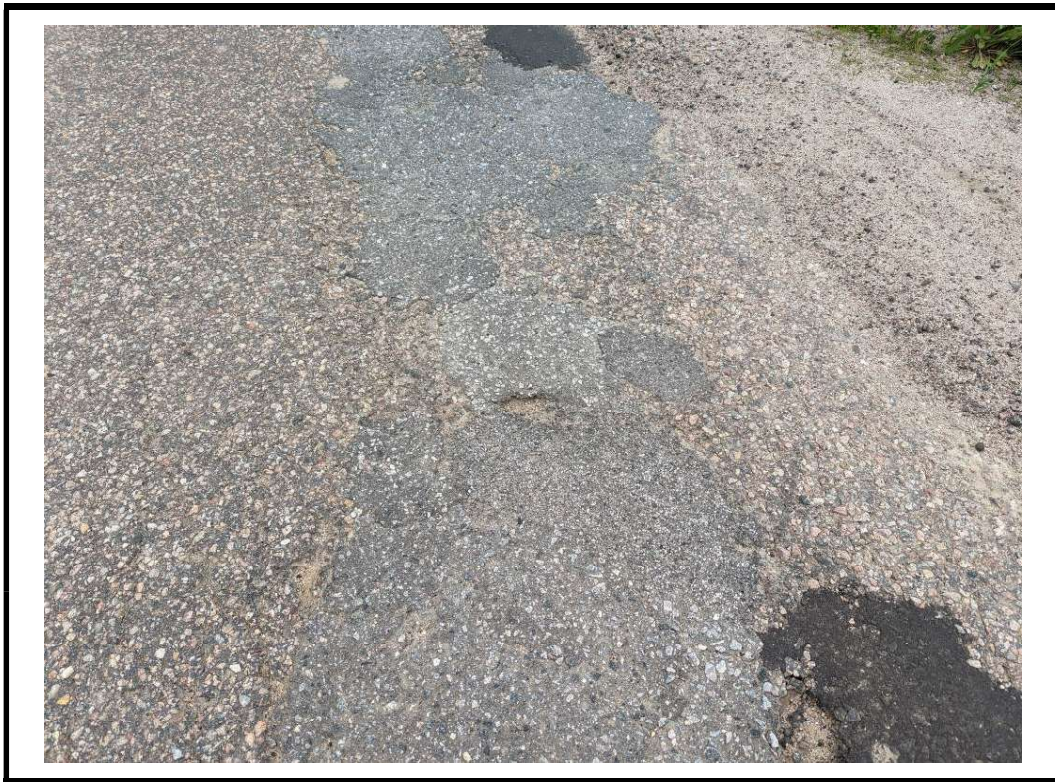
Photo 7 Asphalt patches and small pothole on west approach wearing surface

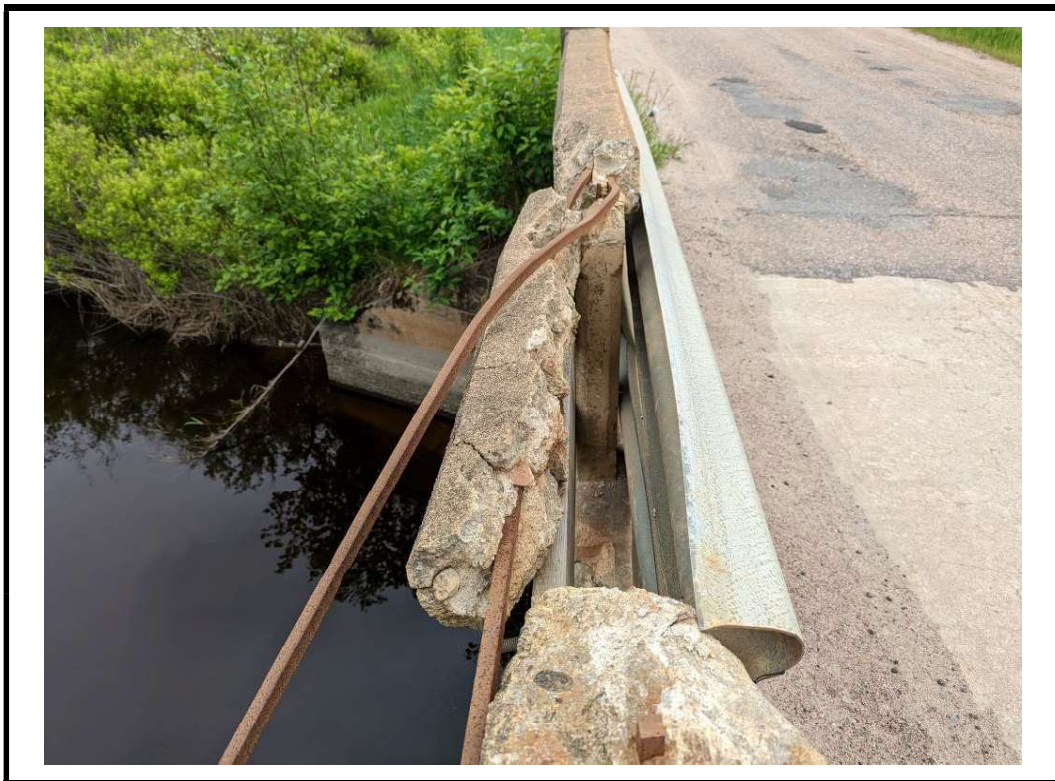
Photo 8 Exposed corroded reinforcement and steel beam on barrier

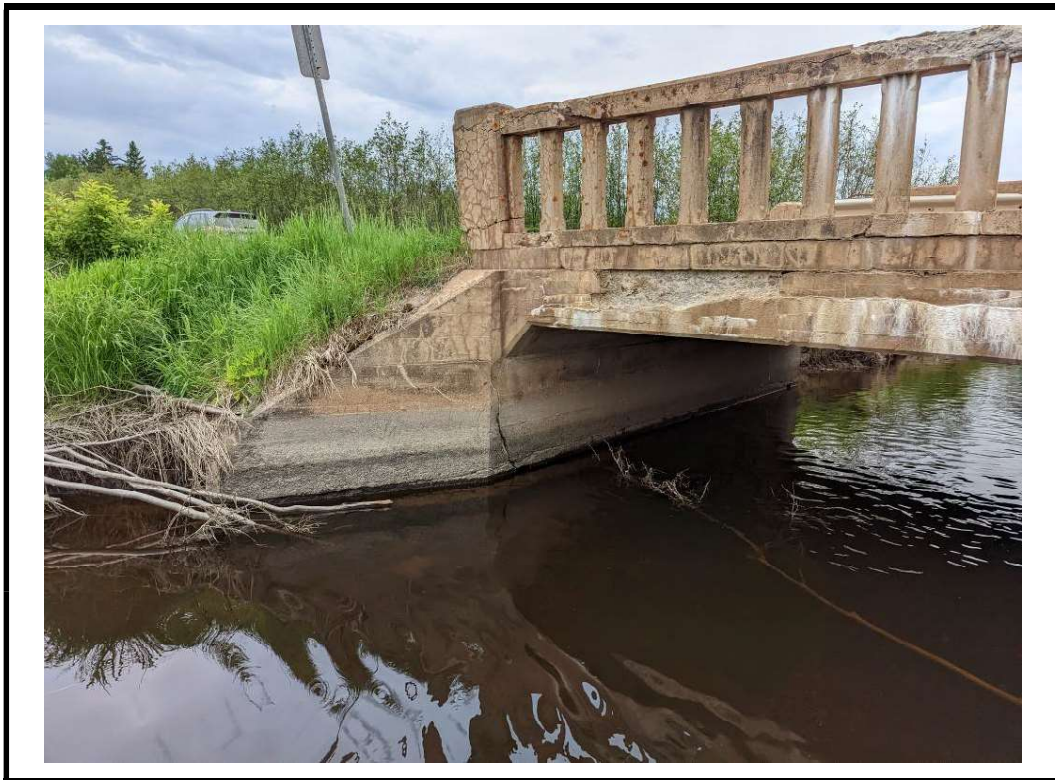
Photo 9 Severe spall and cracks with efflorescence noted on south fascia

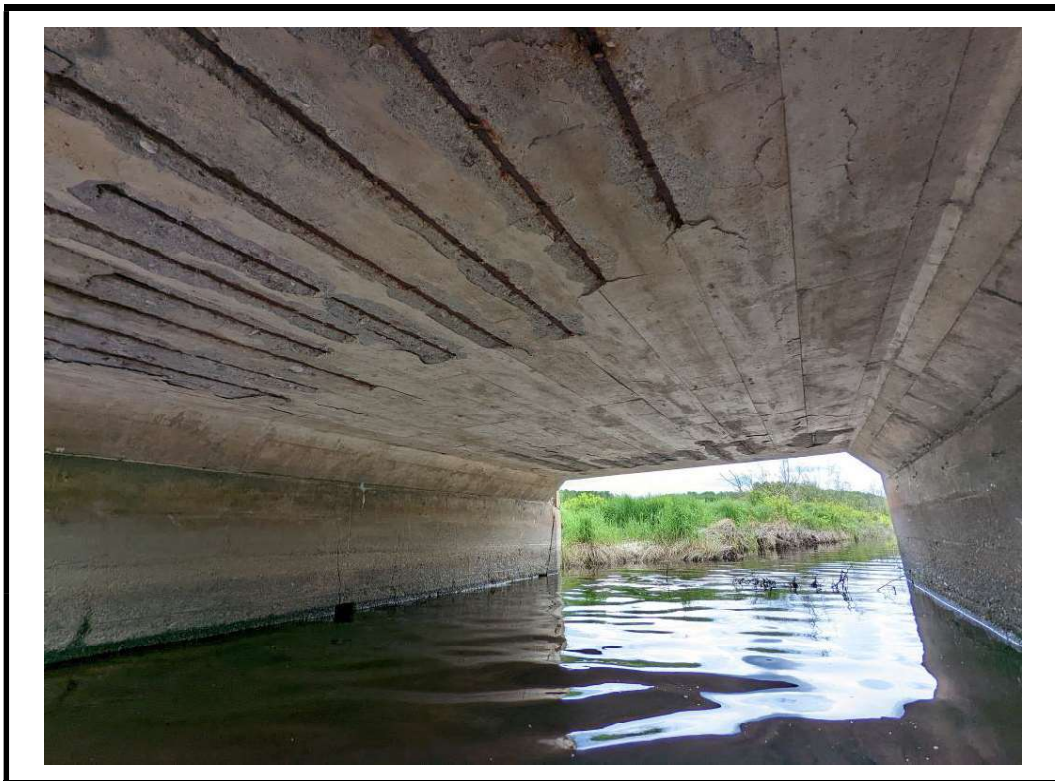
Photo 10 Spalls with exposed corroded reinforcement and severe delamination on soffit.

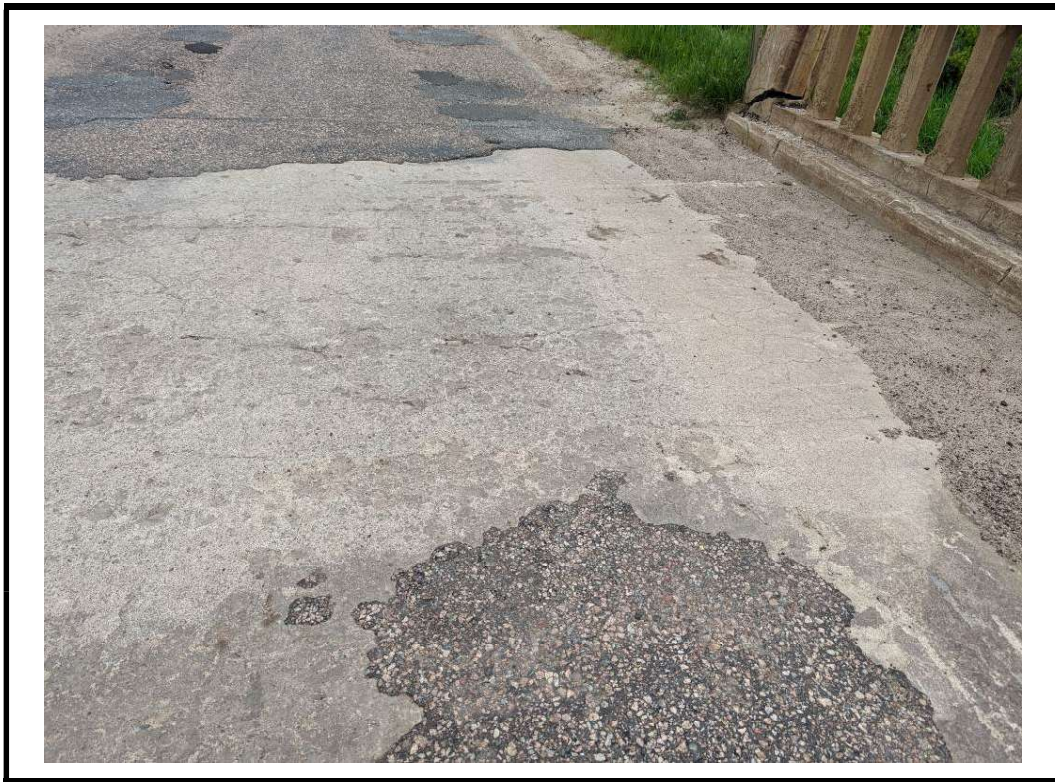
Photo 11 Minor scaling, medium spall and debris noted on deck top

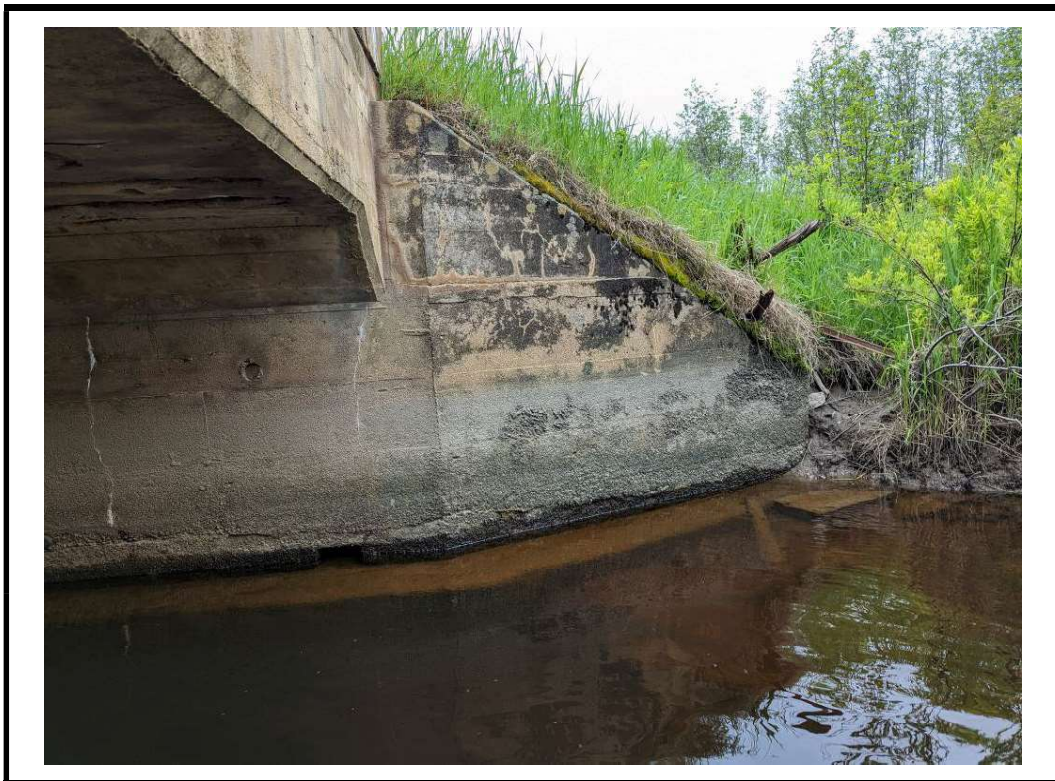
Photo 12 Narrow cracks with efflorescence noted on northwest wingwall.
