MUNICIPAL STRUCTURE INSPECTION FORM

SITE PHOTOGRAPHS

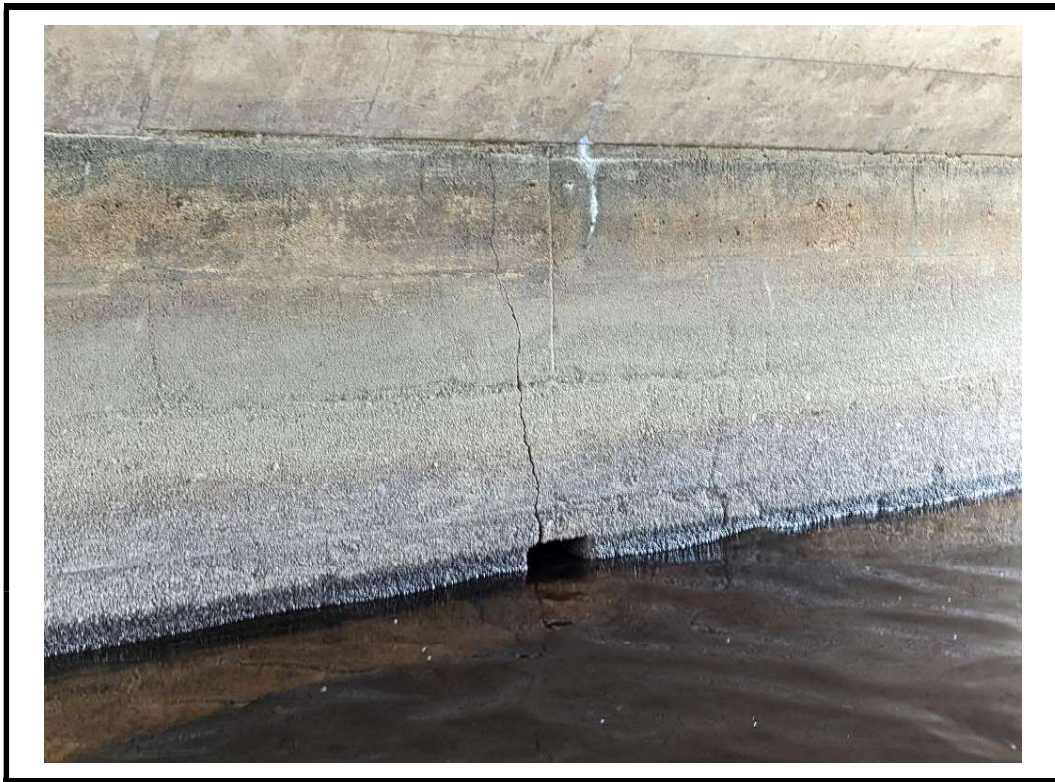
Photo 13 Medium crack with efflorescence observed on abutment wall

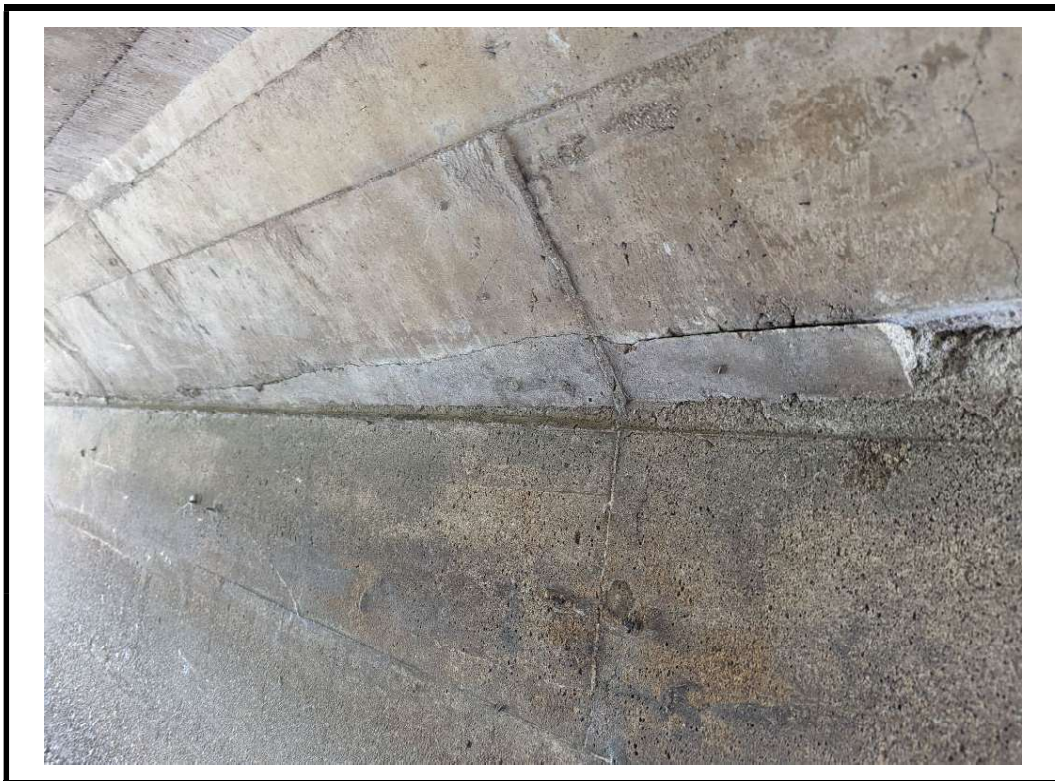
Photo 14 Small spall and longitudinal cracks noted at haunches

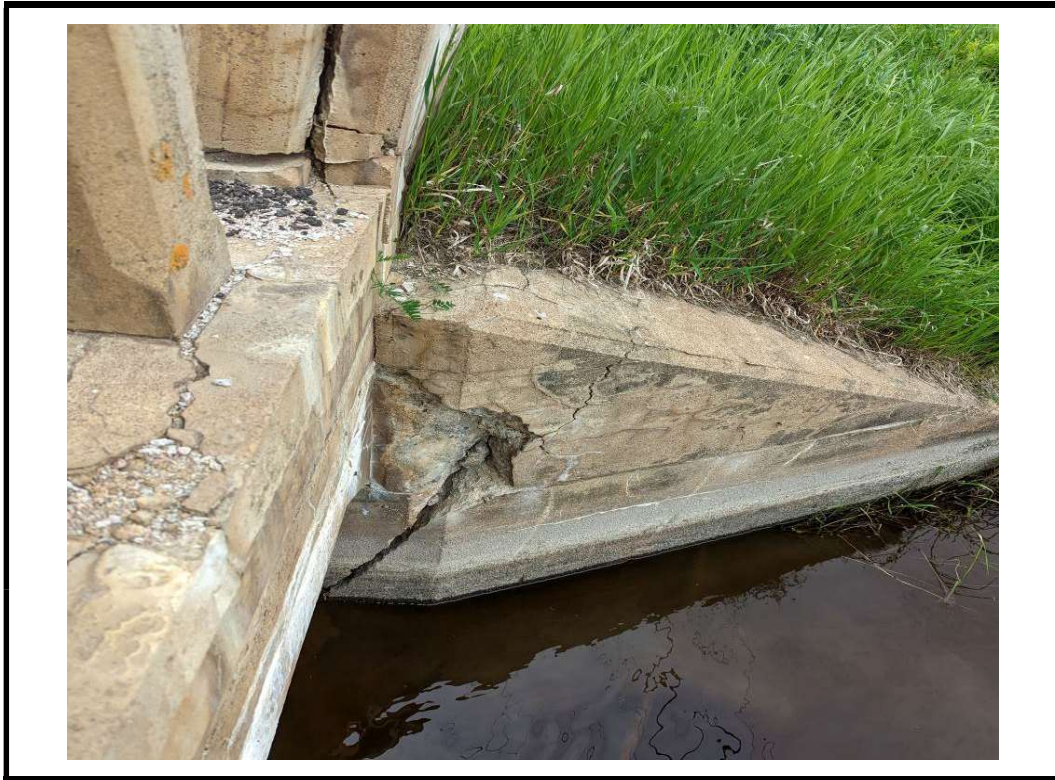
Photo 15 Large spall with crack noted on southeast wingwall

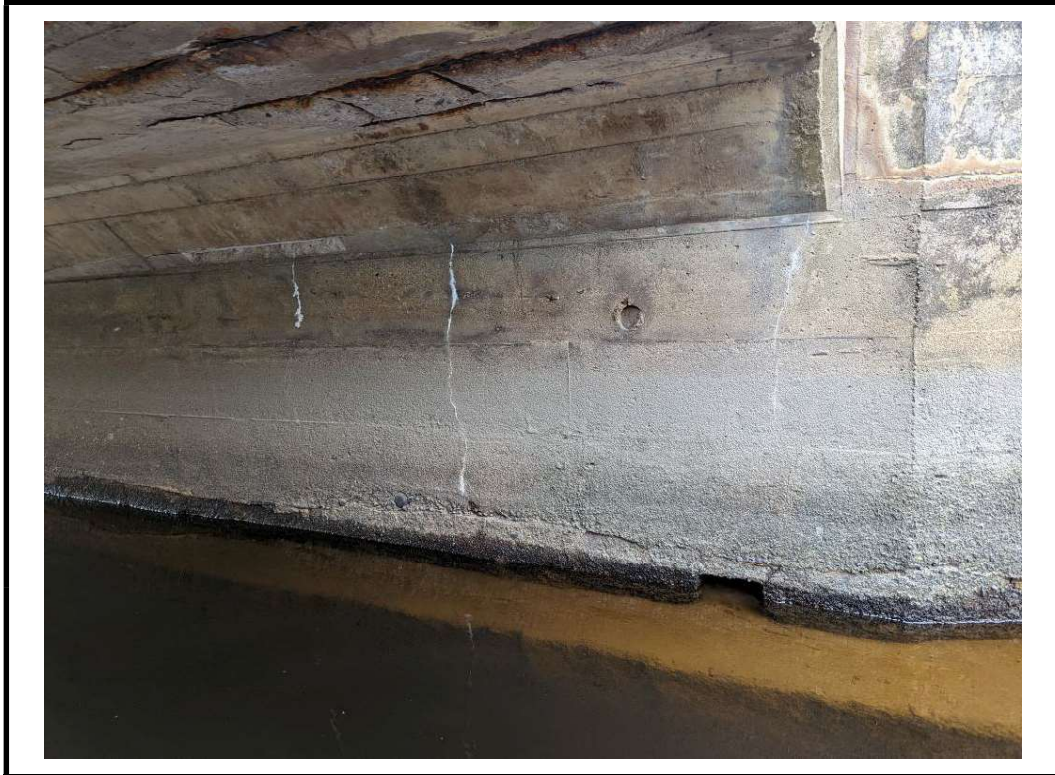
Photo 16 Moderate scaling, narrow cracks with efflorescence noted on west abutment wall
