**MUNICIPAL STRUCTURE INSPECTION FORM**

**BRIDGE**

Site No.: 10

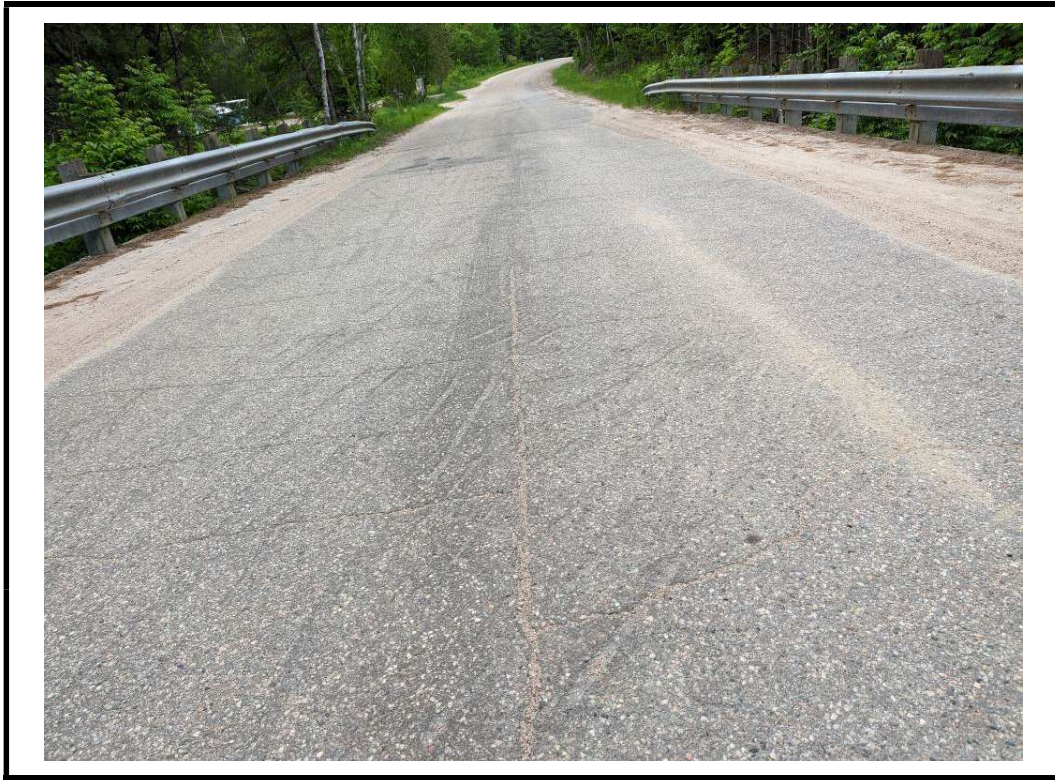
Photo 7 Wide longitudinal and transverse cracks noted on wearing surface

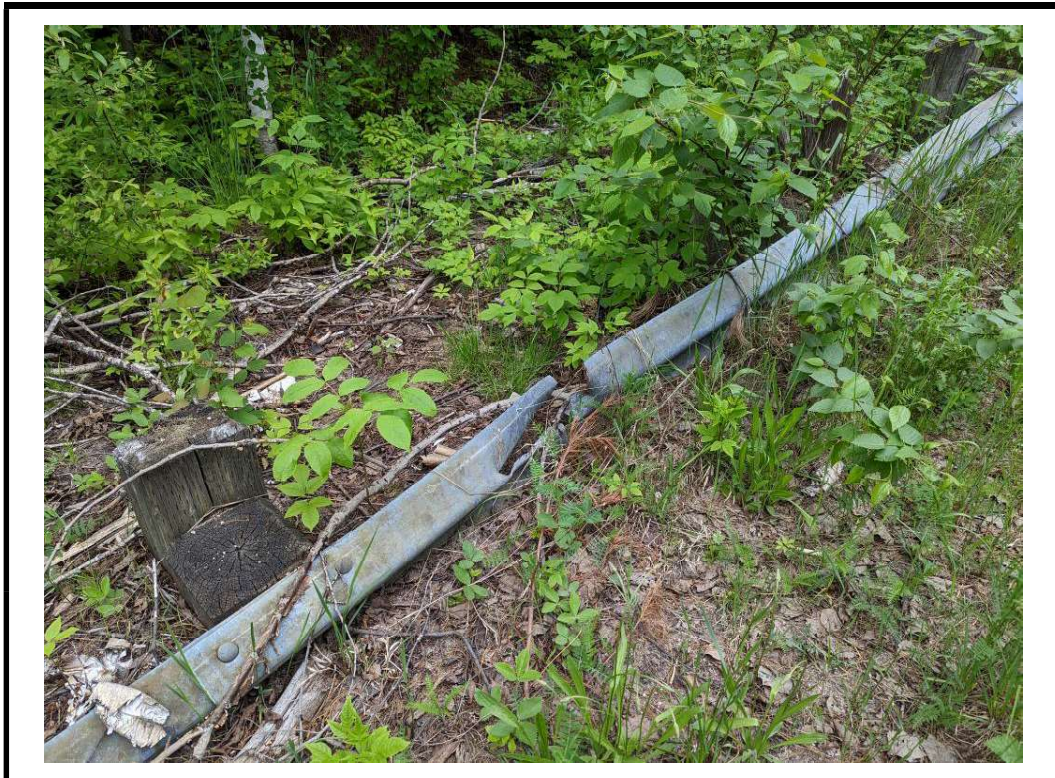
Photo 8 Damage observed on steel beam at southwest corner

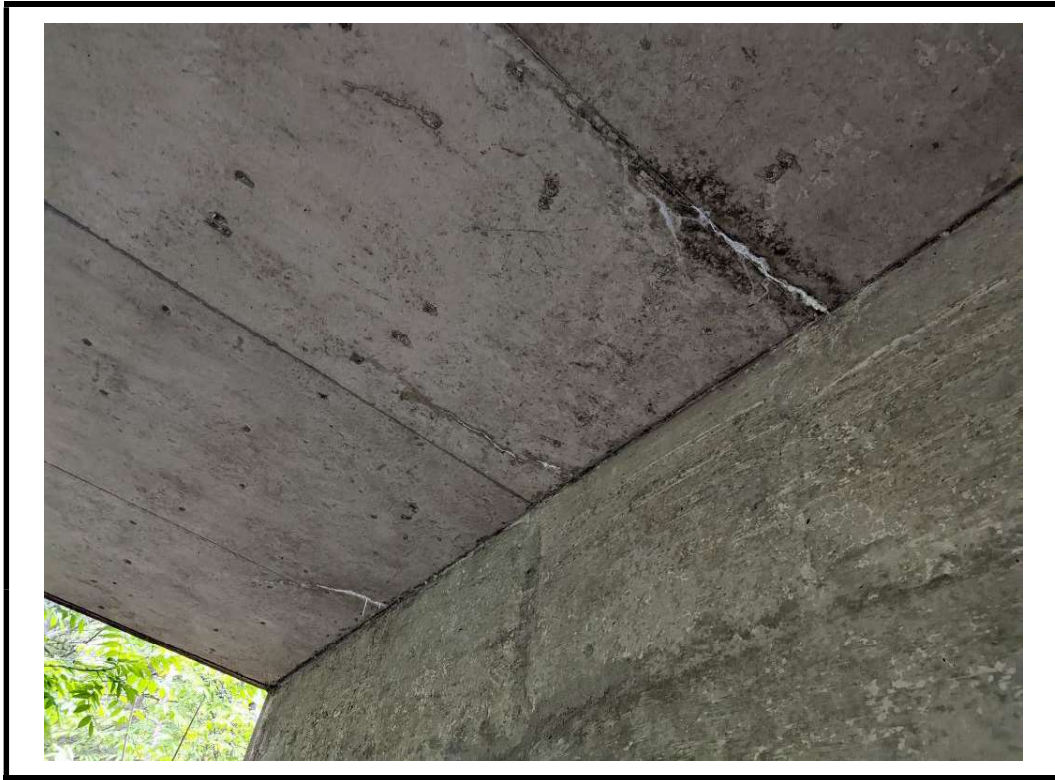
Photo 9 Narrow crack with efflorescence on north deck soffit

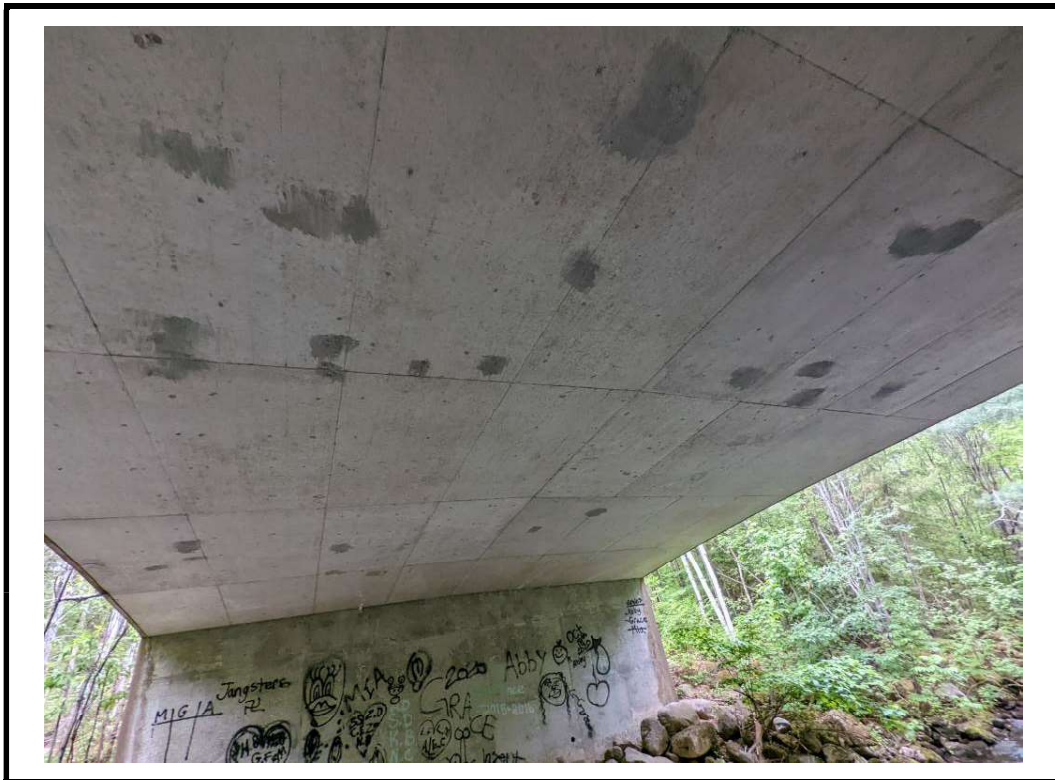
Photo 10 Typical deck soffit with previous concrete repairs

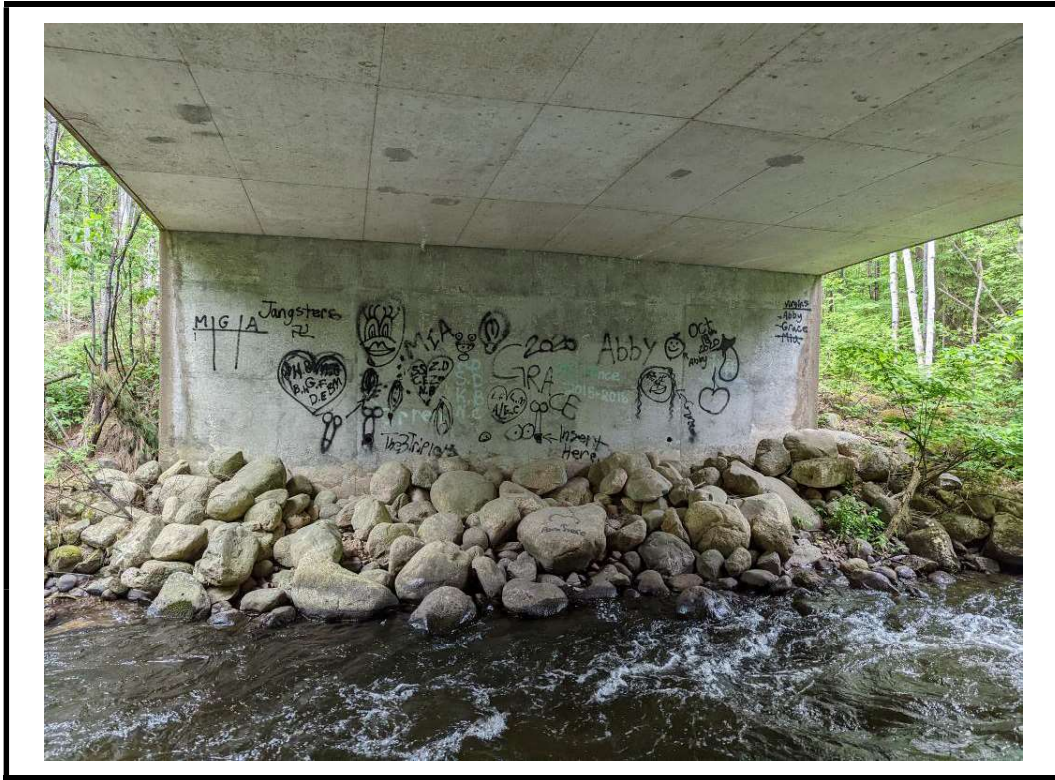
Photo 13 Graffiti on south abutment wall

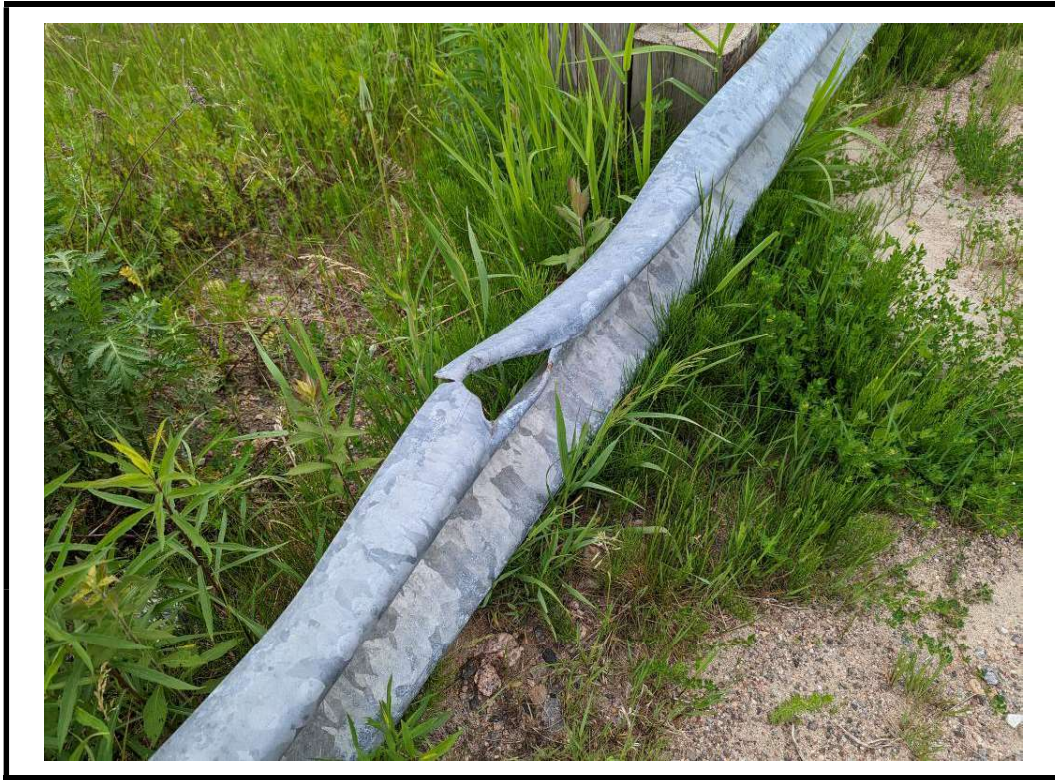
Photo 7 Collision damage noted on approach barrier at northeast corner

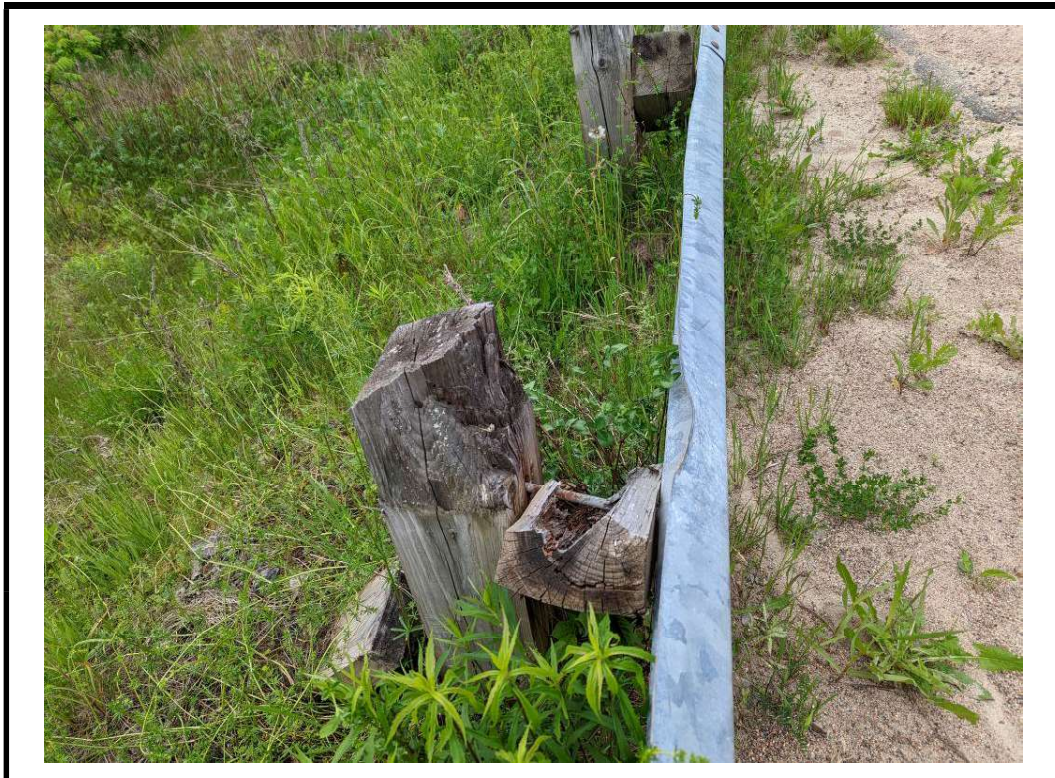
Photo 8 Checks and splits on barrier post with damaged and rotated spacer block

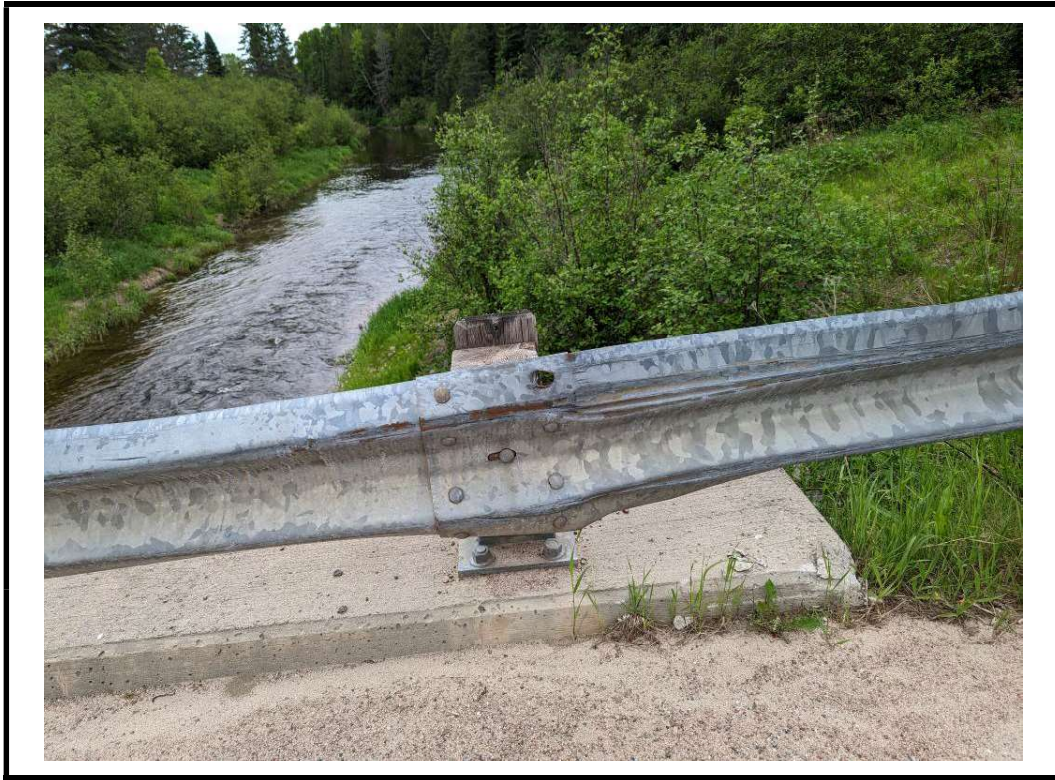
Photo 9 Vehicle damaged noted on deck barrier at southeast corner

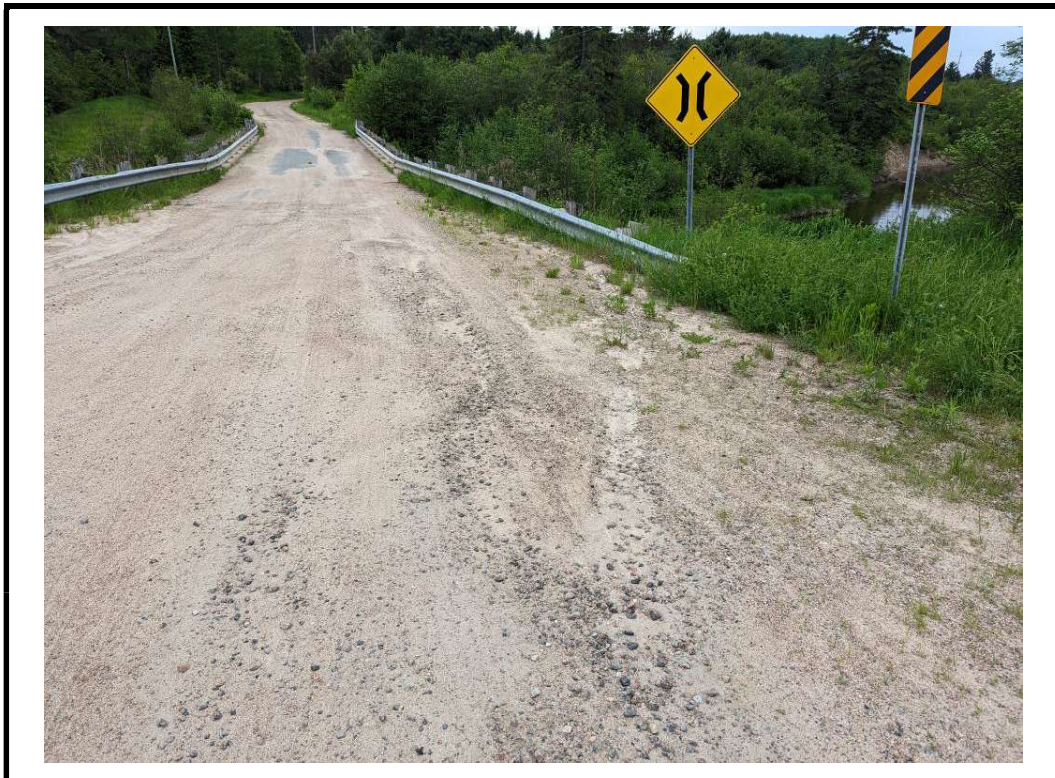
Photo 10 Washout noted in wearing surface at north approach

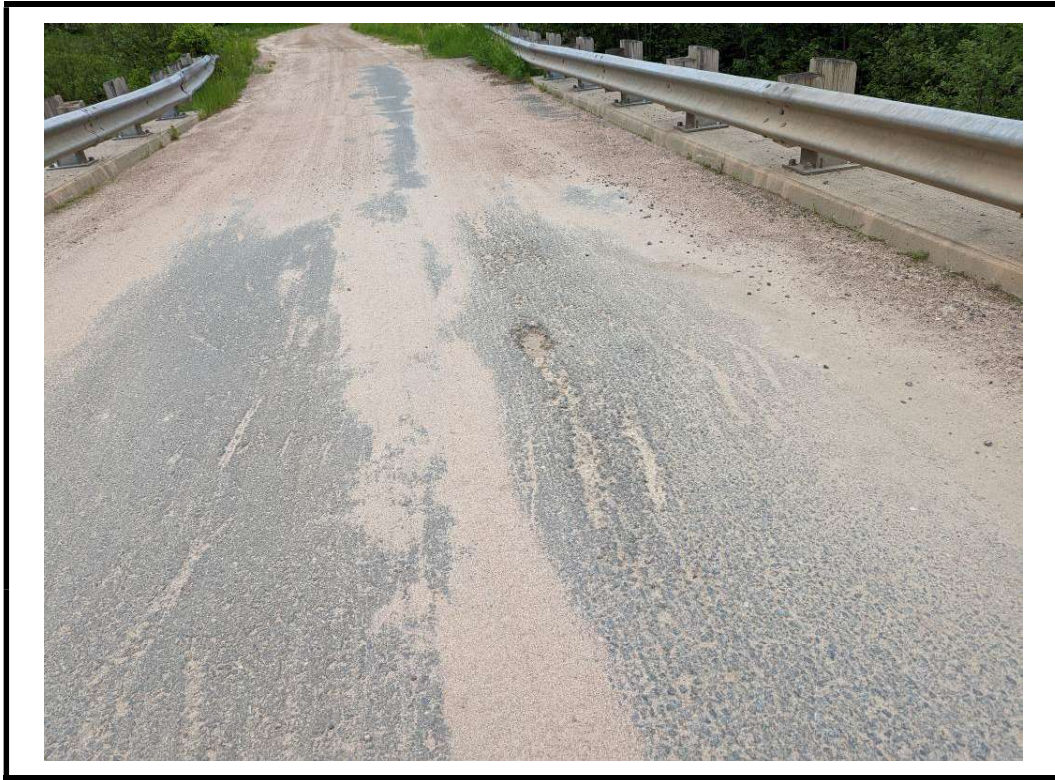
Photo 11 Minor scaling and small gouges noted in middle of deck wearing surface

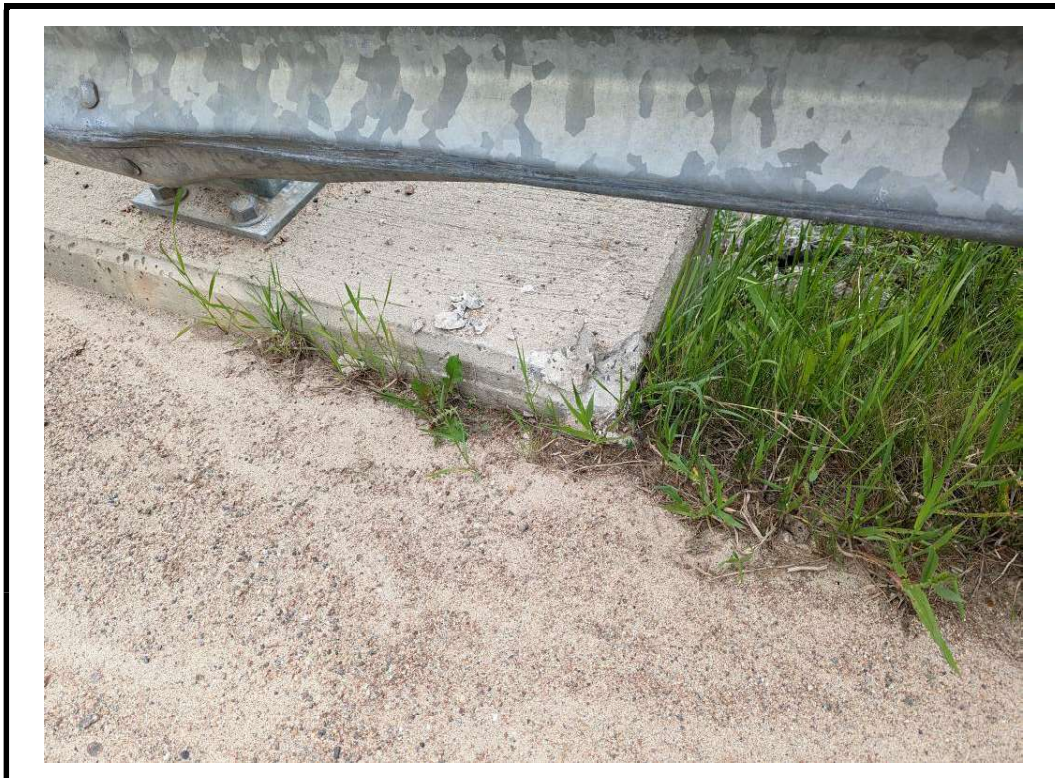
Photo 12 Small spall noted in curb at southeast corner

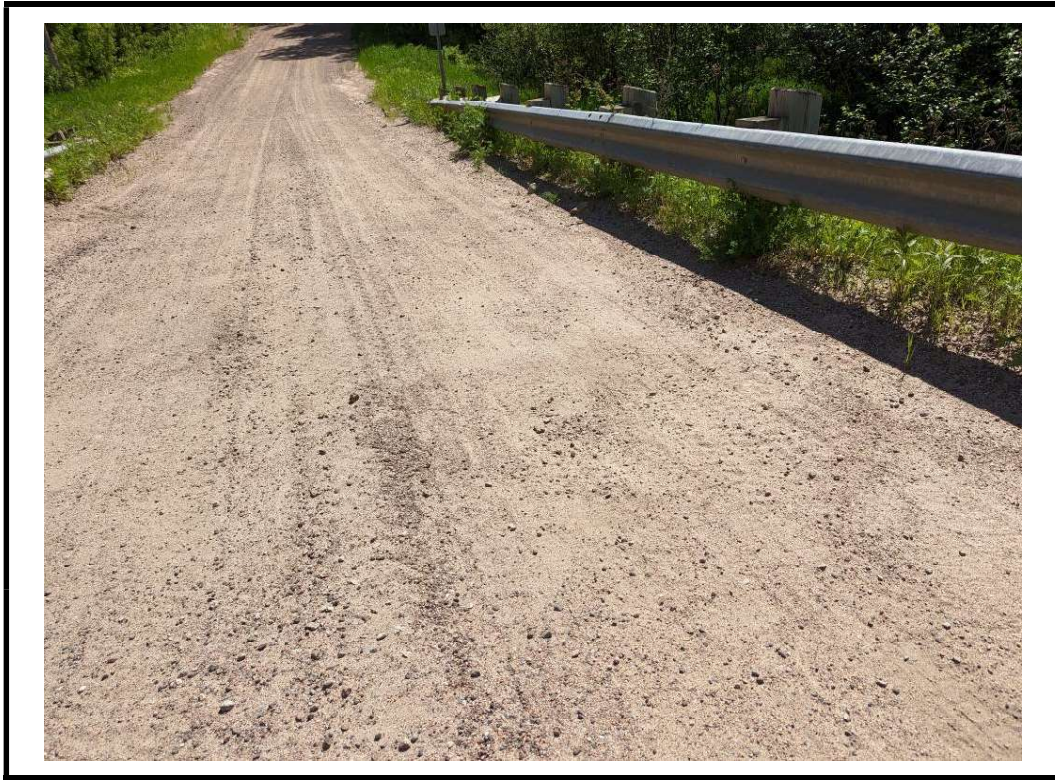
Photo 7 Tire rutting and loose gravel on east approach.

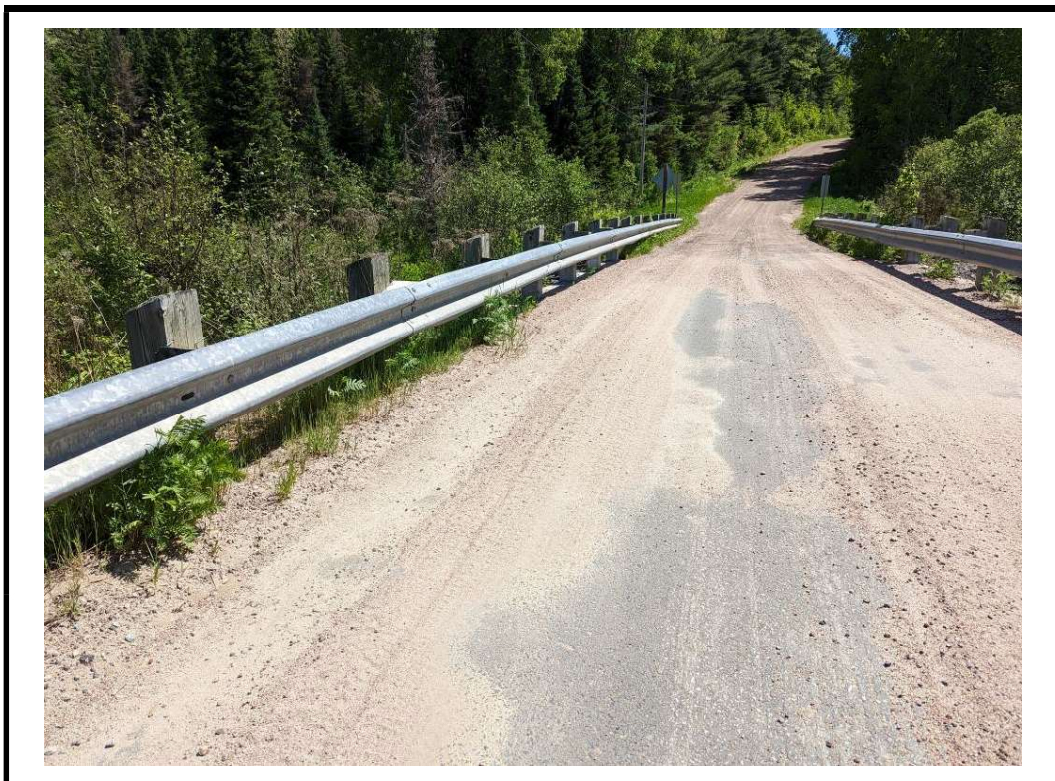
Photo 8 Longitudinal grooves on structure wearing surface

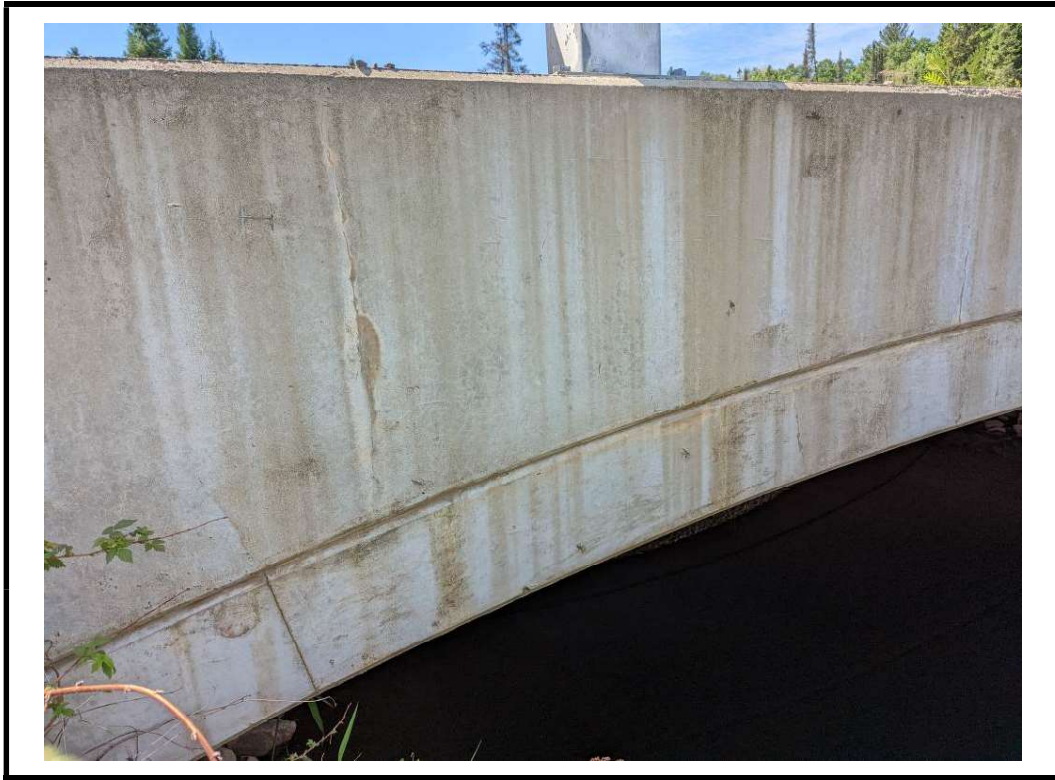
Photo 9 Stained map cracks noted on exterior face of soffit

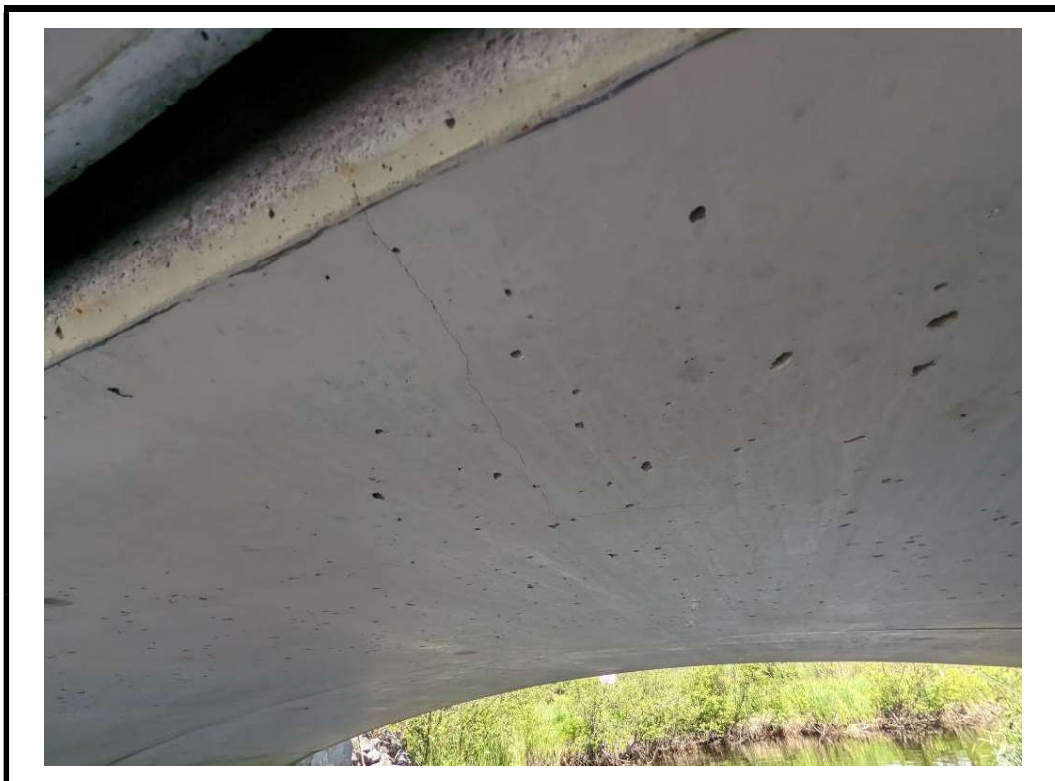
Photo 10 Narrow transverse crack noted in centre of soffit at south end

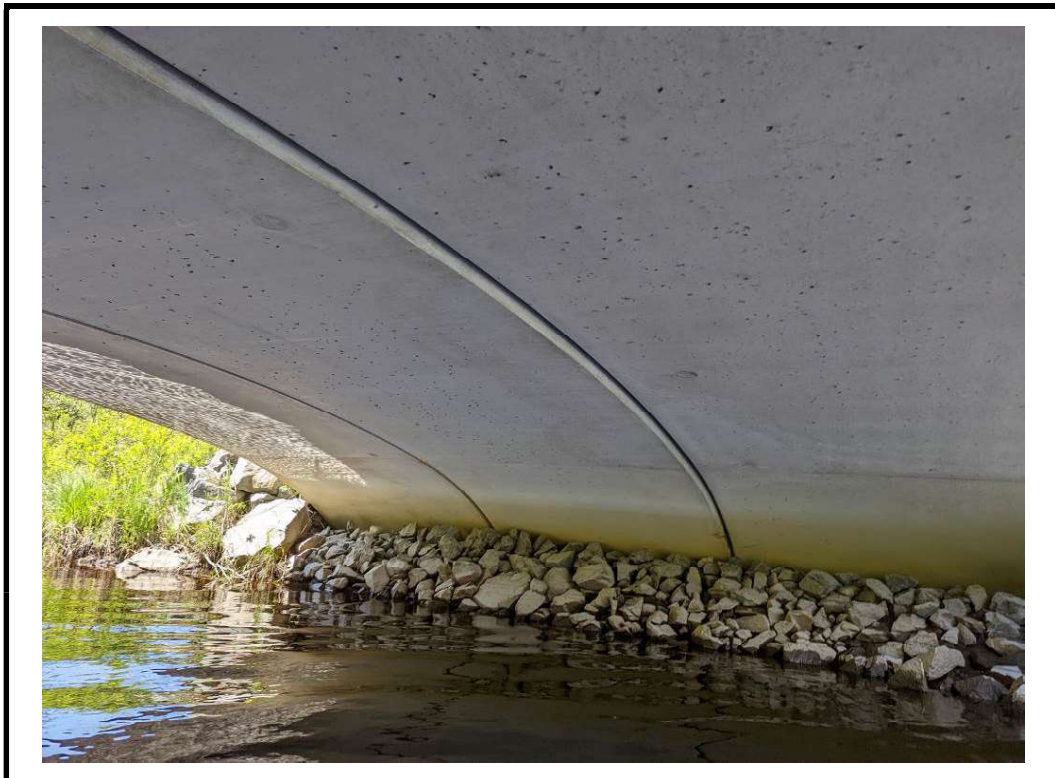
Photo 12 Bug holes noted throughout barrel soffit
